FINAL REPORT:

BRIODY DRIVE - DEEP CREEK GEOMORPHIC ASSESSMENT

December 2023

Client: Summerset Torquay
Contact: Harry Mohan
Project: Briody Drive Geomorphic Assessment

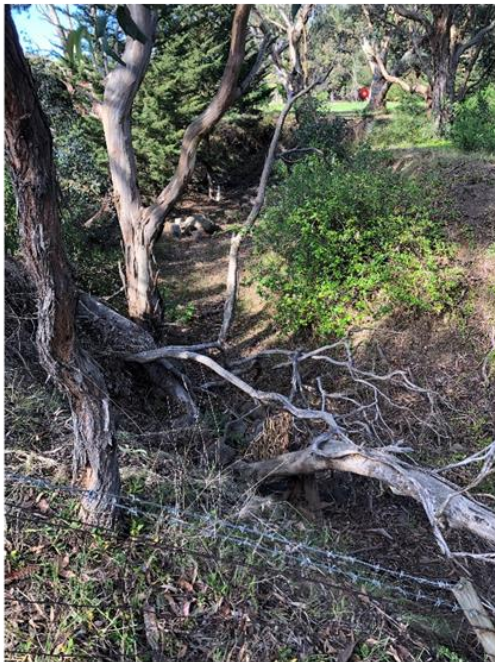
Photo 1 – Tributary input to Deep Creek (looking upstream). Gully is developing and deepening in response to lower bed level in Deep Creek.

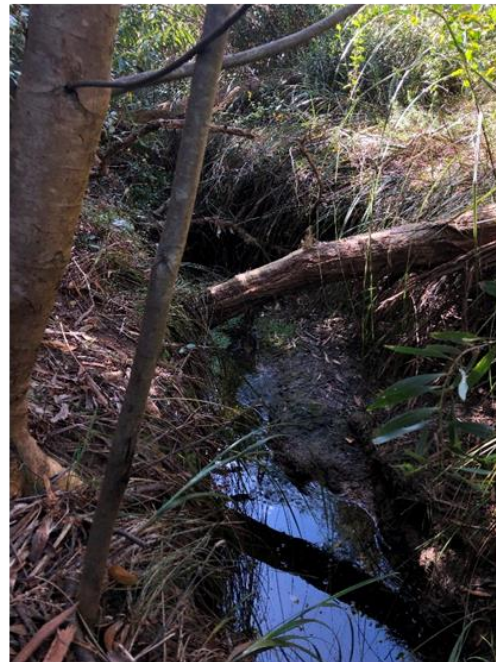
Photo 2 – Deep Creek (looking downstream). The waterway has incised with a 1.5 x 1.5m box channel cut into the creek bed. Subsequent widening as the next phase following incision has not occurred. Streambed is sandy. Riparian vegetation is relatively intact.

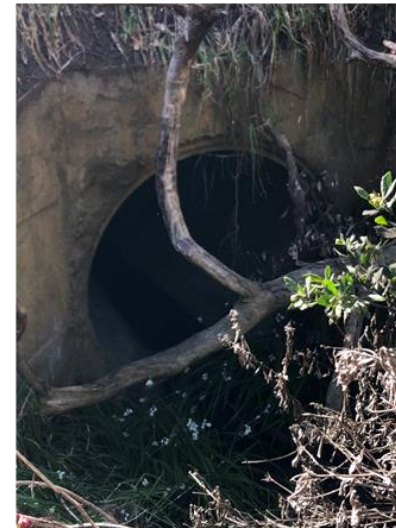
Photo 3 – Upstream end of culvert at Deep Creek crossing. Pipe diameter is approx. 1.5m.

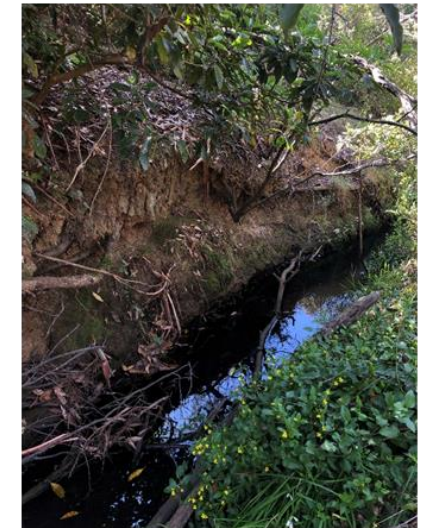
Photo 4 – Below informal timber crossing of Deep Creek (looking downstream). Waterway is incised with evidence of bank undercutting. Right bank vegetation becomes more cleared allowing introduced grasses to enter the riparian zone.

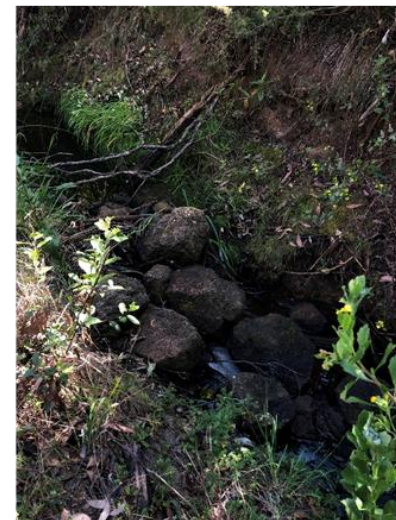
Photo 5 – Informal rock structure in Deep Creek. Rocks have been placed to reduce bed deepening with noticeable effect on water levels upstream and downstream.

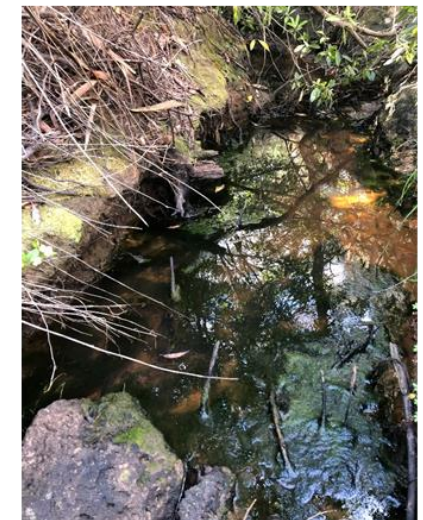
Photo 6 – Deep Creek looking downstream from informal rock structure. Evidence of undercutting occurring along left bank.

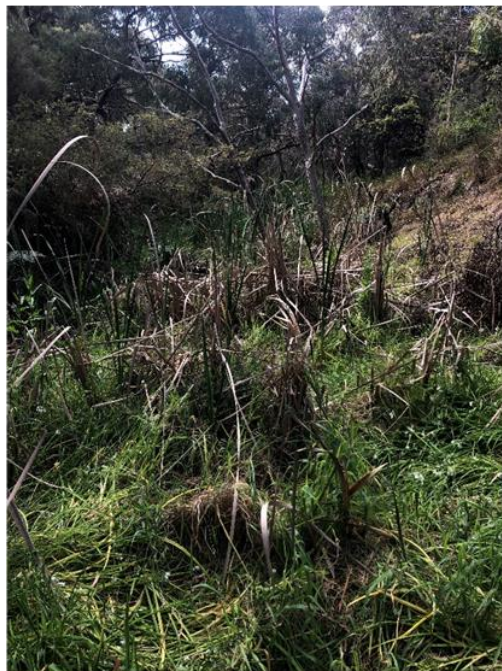
Photo 7 – Beginning of emergent aquatic vegetation (cumbungi) in the streambed of Deep Creek.

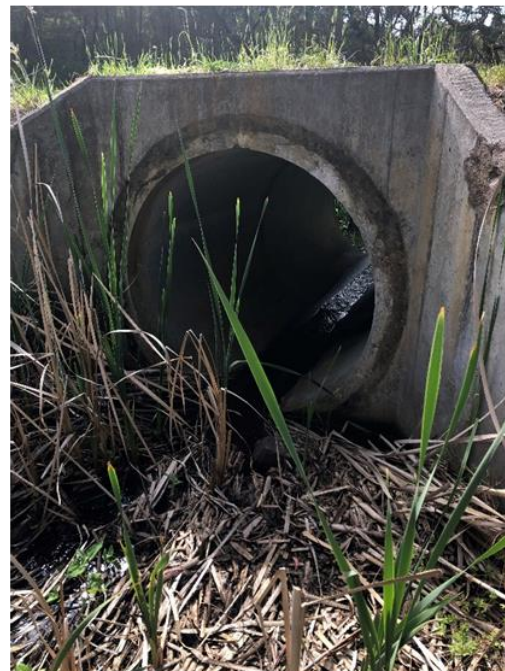
Photo 8 –Upstream end of culvert at Deep Creek crossing. Pipe diameter is approx. 1.5m.

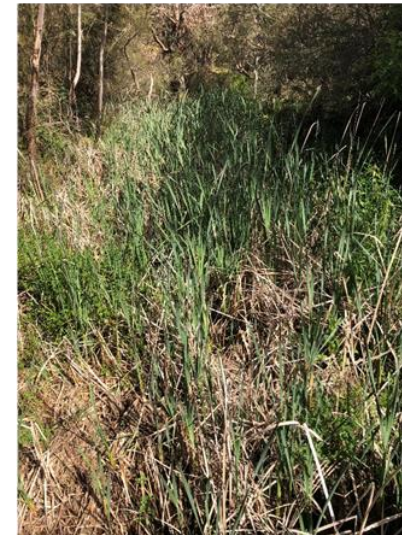
Photo 9 – Dense cumbungi stand (looking upstream from Deep Creek crossing).

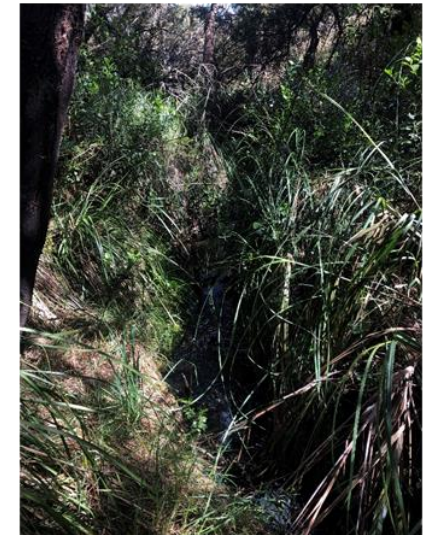
Photo 10 – Typical channel profile of Deep Creek (looking downstream). Streambed has changed from sandy to gravels overlaying sands. The gravels are coming from the adjacent road networks to the south and entering the channel via stormwater (particularly overflow structures).

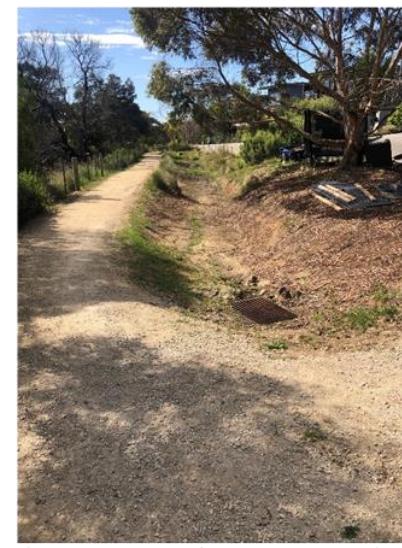
Photo 11 – Stormwater infrastructure adjacent to the walking track at the bottom of Tea Tree Rise.

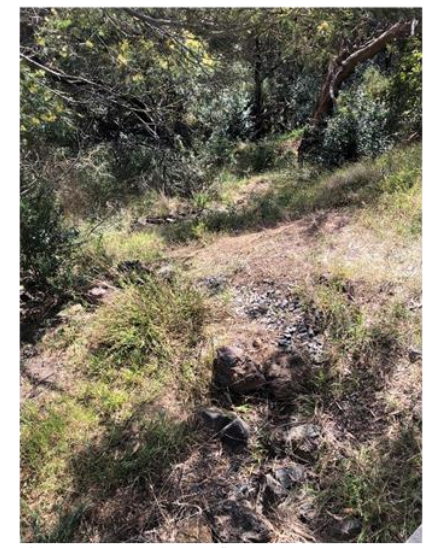
Photo 12 – Stormwater overflow structure entering Deep Creek at the bottom of Tea Tree Rise.

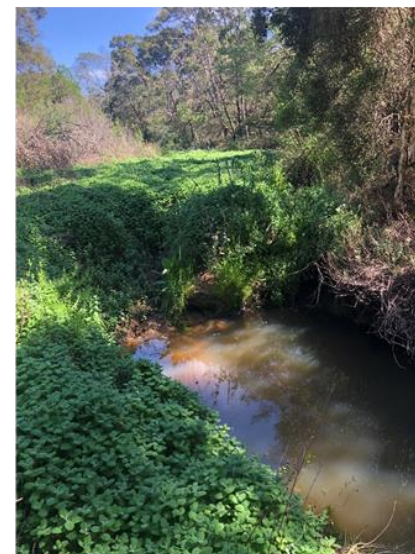
Photo 14 – Typical channel profile of Deep Creek (looking upstream from Fisher Street culvert).

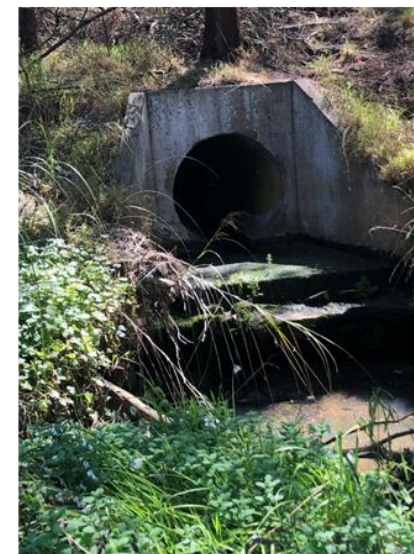
Photo 15 – Downstream end of stormwater inlet to Deep Creek (upstream of Fisher Street). Pipe diameter is approx. 1.0m.

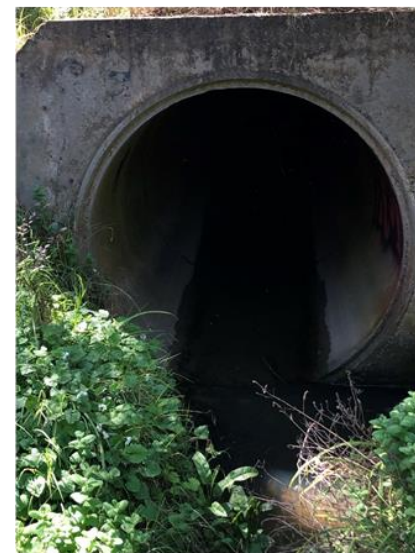
Photo 16 – Upstream end of culvert along Deep Creek at Fisher Street crossing. Pipe diameter is approx. 2.0m.

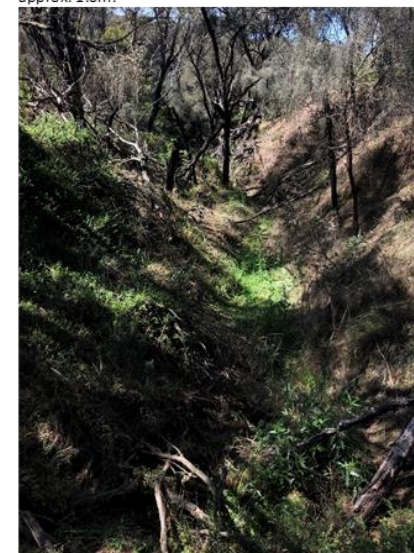
Photo 17 – Typical channel profile of Deep Creek (looking downstream from walk-bridge towards The Esplanade).

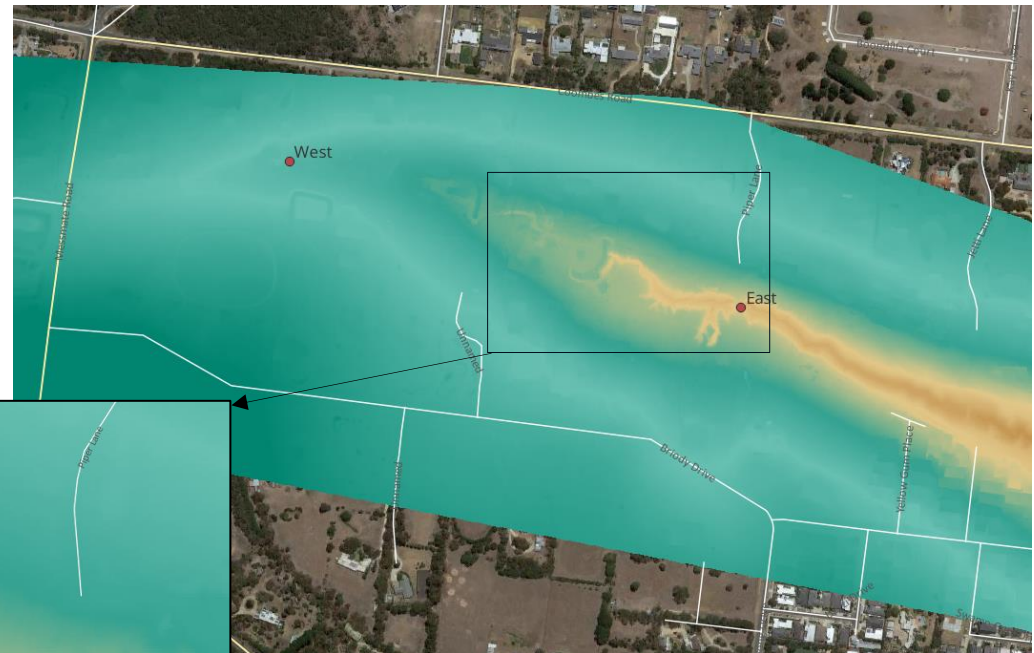
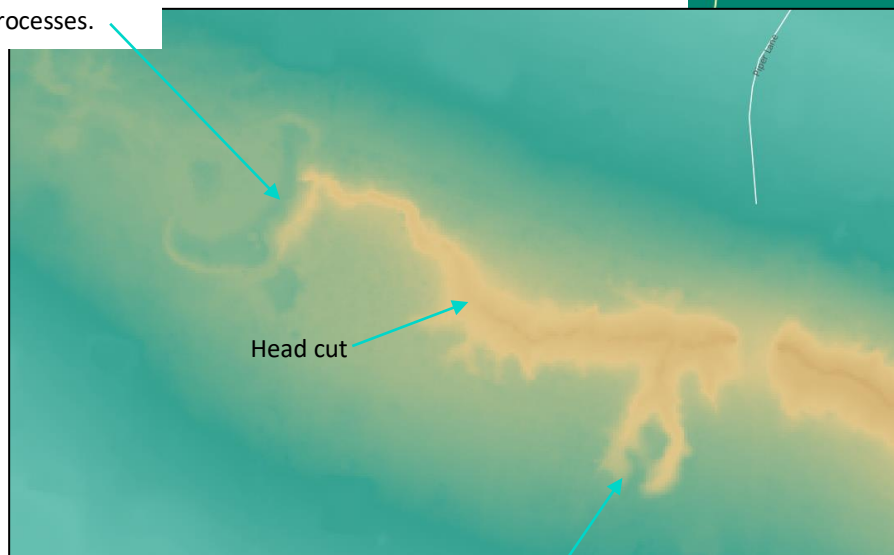
The existing dam has altered the flow regime in Deep Creek, concentrating outflows and has triggered channel deepening and incision processes.

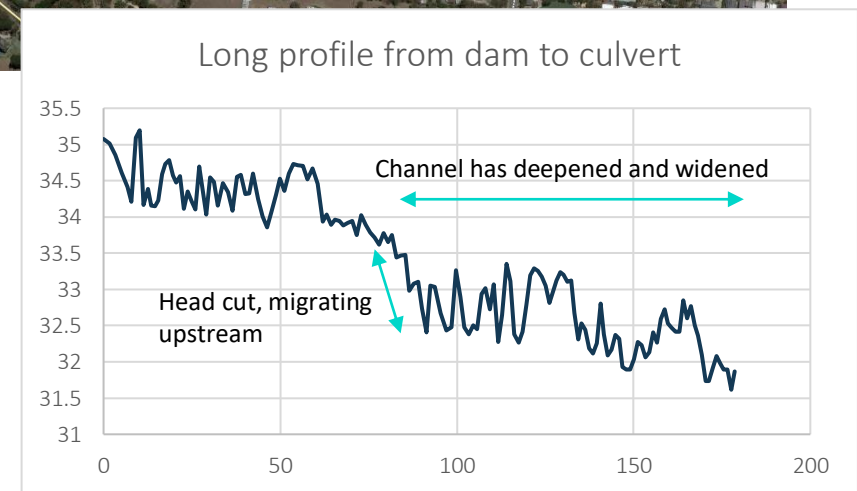
Gullying is occurring and will likely continue to develop because of overland flows.

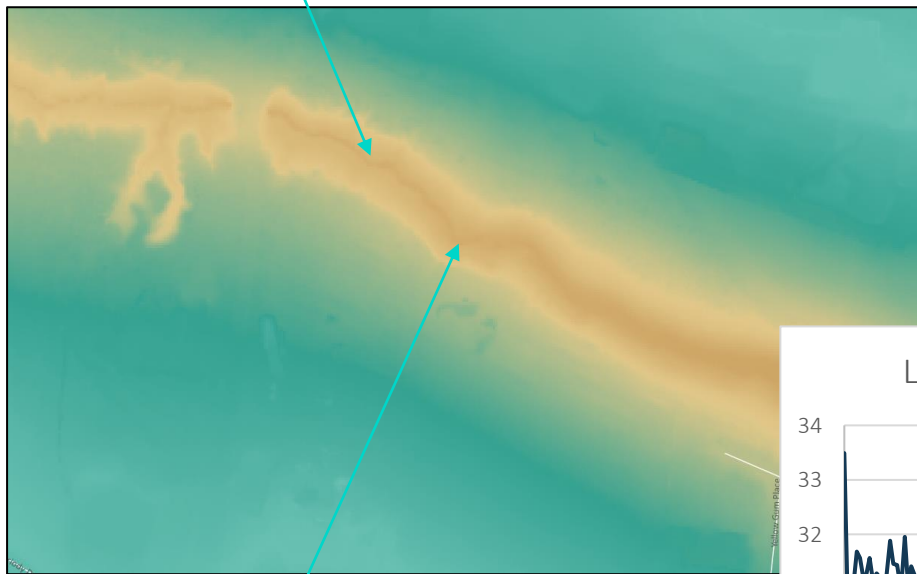
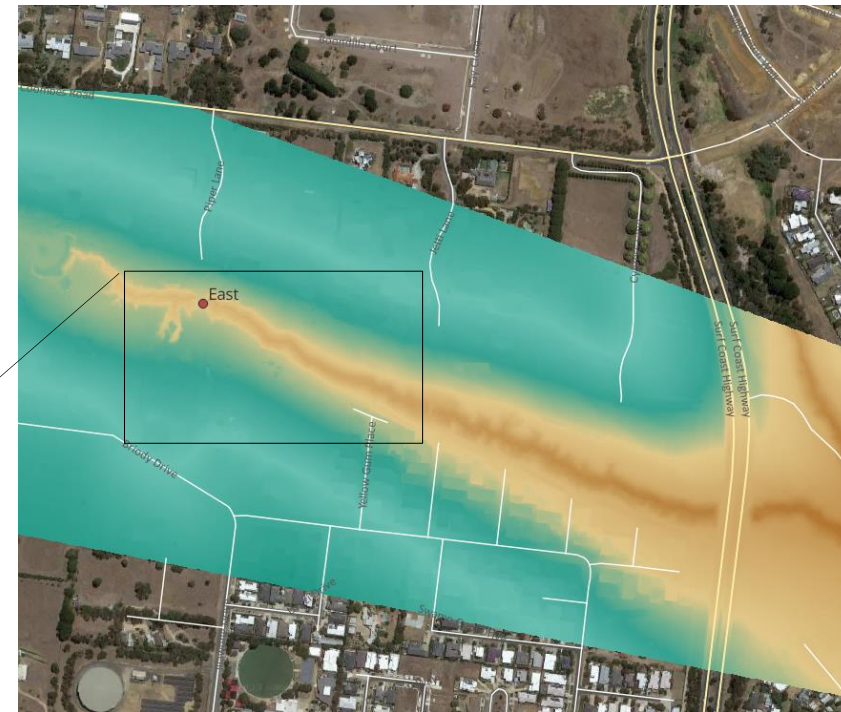
Downstream of the existing culvert the channel is wider, with a deepening low flow channel. There is a step change in the bed level at the culvert, with the invert of the bed upstream at 31.8 m AHD, and 31.1 m AHD downstream of the culvert.

Defined low flow channel.

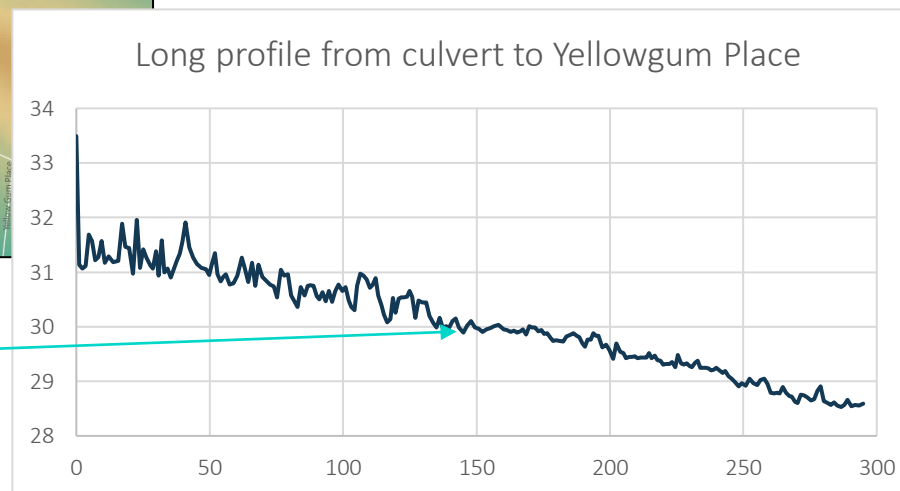
Approximately 150m downstream of the culvert the channel appears to have stabilised where a sediment depositional zone has formed.

Depositional zone, increased stability downstream to the Surf Coast Highway.

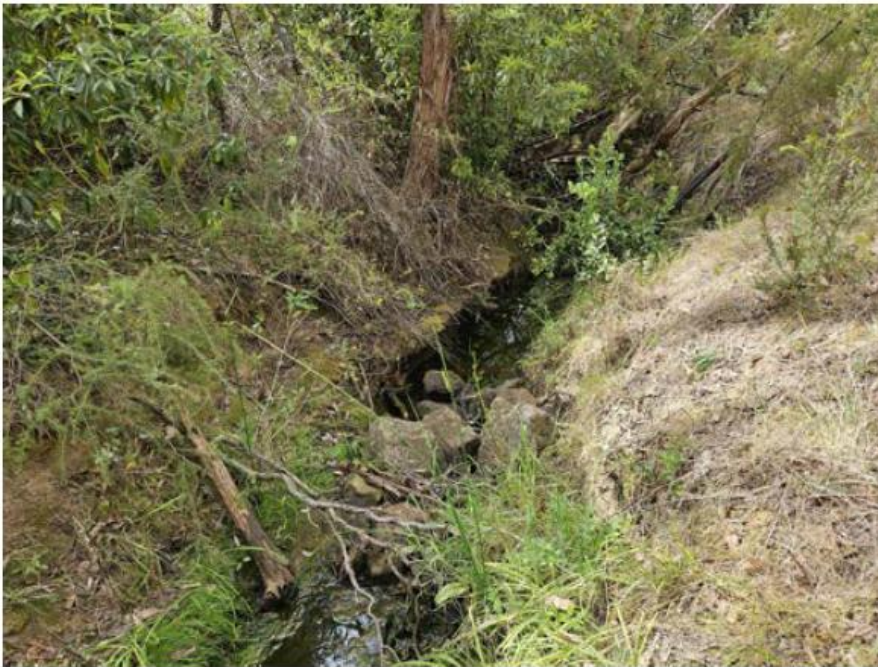
Photo 8. - (Cross section H)

There are several steeper sections of channel downstream of the culvert some of which appear to be associated with previous in-channel bed stabilisation works (i.e., grade control works). For example, approximately 70 m downstream of the culvert, dumped rock was observed in the channel (approximately cross-section H from the field survey, Figure 19).

Figure 19 Photo from the field survey at cross-section H showing previous in-channel rock works, likely installed to address incision and erosion processes

Given the low risk of additional erosion being triggered by the proposed outlet, not additional erosion control works are necessary beyond the outlet. However, to stabilise the existing incision and widening processes downstream of the culvert and the new outlet structure, formalising the existing dumped rock structure approximately 70m downstream of the culvert using a grade control structure such as a rock chute is recommended. The change in grade at this location is around 0.5 m, and assuming a 1 in 15 grade, the rock chute would need to be approximately 7.5 m long plus an

additional 1 m upstream and downstream to merge into the existing channel bed. Alternatively, a simpler rock weir structure to replace the existing rock structure may suffice, given constraints on access and vegetation removal.
