BUILDING CONDITION REPORT

**AT: DEANS MARSH COMMUNITY HALL
20 PENNYROYAL VALLEY ROAD,
DEANS MARSH**

REPORT NO.: 23688 F1 REV 1

P.J. YTTRUP & ASSOCIATES PTY LTD

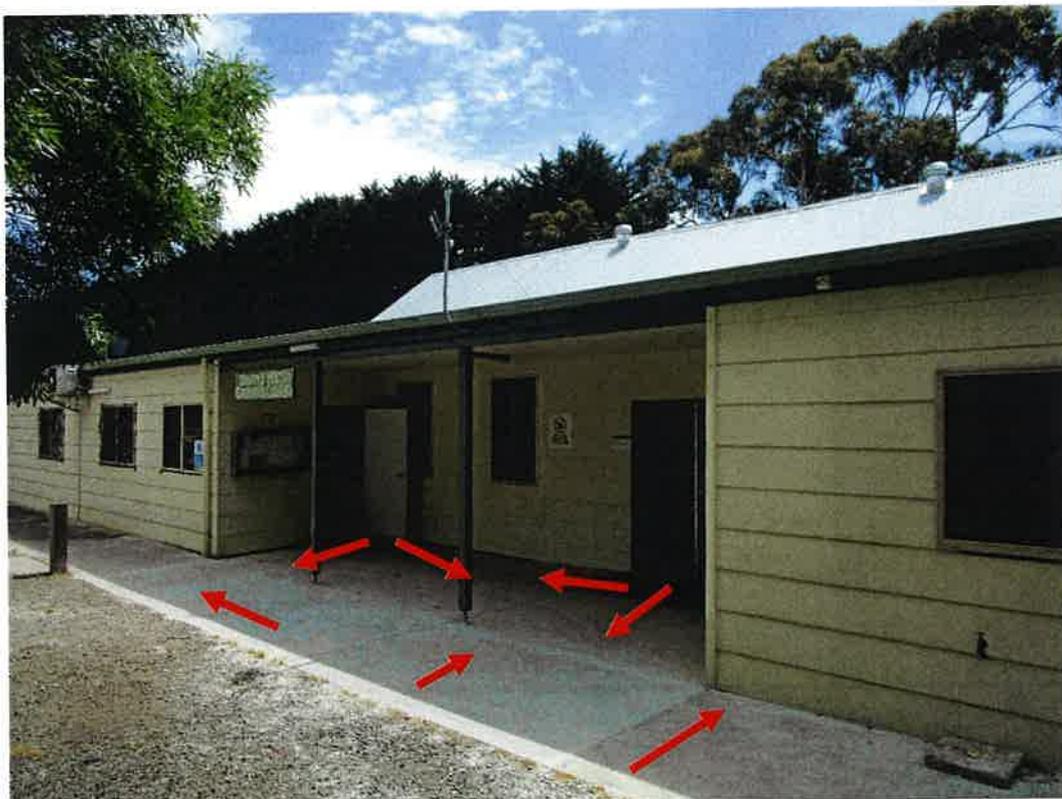
Photo 2; South of hall. Arrows show direction of paving fall.

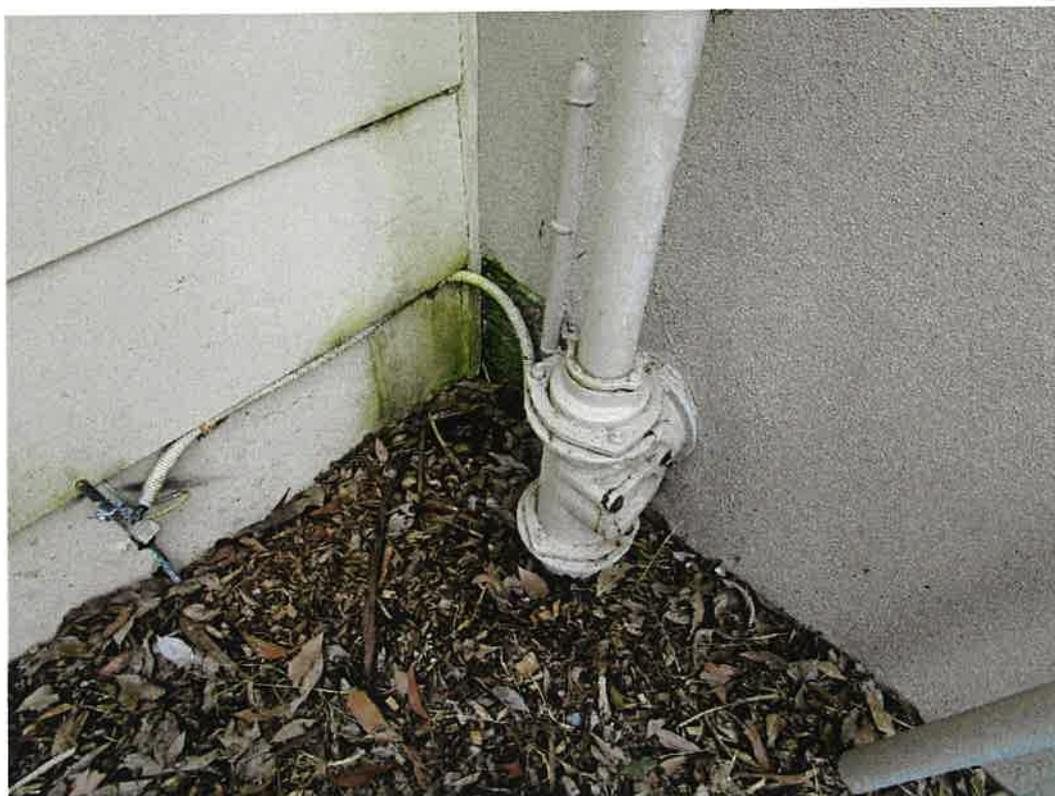
Photo 4; South east re-entrant corner. Algal growth indicating high moisture levels.

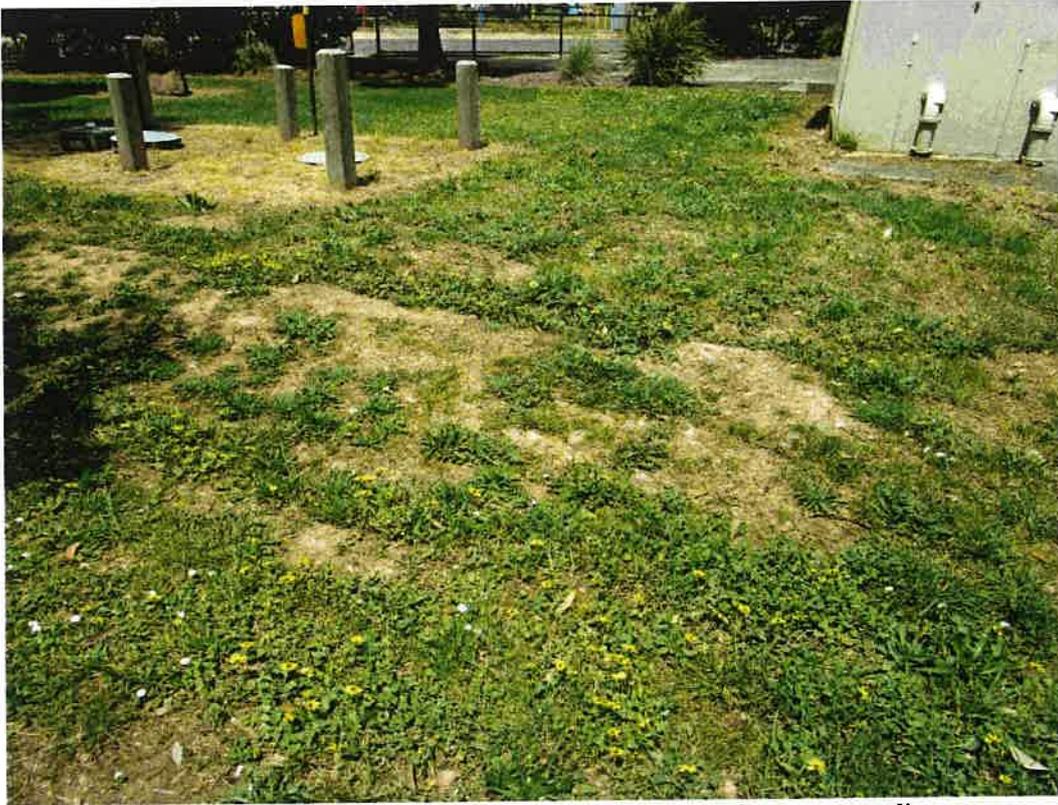
Photo 5; Septic tank location, within bollards. Uneven soil surface allowing for water ponding.

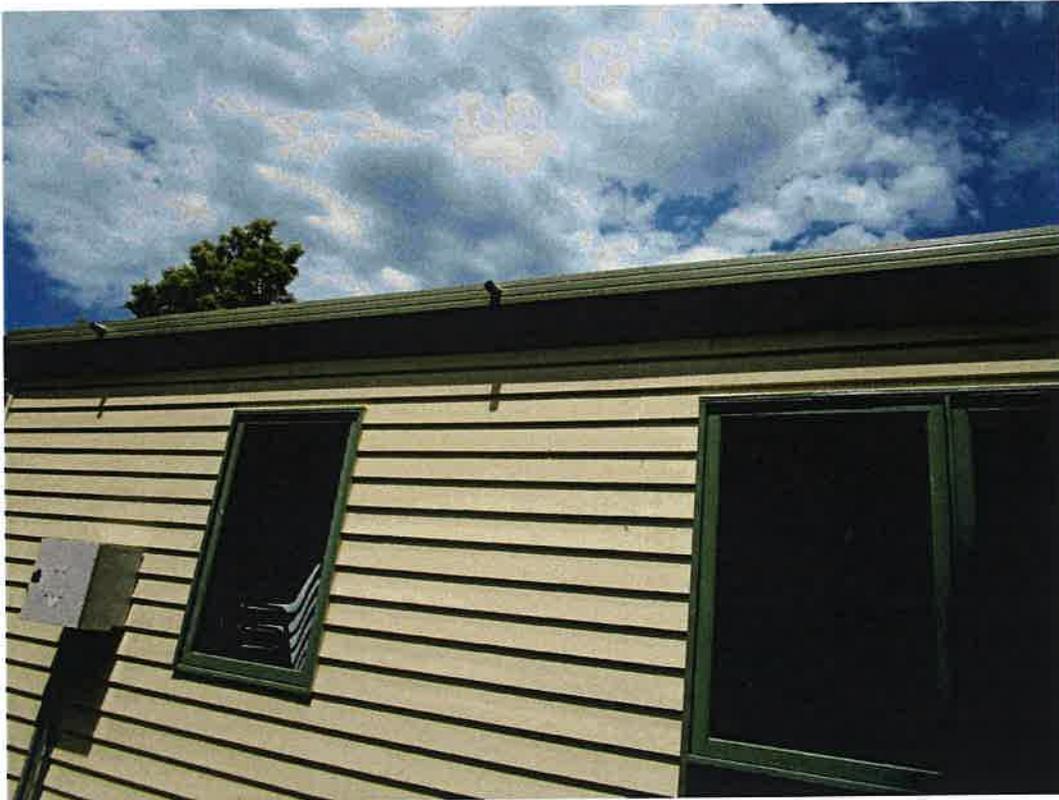
Photo 6; North gutter showing overflow outlets.

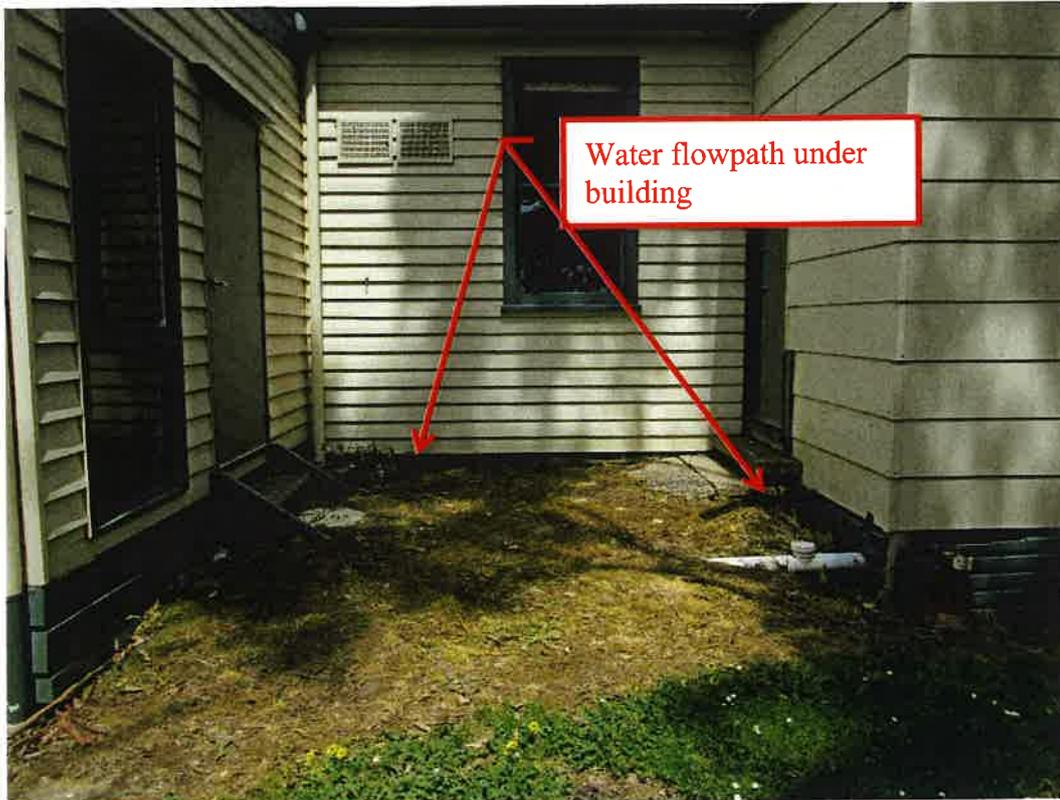
Photo 7; North courtyard; soil surface level higher than under building.

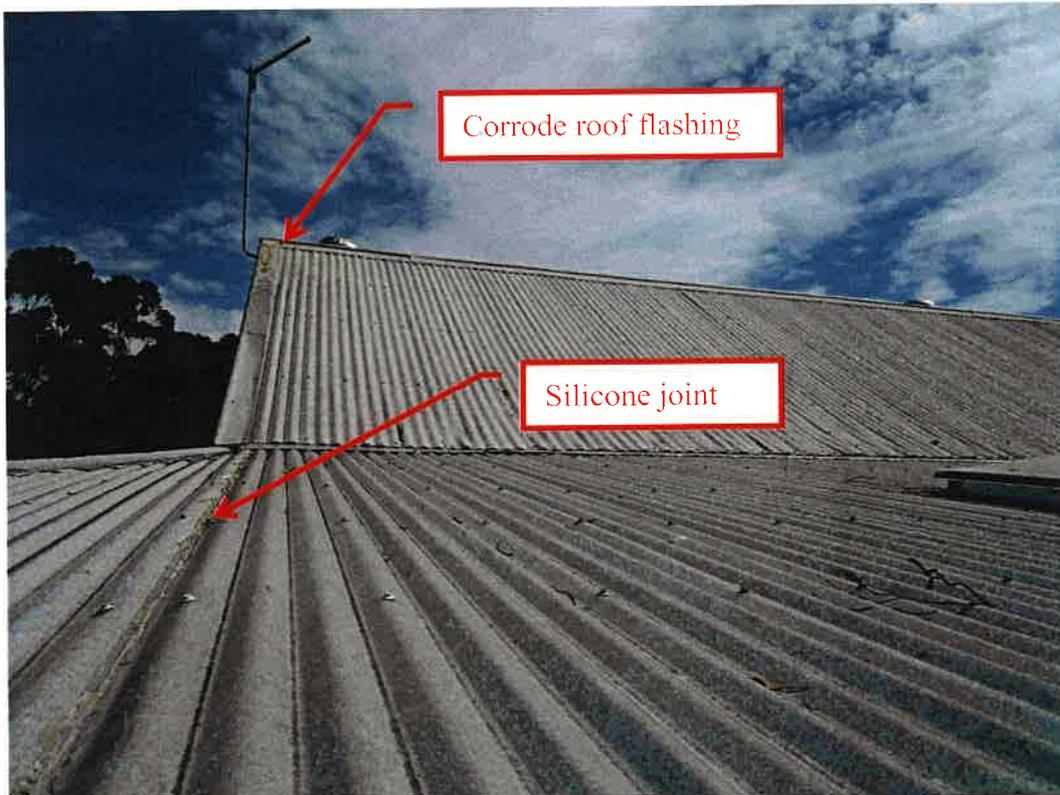
Photo 10; North side roof. Silicane joint. Corroded roof flashing.

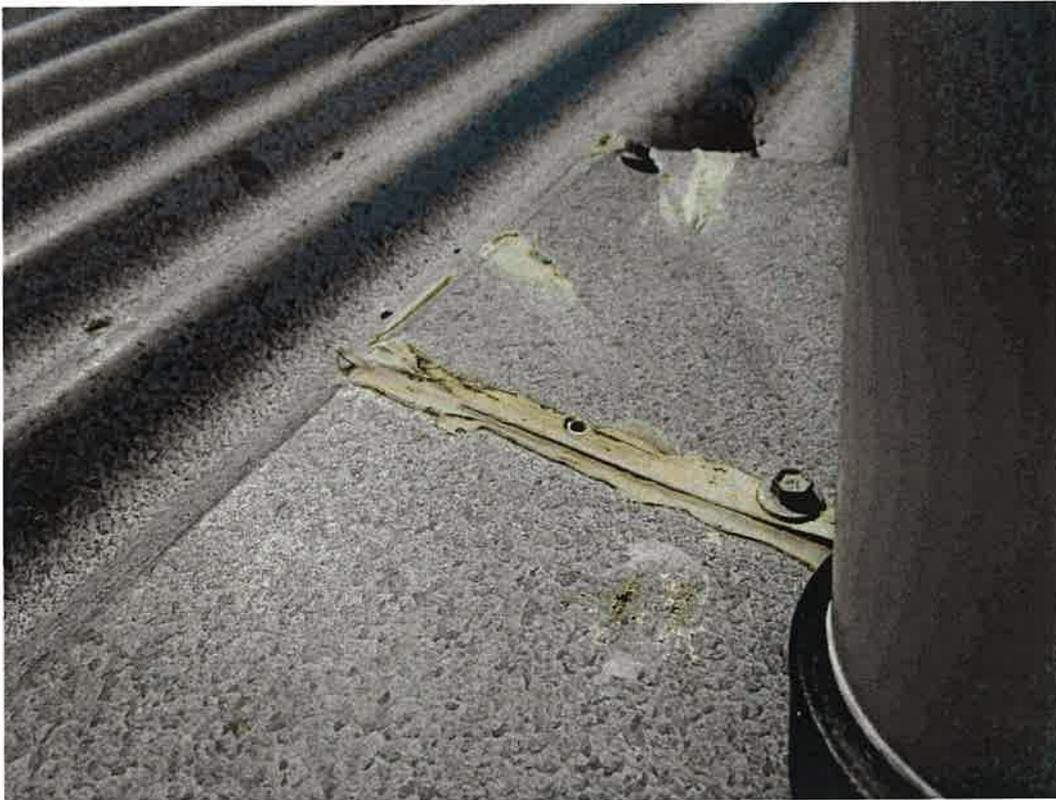
Photo 11; Example of poorly installed flashing. Missing roof screw and no pop rivets to hold sections together. Flashing not wide enough to extend to next corrugation fully. Screw at top not into top of corrugation.

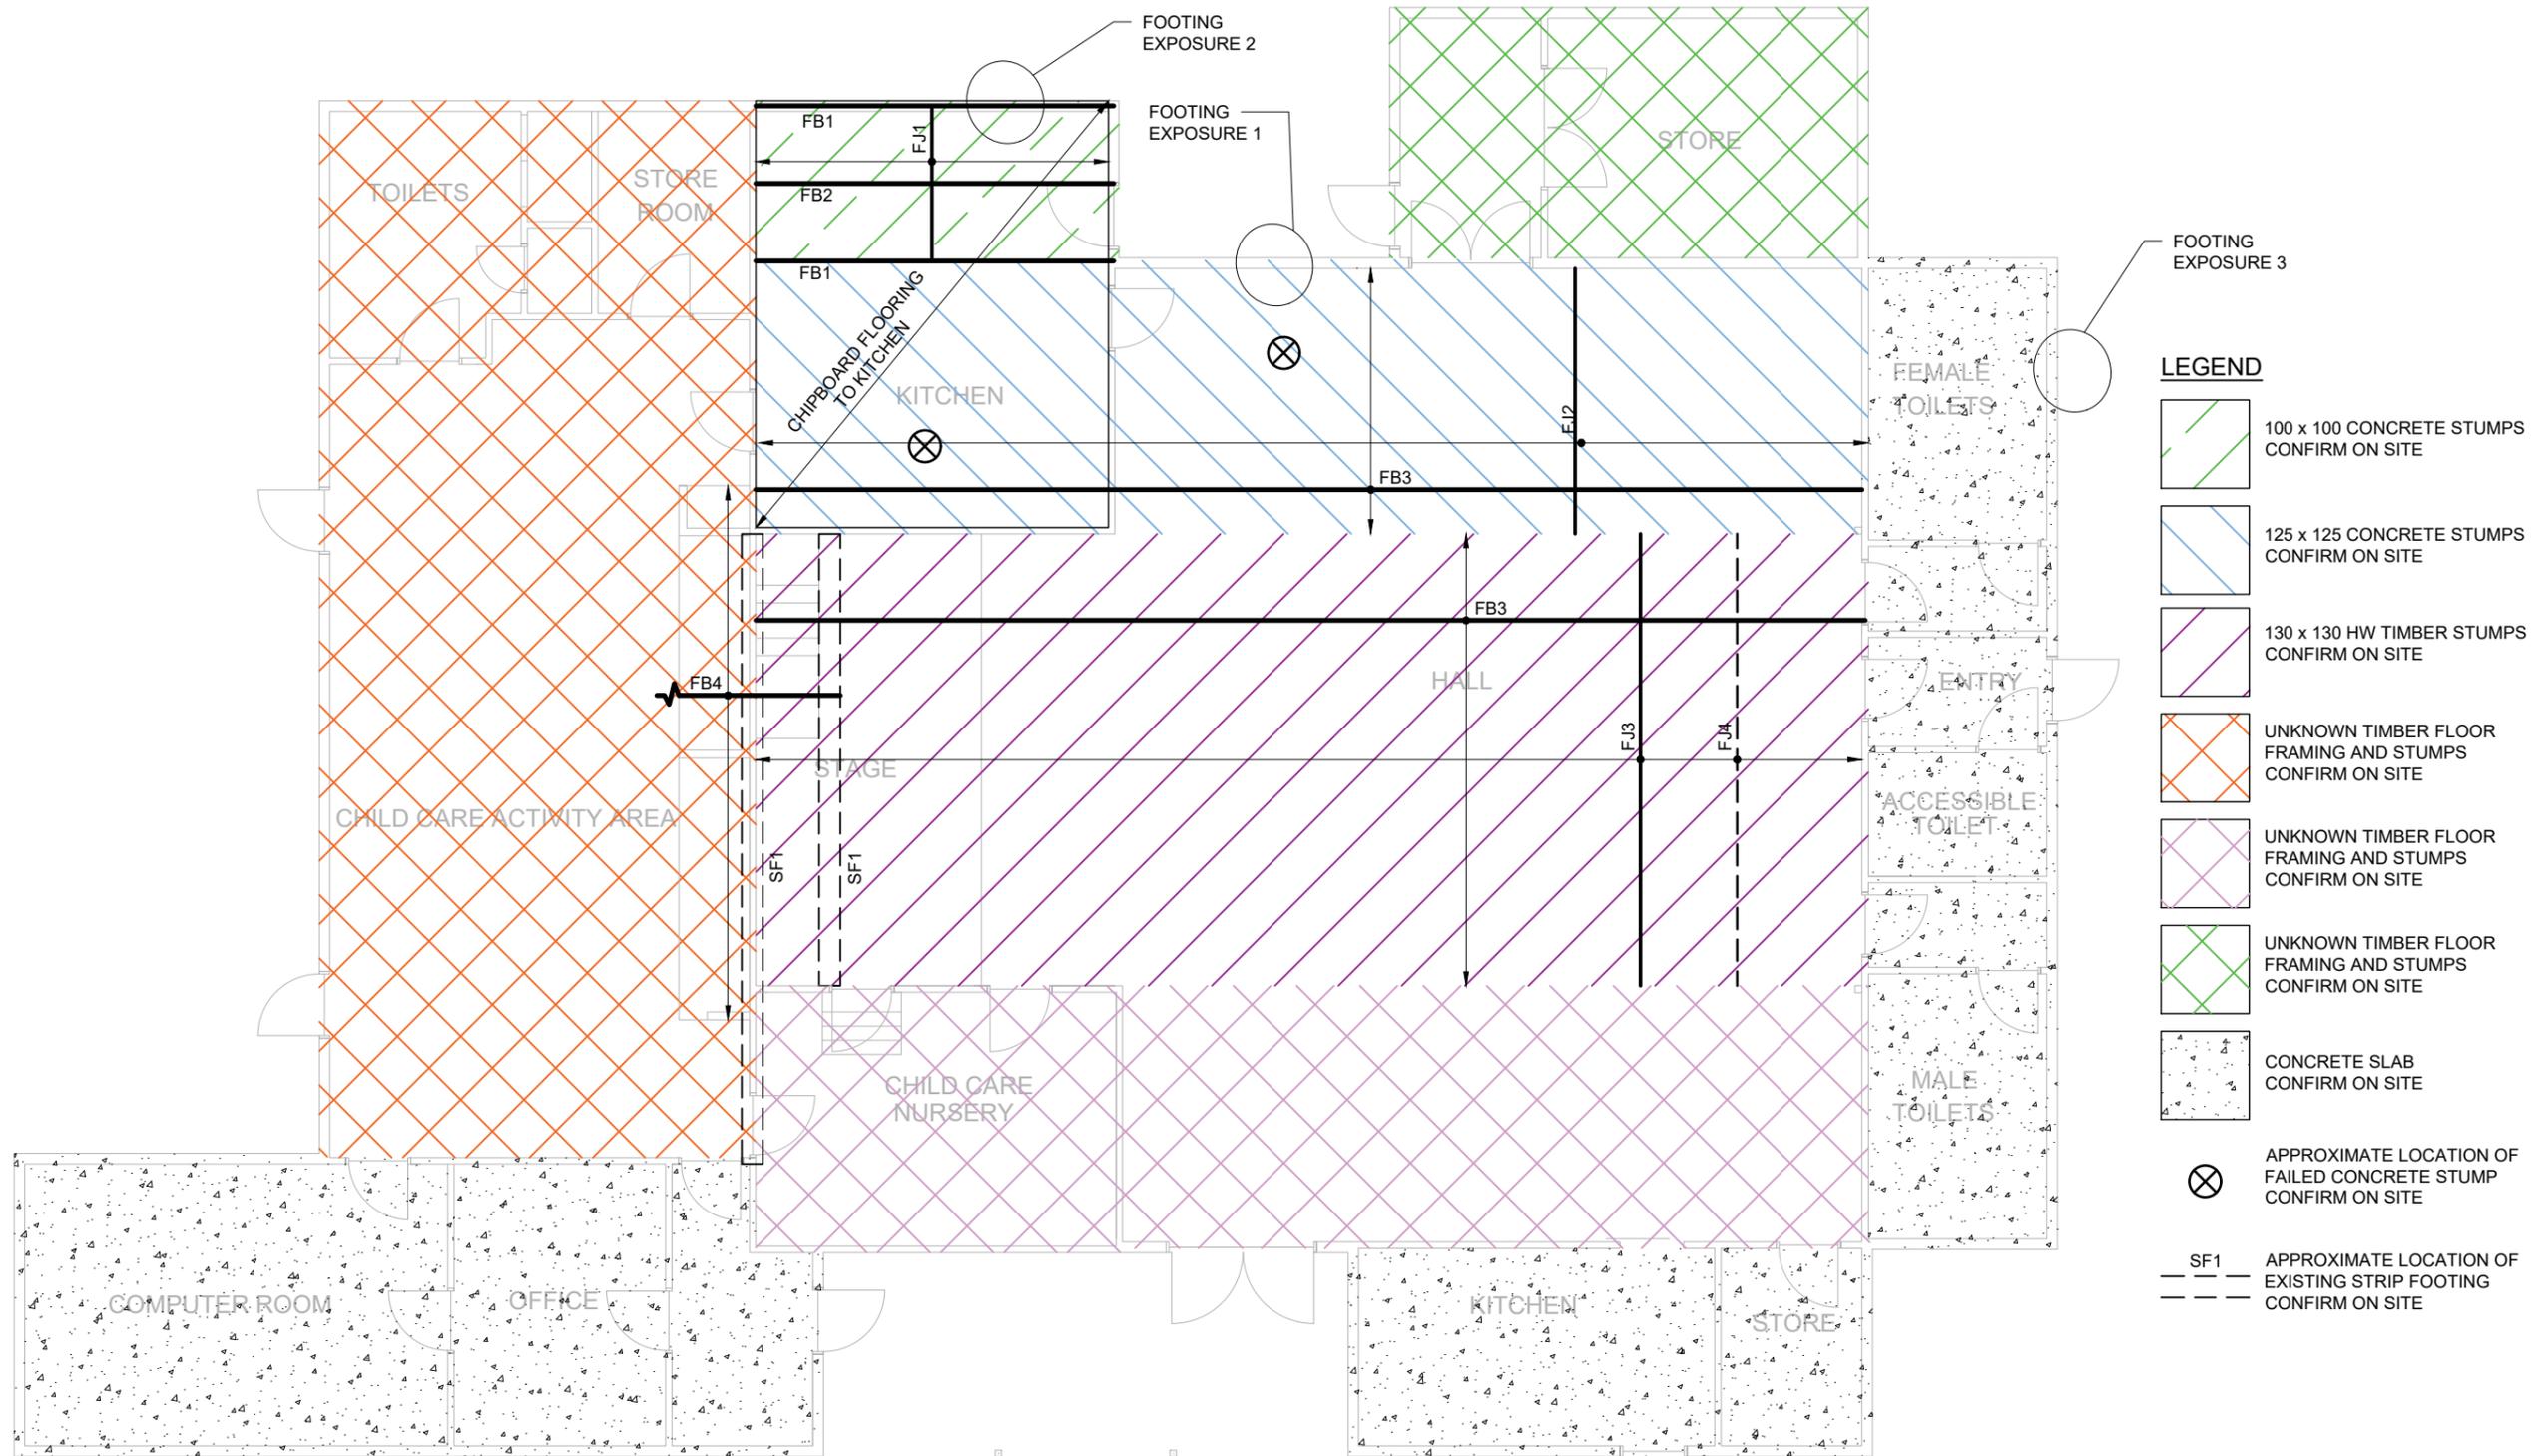
EXISTING FOOTING & FLOOR FRAMING LAYOUT PLAN 1:100

Details of the observed floor framing are detailed on drawing 23688_F07 in Appendix B.

In the area to the rear of the stage an unusual floor system was observed. There appeared to be two strip footings running parallel with walls and stairway behind the stage. This supported floorboards on bearers (FB4) on stumps/stub wall framing. No floor joists were visible.

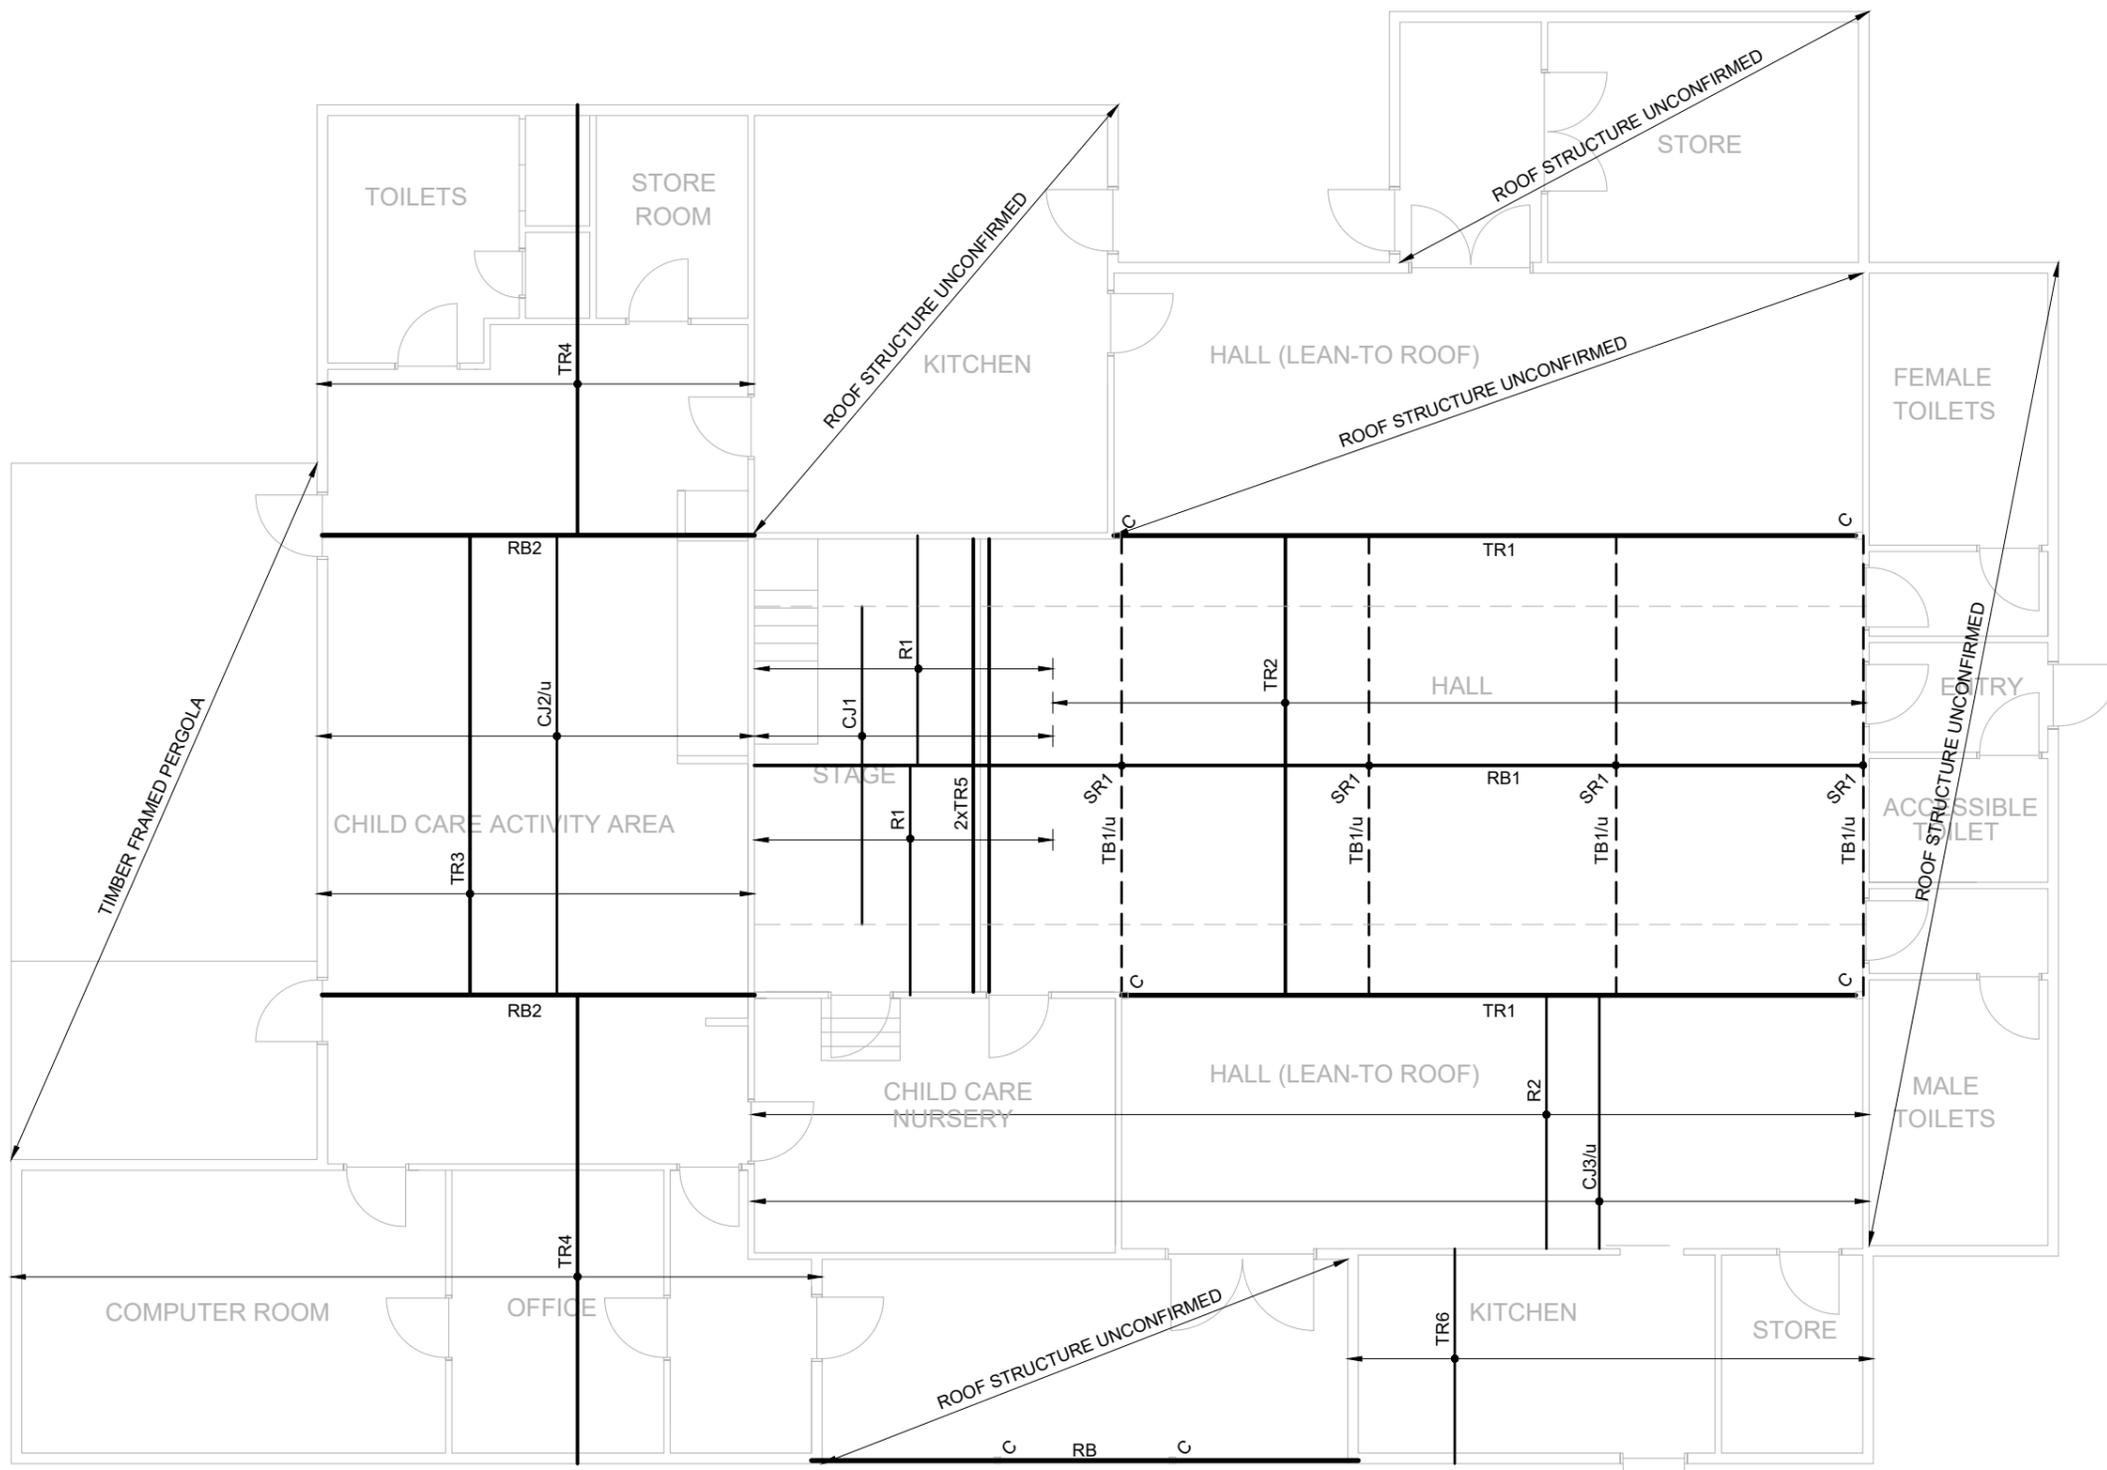
EXISTING ROOF FRAMING LAYOUT PLAN 1:100

Details of the observed roof framing are detailed on drawing 23688_F08 in Appendix B.

The remainder of the central hall roof was framed with struts/web members to create a series of trusses. Horizontal tie rods (TB1) and vertical sag rods (SR1) between the ends of the rafters were visible at discrete locations (Photo 43). Rust was noted on vertical sag rods (SR1) within the roof space. Connections typically consisted of two nails between members.

As noted on the attached drawing not all roof framing was accessible at the time of inspection.

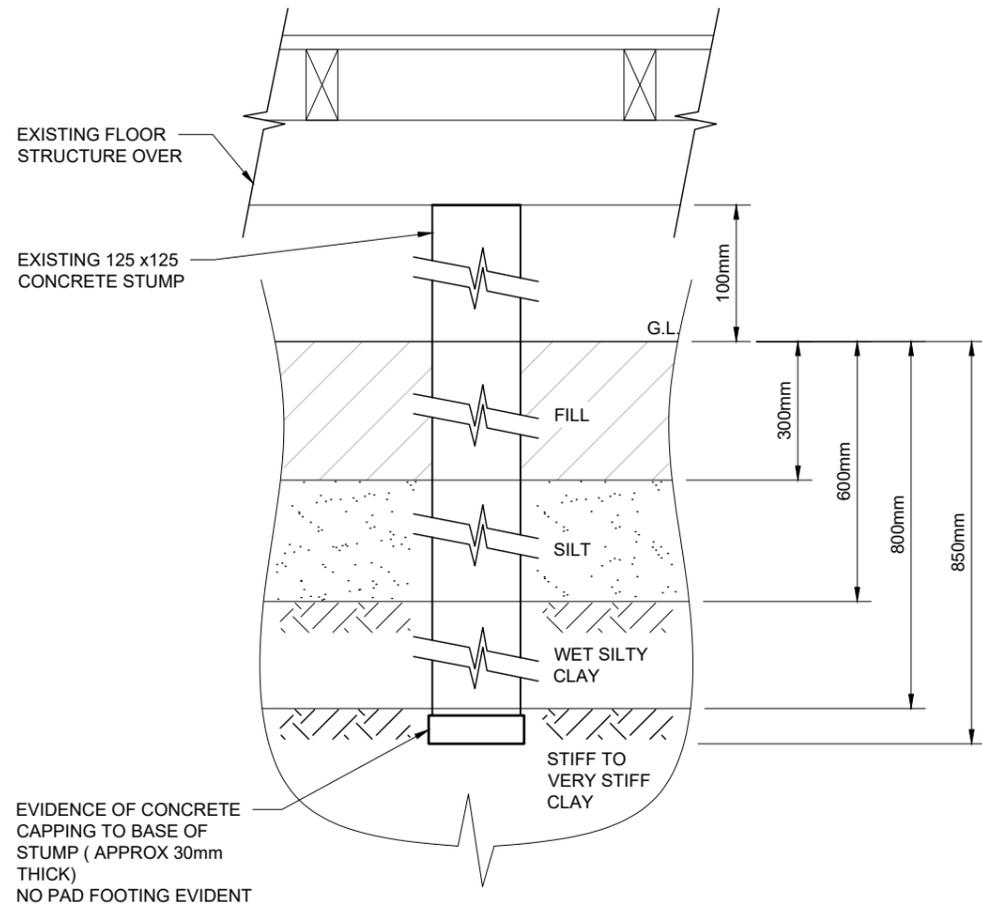
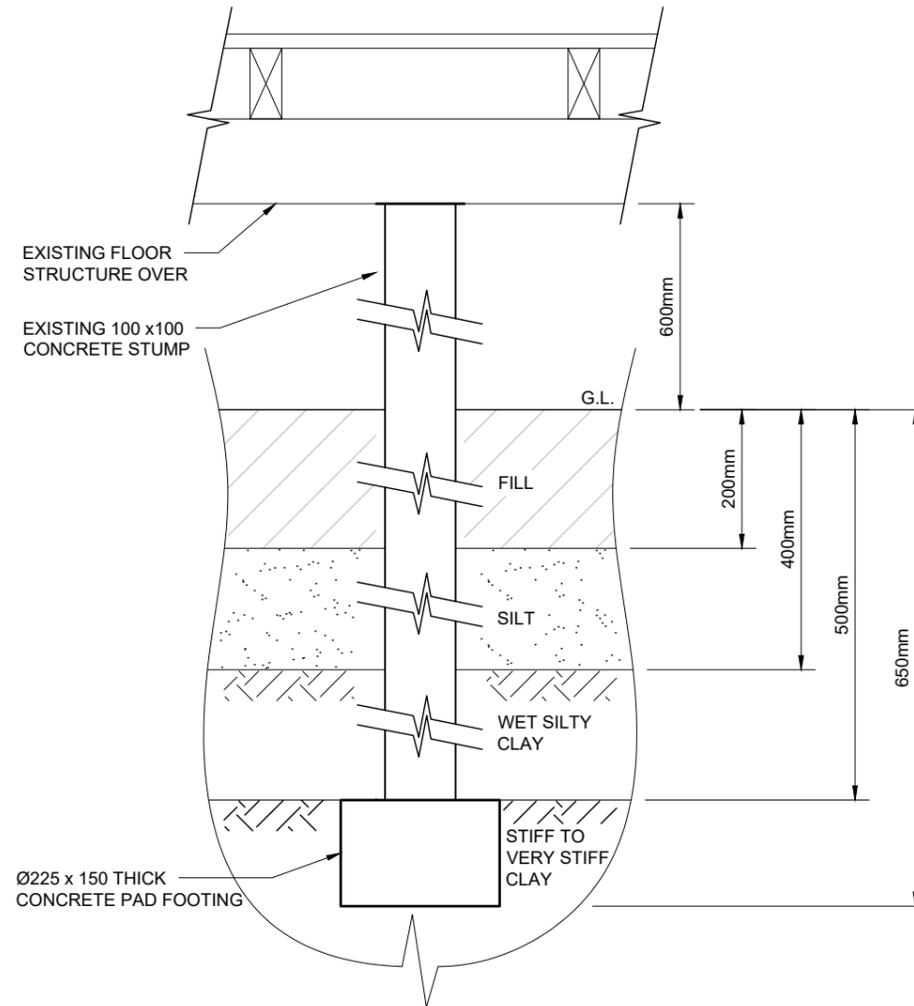
Two footing exposures were completed on the northern perimeter (Drawing 23688_F09). Stumps were founded 650-850 below ground level. No pad footing was evident at footing exposure 1 and a small pad footing ($\varnothing 225 \times 150$ thick) was evident at footing exposure 2. Footings were founded 30-150mm into stiff to very stiff clay with overlying soft fill/silt/silty clay. Founding material was wet (Photo 10 & 12).

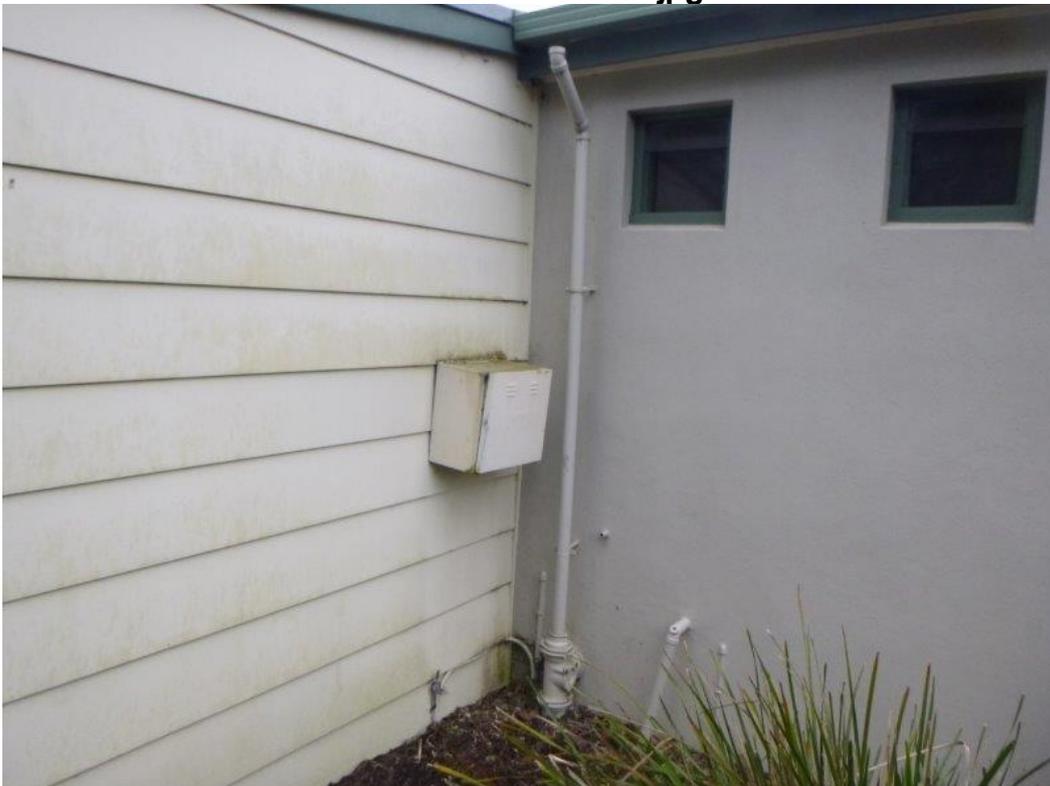
Photo 04 - External.jpg

There is generally a very slight fall away from the building on the east and southern side and better fall away on the west side. However, there are several areas around the building perimeter where water can pond (eg photo 04) and given the relative flat and marshy soils even with slight surface fall, drainage remains poor with water permeating the upper silty soils and being trapped on the underlying clay as noted in the footing exposures (Photo 10 & 12, Drawing 23688_F09 in Appendix B). There is also likely to be subsurface flow towards the building, following the natural ground slope.

Roof seals, screw rubber seals and flashing were in fair to poor condition with many poorly constructed. Roof sheeting was corroded in places (Photo 04, 22, 25-27). Signs of water ingress were noted internally in several locations (Photo 54, 56, 59-61, 66).

It appears the gutter system to the south east corner regularly overflows, with a build up of algae and staining visible (Photo 04).

It is recommended that a surface (concrete spoon drain or grated trench) and subsurface cut-off drain be installed to the southern and eastern sides of the building (uphill sides). Due to limited fall along the length of the building, an underground collector pipe may be required to achieve sufficient fall to a discharge point (ideally 1:100 or 1:200 for Ø225 pipe). The subsurface drain shall consist of a slotted drain in a filter sock in a screening pocket and the drain shall be embedded a minimum of 100mm into the underlying low permeability clay layer. Given the depth to clay and the very limited natural fall across the site, the subsurface drain will need to be directed to a sump and pumped out to the suitable discharge point.

Gutters with negative falls, ad hoc over flows and areas showing signs of regular overflow should be replaced with correctly sized and graded gutters in accordance with AS3500. Additional down pipes may be required to achieve the required gutter capacity.

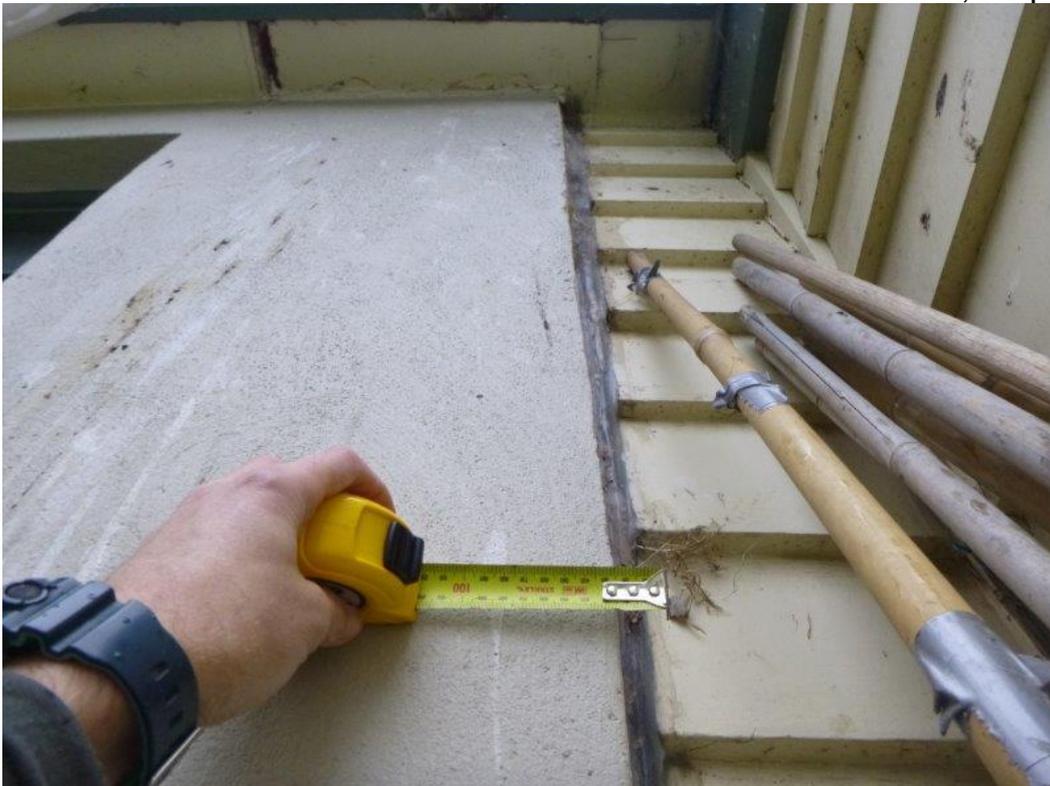
Photo 07 - External.jpg

There is some isolated brickwork cracking to the eastern toilets (reported as circa 1975, previously reported as circa 1999) and there is differential movement visible at the northern junction with adjacent hall building on stumps (Photo 07, 55, 56). Similar damage was noted and reported by this office in 2013 (Our ref 21166 Letter dated 1 October 2013). A footing exposure was completed to the east of this area with the edge beam being in excess of 800mm deep. Up to 30mm of relative level difference was measured across the slab with the relative low point at the north east corner.

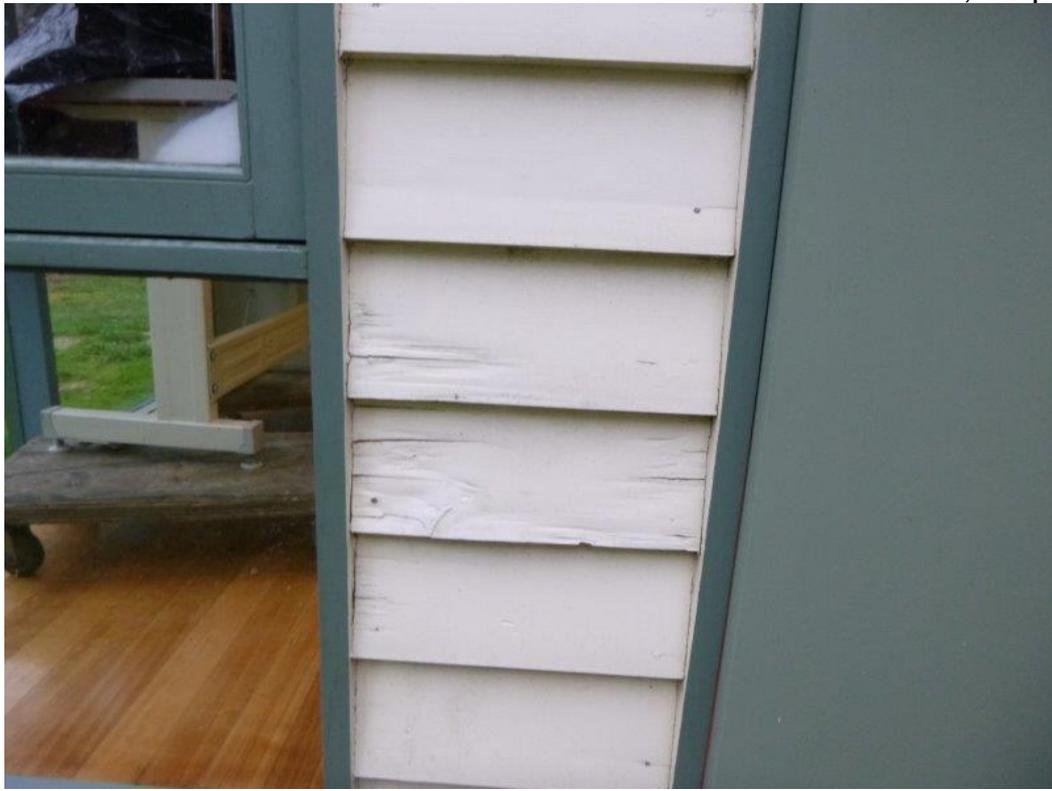
Photo 09 - External.jpg

Wall cladding varied in material, style and age around the building. The external cladding was mostly fibre cement weatherboard with some traditional timber weatherboard to the southern side. Refer to external photos in Appendix C for further details and extents. Some localised damage and rot were evident in some locations (Photo 09, 15, 19).

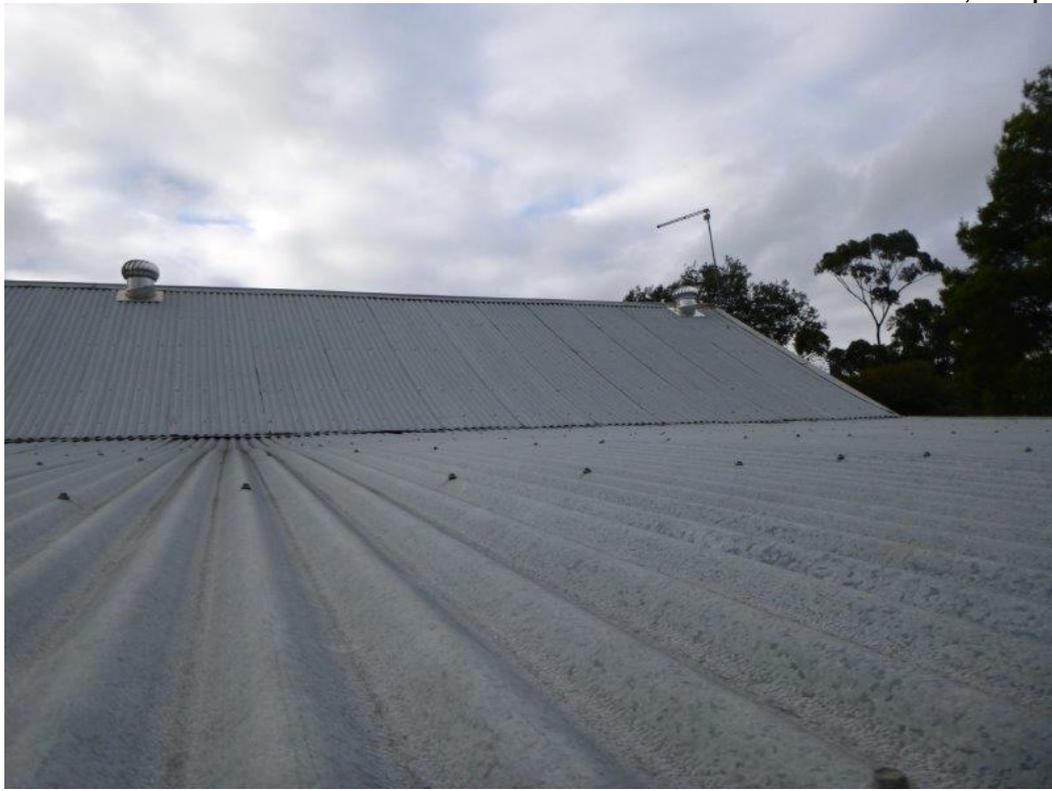
Photo 21 - External.jpg

- An excessive dip in the roof sheeting is visible externally (Photo 21). The reason for this was not explicitly clear on removal of the roof sheet, however some of the battens had signs of damage and/or defects (Photo 41). The battens were measured as approximately 70x35 on flat at approximately 900-1200 CTS;

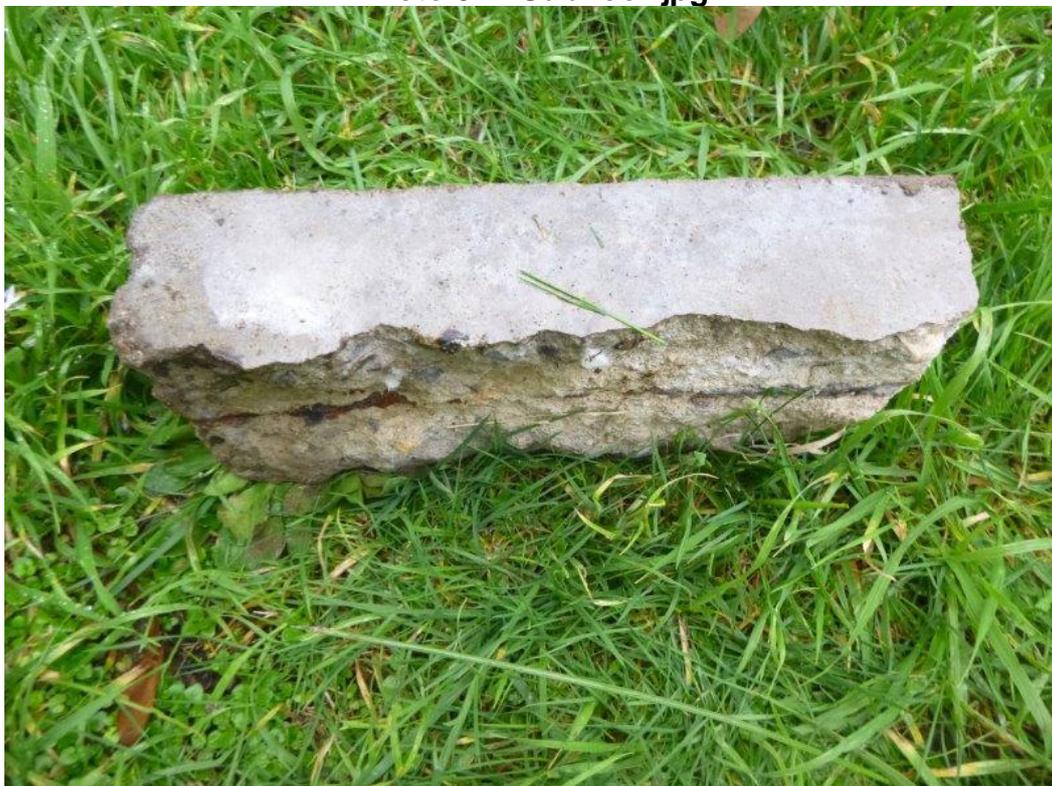
Photo 32 - Subfloor.jpg

The subfloor area accessed was wet on the surface with extensive signs of ongoing rising damp on concrete and timber stumps with efflorescence prolific (Photo 30-33). Ongoing excessive moisture has caused severe concrete cancer in some concrete stumps with failed stumps observed in two locations. Timber stumps were damp to touch.

Hardwood timber stumps were observed through the central portion of the hall (Photo 33). The northern portion of the hall and northern kitchen had concrete stumps (100-125 square). The stumps were damp to touch and efflorescence was extensive. No integrity testing was carried out on the timber stumps. Severe concrete cancer was visible in some concrete stumps with failed stumps observed in two locations (Photo 30-32, 35).

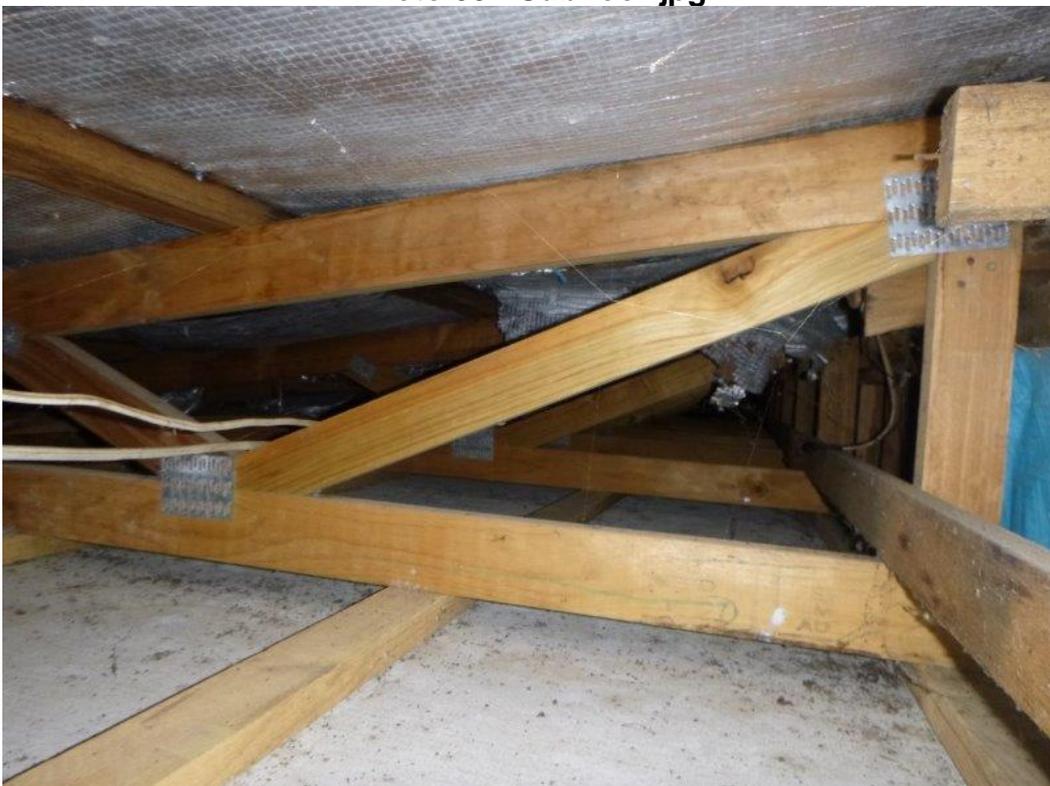
Photo 40 - Roof Space.jpg

- The southern kitchen roof consists of prefabricated trusses (Photo 40);
- The junction between the higher pitched roof and the “lean to” roof of the main hall is supported by a steel truss (TR1). There was rust present on much of the truss (Photo 42). Access to accurately measure the truss was limited however approximate dimensions are provided on the attached drawings. This truss spans approximately 10.5m. Columns, likely timber, are visible internally at the ends of the truss with two exposed bolt heads to the underside of the truss bulkhead. The timber panelling to the truss bulkhead appeared to be pine when viewed from the roof space;

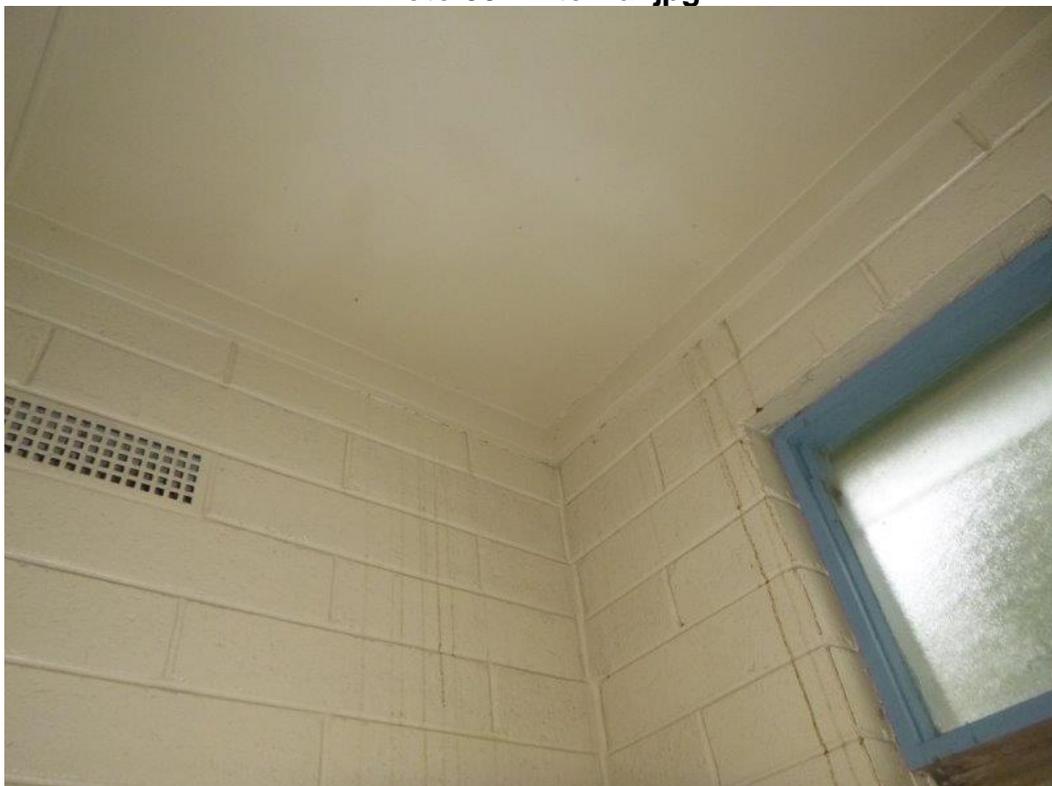
Photo 54 - Internal.jpg

Internal wall lining to the main hall area was a mixture of timber panelling (some possibly original) and plasterboard (unlikely original). Elsewhere the internal lining was typically plasterboard with exposed brickwork to the toilet area. Some minor cracking to brickwork and plaster was noted in some locations (Photo 55, 57, 58, 60, 62- 64). There were no other obvious signs of any major structural issues other than some localised signs of moisture ingress (Photo 54, 56, 59-61, 66).
