BUILDING CONDITION REPORT

**AT: DEANS MARSH COMMUNITY HALL
20 PENNYROYAL VALLEY ROAD,
DEANS MARSH**

REPORT NO.: 23688 F1 REV 1

P.J. YTTRUP & ASSOCIATES PTY LTD

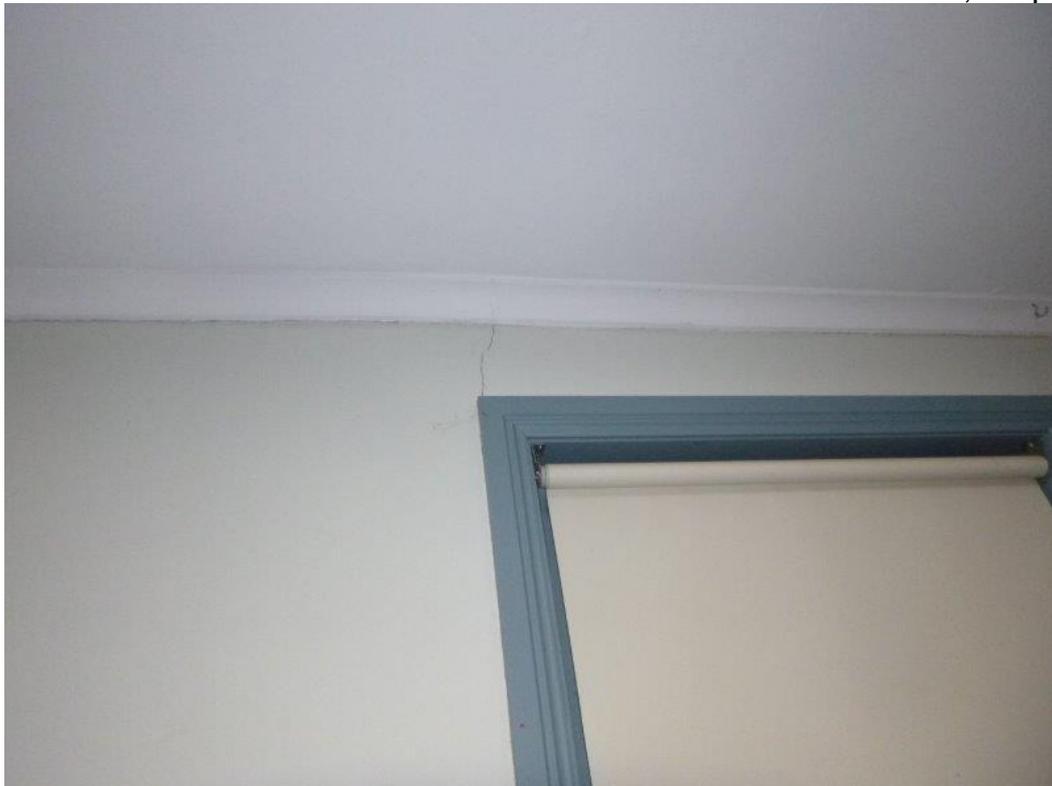
Photo 57 - Internal.jpg

Up to 70mm of relative level difference was measured across the central hall area with the southern side being higher relative to the northern areas. Some relatively minor cracking was noted on the southern wall (Photo 57, 58, 60). A localised level anomaly was observed in the north west corner of child care nursery with up to 60mm level difference between this room and the adjacent hall. Due to limited access at the time

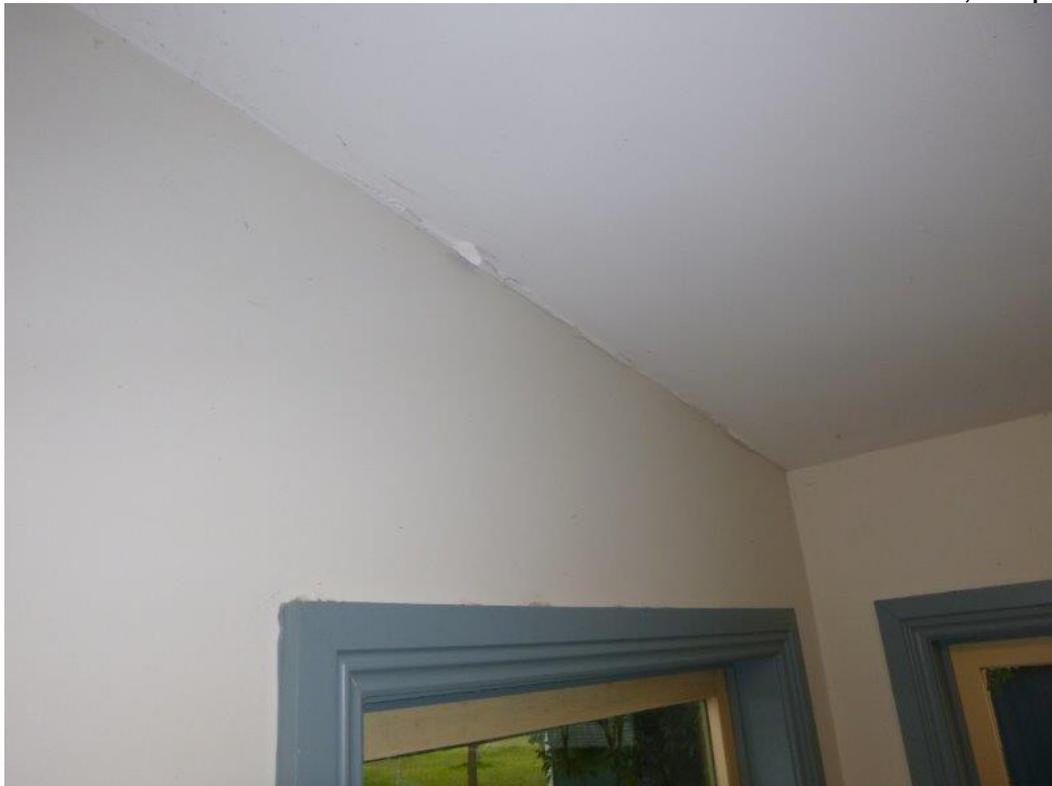
Photo 59 - Internal.jpg

Roof seals, screw rubber seals and flashing were in fair to poor condition with many poorly constructed. Roof sheeting was corroded in places (Photo 04, 22, 25-27). Signs of water ingress were noted internally in several locations (Photo 54, 56, 59-61, 66).

Internal wall lining to the main hall area was a mixture of timber panelling (some possibly original) and plasterboard (unlikely original). Elsewhere the internal lining was typically plasterboard with exposed brickwork to the toilet area. Some minor cracking to brickwork and plaster was noted in some locations (Photo 55, 57, 58, 60, 62- 64). There were no other obvious signs of any major structural issues other than some localised signs of moisture ingress (Photo 54, 56, 59-61, 66).

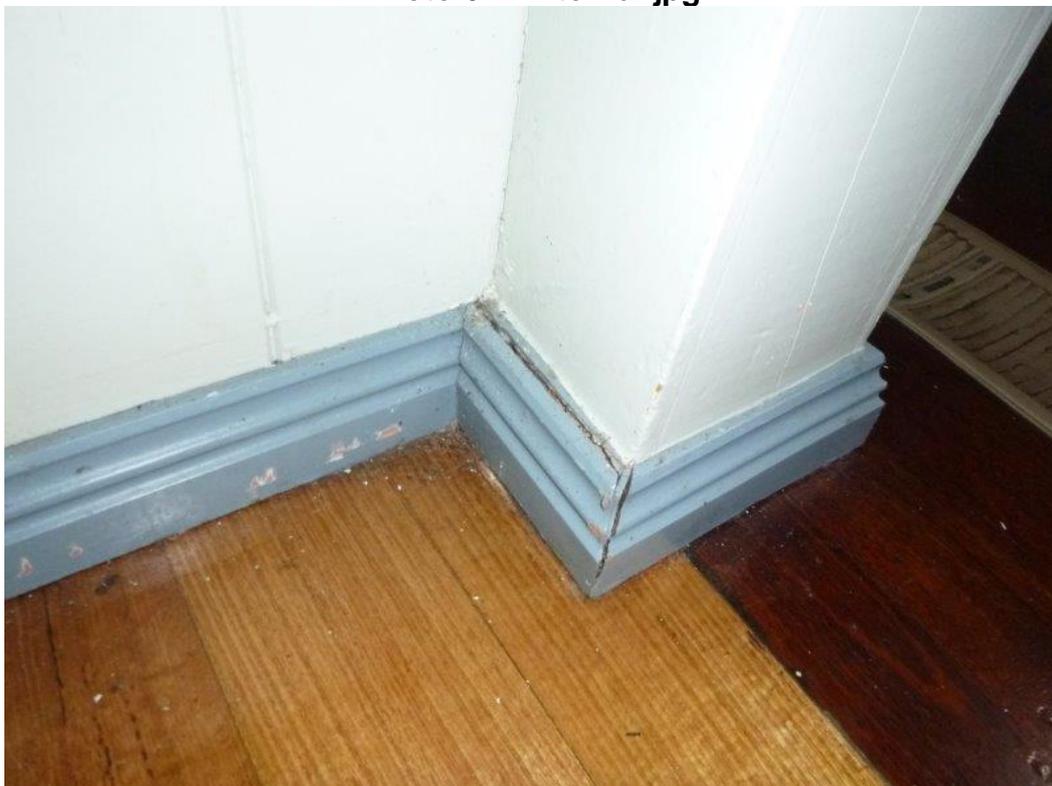
Photo 62 - Internal.jpg

of inspection it is not clear if floor level was set down lower than the adjacent hall. Some localised damage to the skirting was noted in this location (Photo 62).
