Moriac Septic Study Report

June 2021

Moriac Septic Study

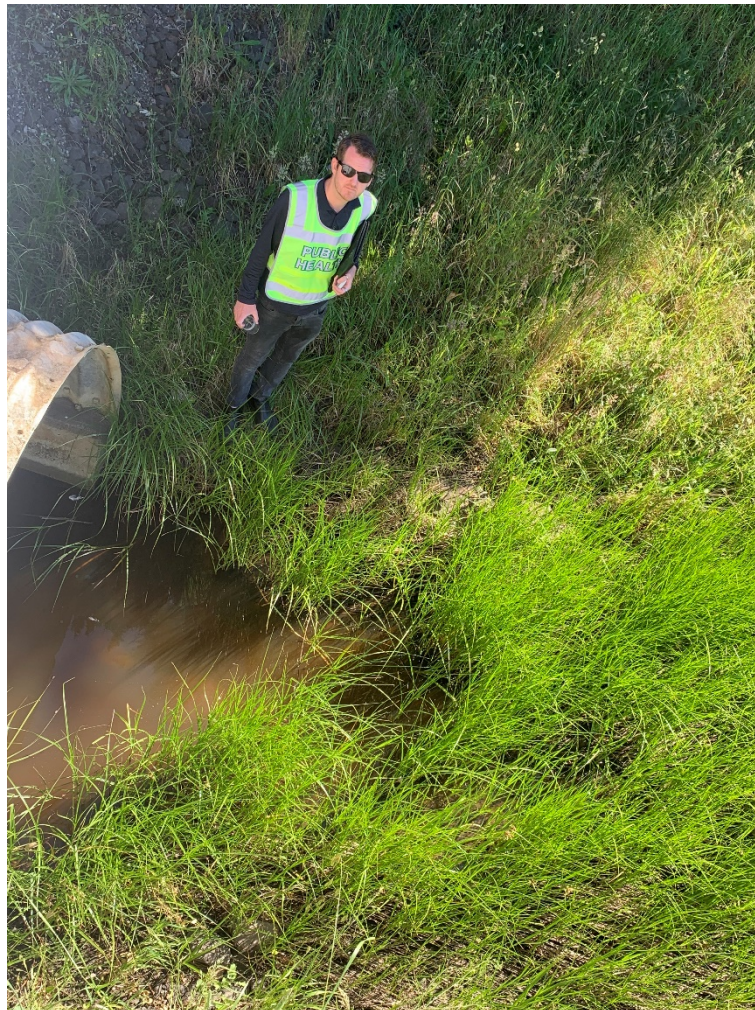
Council's EHO inspecting Thompsons Creek.

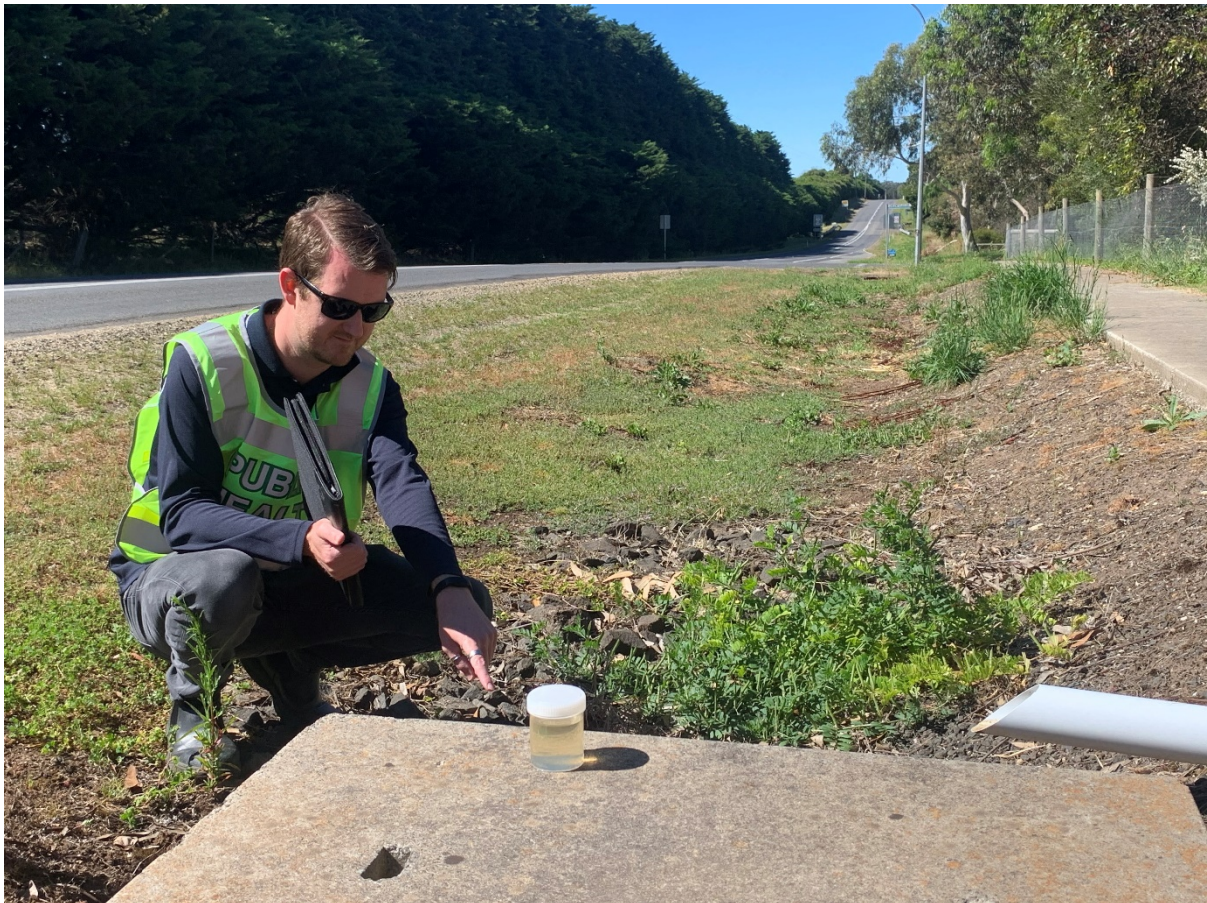
Council's EHO collecting a water sample from storm water drain along Hendy Main Road.

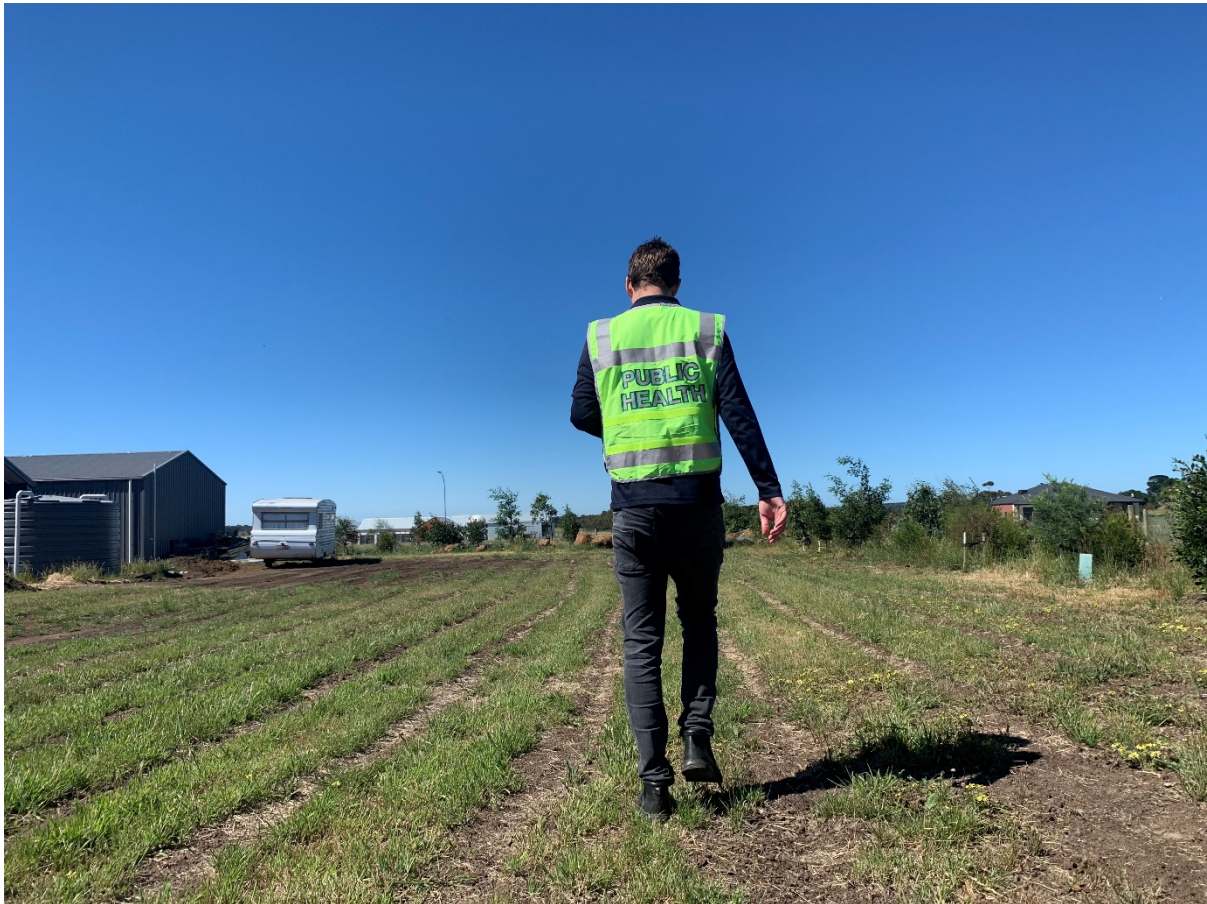
Council's EHO inspecting an effluent irrigation area installed to current day standards using a method called pressure compensating sub-surface irrigation.

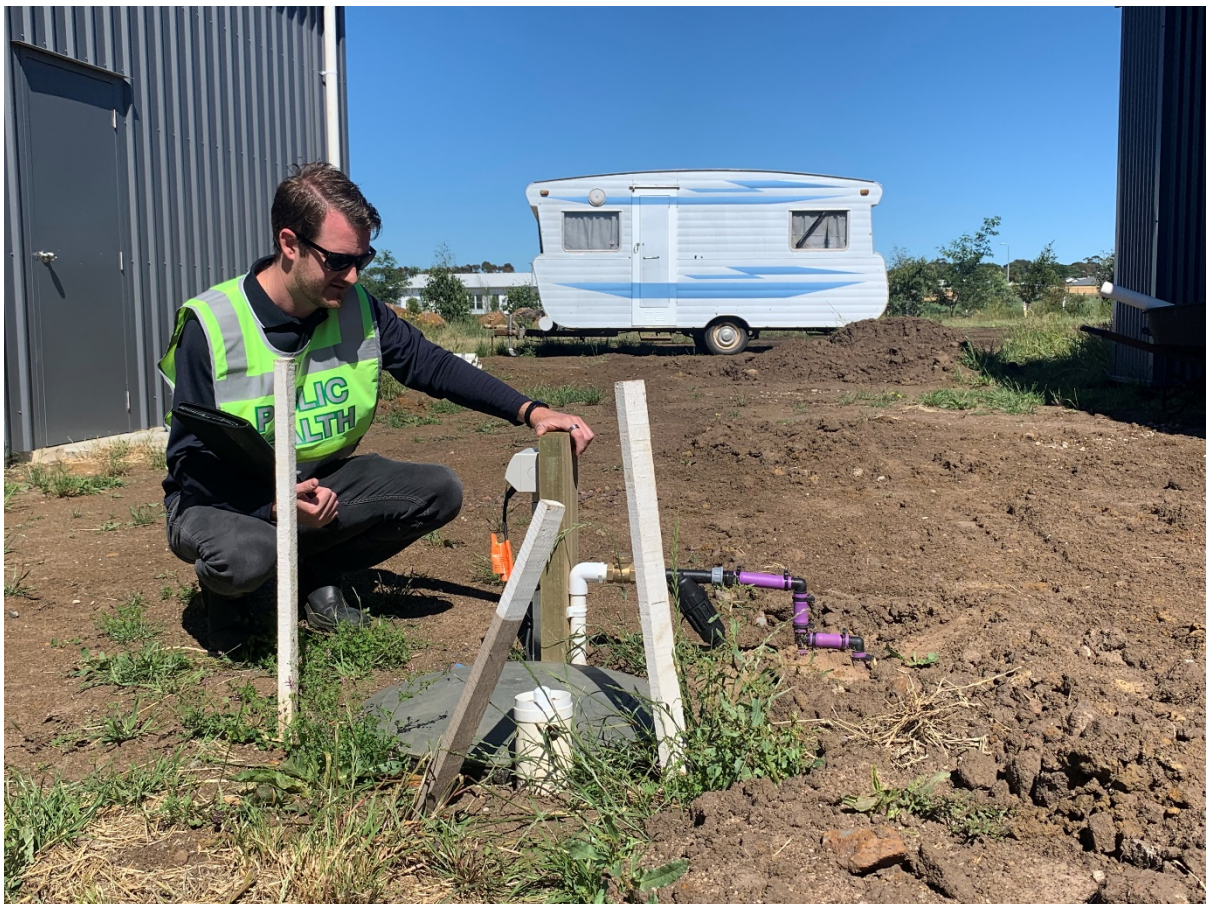
Council's EHO inspecting recently installed pump pit as part of a sand filter system.

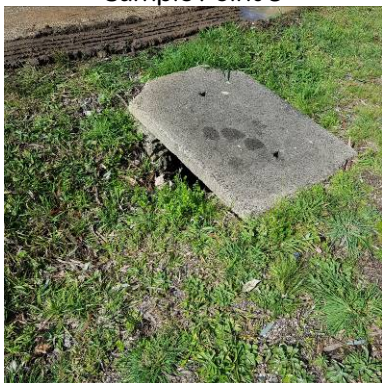
Sample Point 12

The indicators of faecal contamination (E. Coli and enterococci) exceeded the short term levels recommended for water-based recreation in most cases. Human faecal contamination was isolated to location 12. The elevated levels of E. Coli and enterococci are likely to be associated with non-human sources such as dogs and or birds thus posing a lesser risk to human health. Nutrient concentrations were also low across the board supporting the previous conclusion.

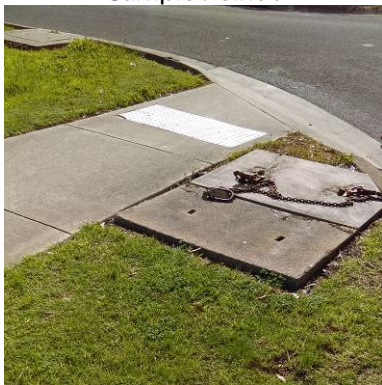
Sample Point 4

Although both detections of human marker level were relevant, the qualitative reading detected in sample 4 on 4 September 2019 is a better indication as the previous sample was heavily diluted by rain water. The qualitative reading from this sample of 35619 copies/L, is less than 0.002% of the level you would expect to find in treated effluent. Therefore, although the human marker was detected, it was at a very low level. It should also be noted that the sampling location where it was originally detected in the surface water was resampled in the second round, the follow up sample was taken from in the stormwater pit and there was no detection. This indicates that the level detected was possibly due to runoff contamination. The second detection of the marker, was down slope of the stormwater system from the first detection, yet it was not found in the same location twice. It should be noted that no levels were detected in Thompson Creek in both rounds of sampling so it appears that there is not a major environmental contamination issue in the Creek. It was surprising that no human marker was detected in the Northern part of the Hendy Main Road stormwater network where the majority of the legacy systems exist that are believed to discharge directly into the stormwater infrastructure.
