Facility Development Plan Issues and Opportunities

Dean's Marsh Community Hub Surf Coast Shire June 2022 REV 1

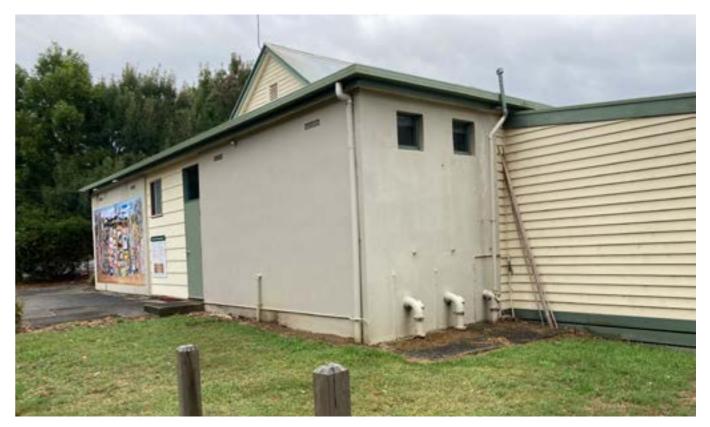
Original entry absorbed in amenities

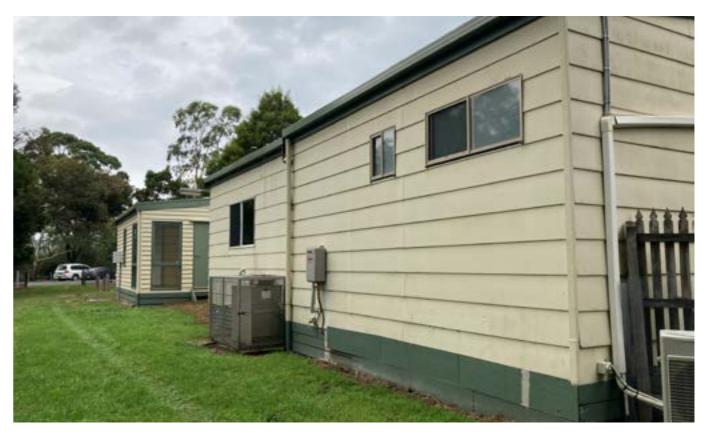
Eastern facade floor approx 400 out of ground mixed lightweight cladding

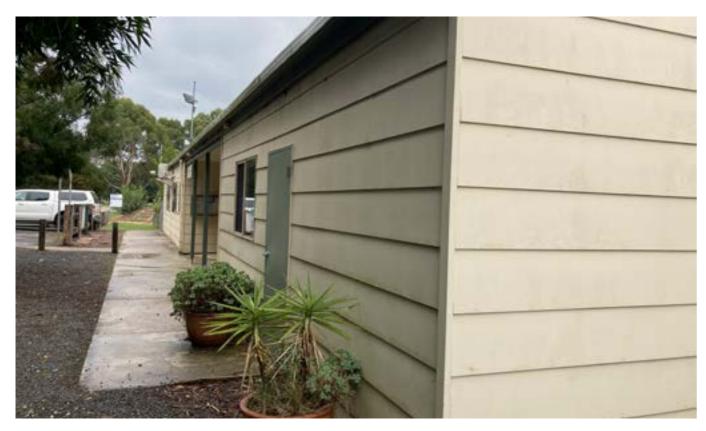
Western facade floor at ground level with combination of pavement finishes

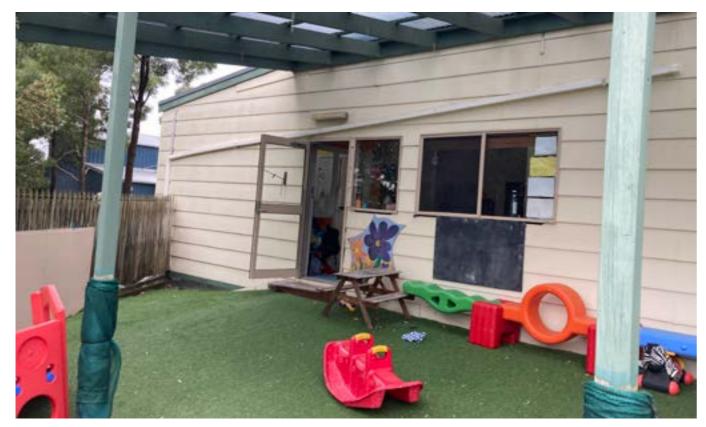
At north ground line locally mounded to provide access to children's rooms

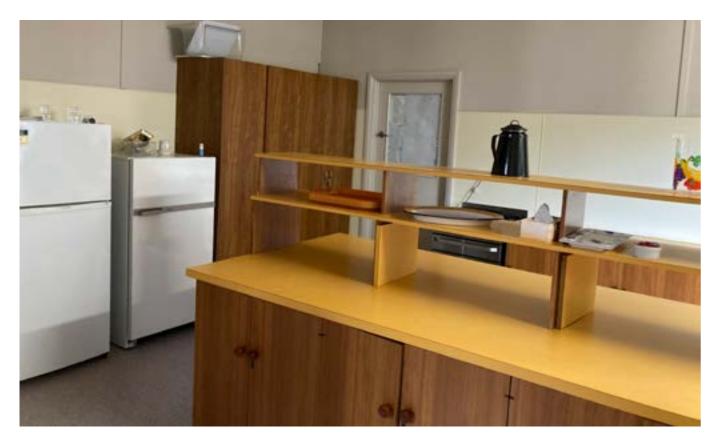
The joinery and fit out to the Kitchen area is aged and of a low amenity. The fit out to the Toilets has basic partition structures and painted face brickwork, with sheet vinyl to the floors.

Kitchen interior

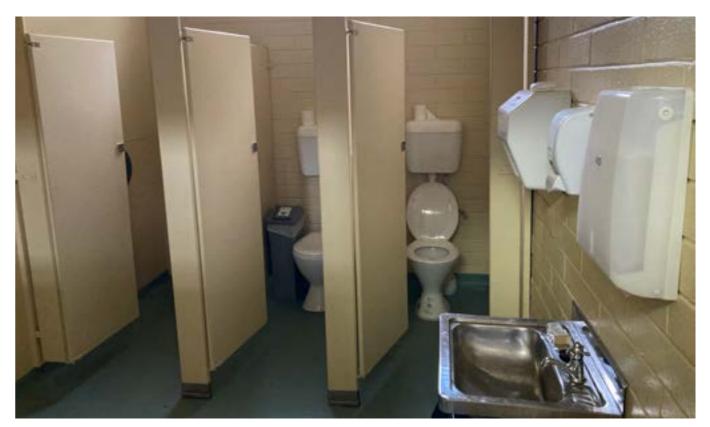
Toilets

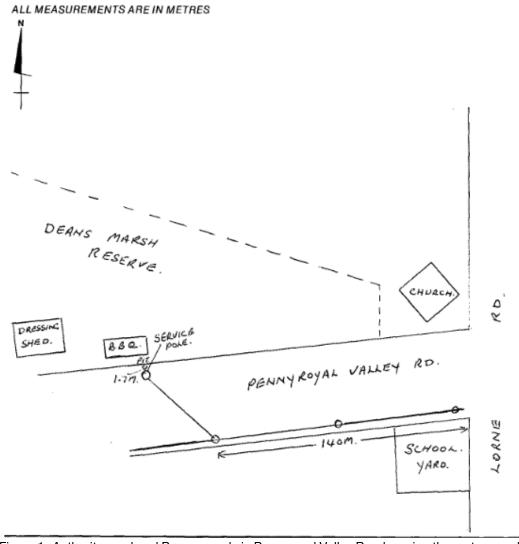
Figure 1- Authority overhead Power supply in Pennyroyal Valley Road serving the meter panel in the Reserve

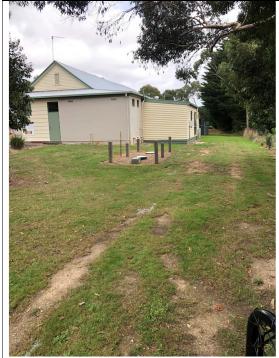
The capacity of the system for any redevelopment would need to be assessed with local council/EPA requirements, however it is likely that the system may need to be upgraded with the size and function of the facility increasing.

Figure 11- Onsite wastewater treatment plant located in NE corner of site

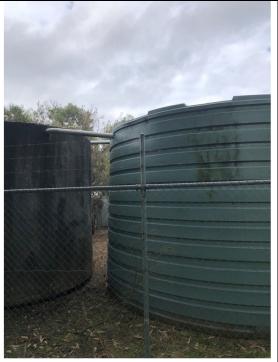
Figure 14- Rainwater tanks of varying age, type and condition located in tank farm

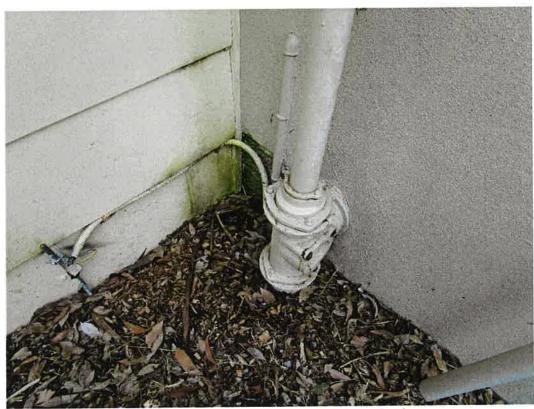
Photo 4; South east re-entrant corner. Algal growth indicating high moisture levels.

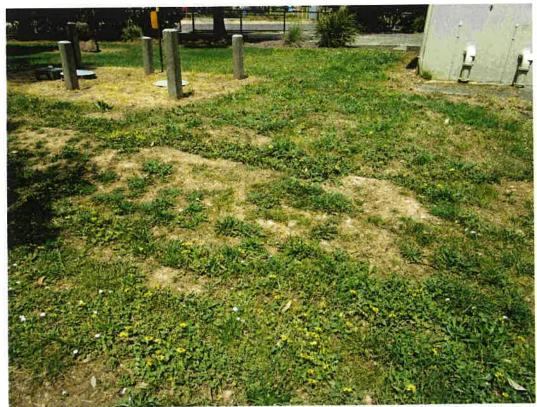
Photo 5; Septic tank location, within bollards. Uneven soil surface allowing for water ponding.

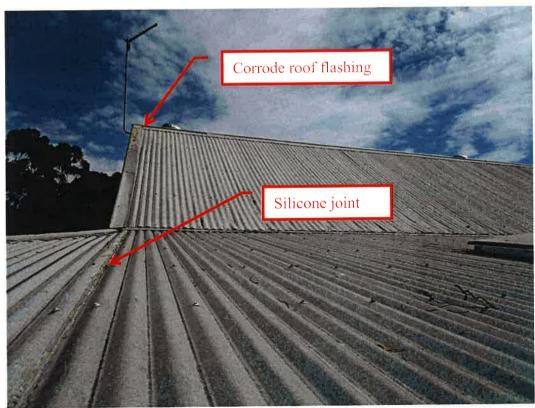
Photo 10; North side roof. Silicane joint. Corroded roof flashing.

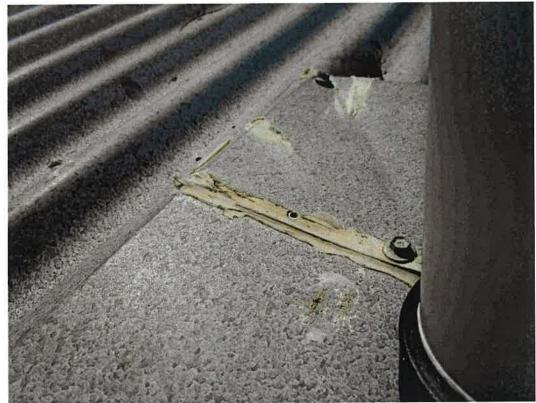
Photo 11; Example of poorly installed flashing. Missing roof screw and no pop rivits to hold sections together. Flashing not wide enough to extend to next corrugation fully. Screw at top not into top of corrugation.

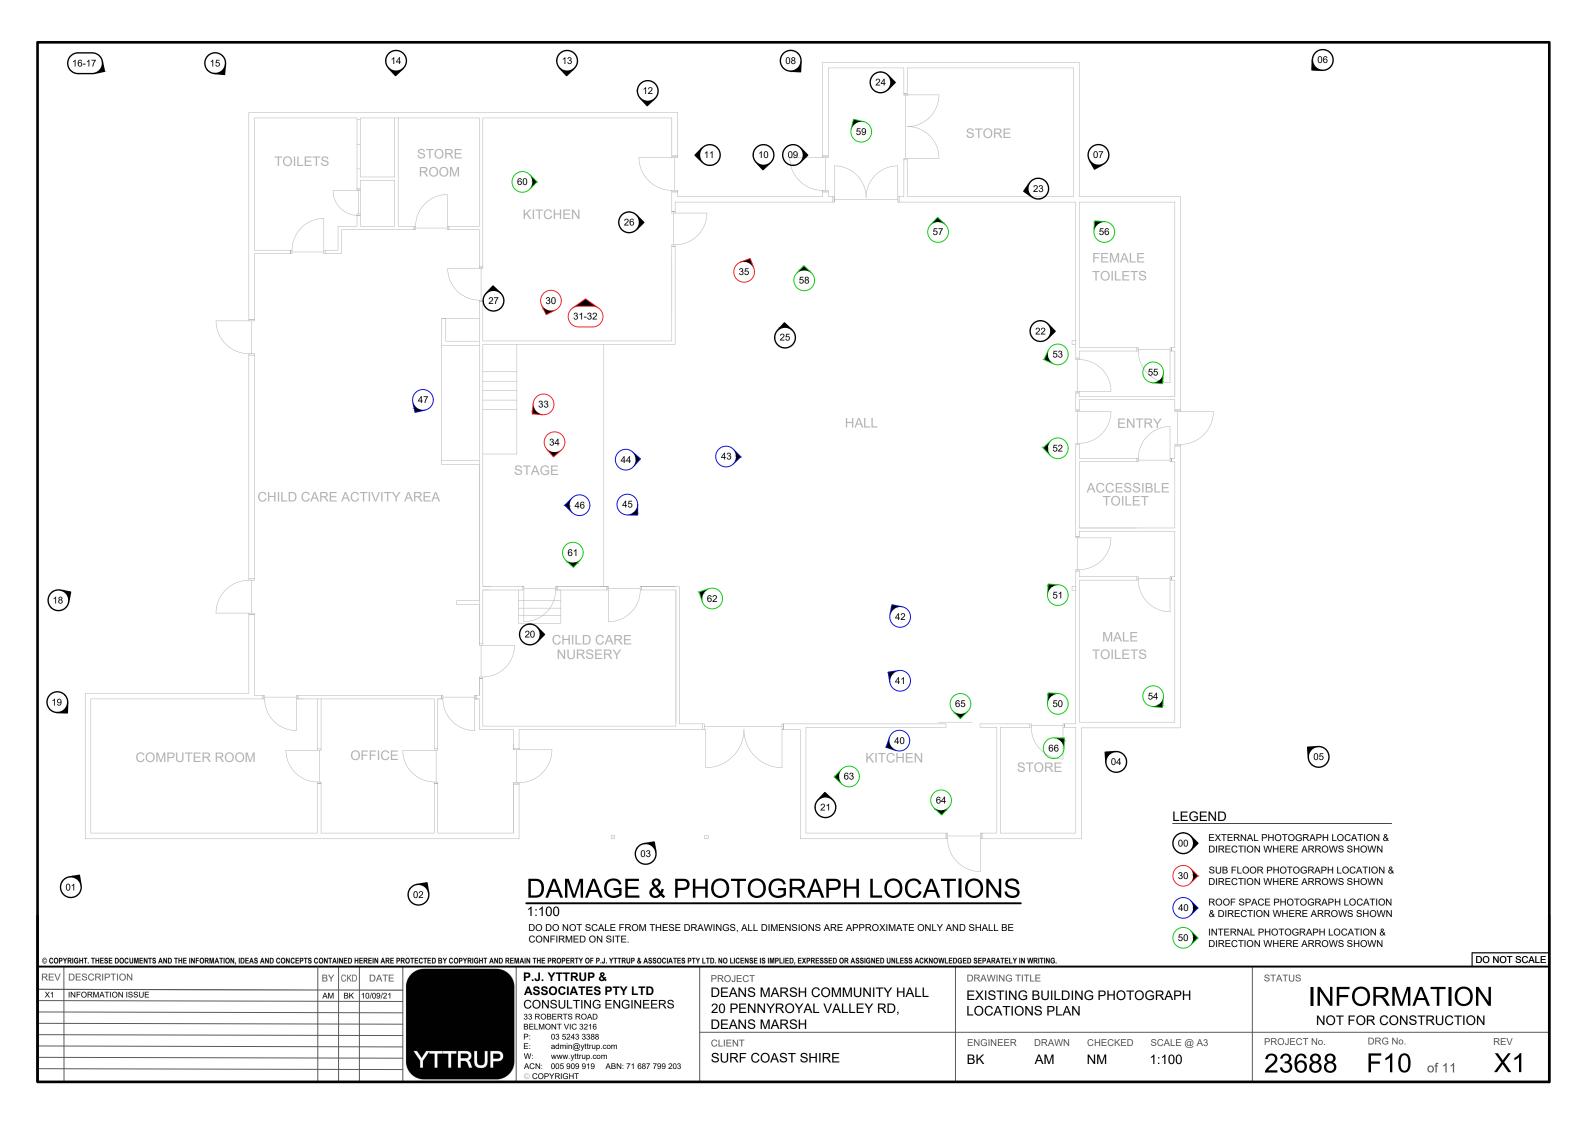
OBSERVED ISSUES				
REPORT SECTION (REFERENCE #)	DESCRIPTION			
4.1.1	POOR SITE / PERIMETER DRAINAGE.			
4.1.2	ROOF DRAINAGE ISSUES.			
4.2.2 (A)	POOR SUBFLOOR CLEARANCE AND VENTILATION.			
4.2.2 (B)	STUMP FAILURE/DEGRADATION AND/OR MOISTURE ISSUES.			
4.3 (A)	LIMITED FLOORING CAPACITY			
4.3 (B)	FB2 INADEQUATE			
4.4	WALL FRAMING CONDITION & TIE DOWN (UNKNOWN - FURTHER INVESTIGATION REQUIRED)			
4.5 (A)	INADEQUATE TRUSS FRAMING TO R1 & CJ1 (OVER STAGE AREA)			
4.5 (B)	TR1 STEEL TRUSS ISSUES			
4.6 (A)	INADEQUATE WALL BRACING			
4.6 (B)	INADEQUATE ROOF BRACING			
	-
