# APPENDIX 1

## PRECINCT DESCRIPTIONS

**A STUDY OF RESIDENT PERCEPTIONS OF NEIGHBOURHOOD  
CHARCATER IN LORNE**

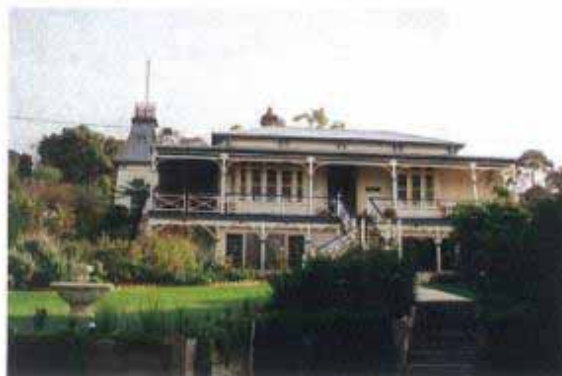
The house that was rated the highest of all residential buildings is a large historic house on Smith Street (Figure 4) in Neighbourhood Three (Photo 1 -  $M = 1.49$ ,  $SD = .55$ ). Of the seven buildings that were rated as being highly compatible with neighbourhood character (mean values from 1.26 to 1.98) four are historic structures (Photos 1, 4, 81 and 31) while one photo depicts the boathouse and café (Photo 46), located on the town side of the river near the end of the Swing Bridge, which although recently built, are reminiscent of an older architecture style. The boathouse and café received a high character compatibility rating ( $M = 1.77$ ,  $SD = 1.53$ ).

Figure 4: Historic House on Smith Street Rated Highest in Neighbourhood Character Compatibility of all Residential Buildings (Photo. No. 1)

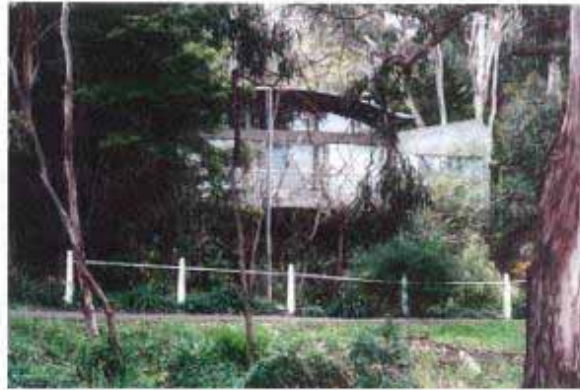
vegetation and gardens. The house depicted in Figure 5 was also described by some people in the mail questionnaire as the first example of this type of contemporary architectural style that was later copied in other areas of the town.

*Figure 5: House on Mountjoy Parade that was Rated Highest in Neighbourhood Character Compatibility of all Contemporary Residential Buildings (Photo. No. 48)*

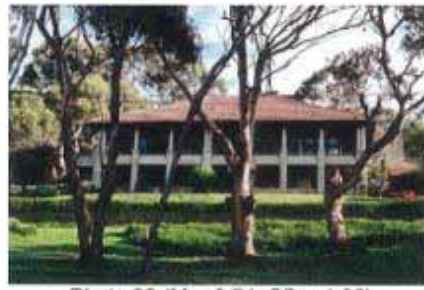
Photo 29 (M = 2.71, SD = 1.98)

Figure 6: Houses Rated Moderately Compatible with Neighbourhood Character from Various Times in the History of Lorne.

<p>Photo 29: House Mean = 2.71, SD = 1.98</p>
<ul style="list-style-type: none"> <li>• Older style beach house</li> <li>• Setback from the road and adjoining properties</li> <li>• Space around building</li> </ul>	<ul style="list-style-type: none"> <li>• Boxy shape</li> <li>• Expanse of lawn</li> <li>• Flat surfaces with small windows</li> </ul>

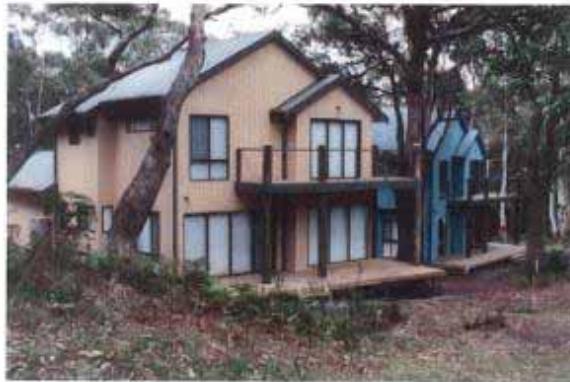
Figure 7: New Houses Rated Slightly Compatible with Neighbourhood Character (Photo 2).

<p>Photo 2: Houses Mean = 3.19, SD = 1.42</p>

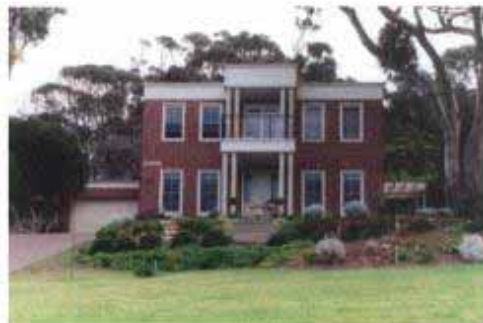
*Figure 9: House in Neighbourhood Four Rated Moderately Incompatible with Neighbourhood Character (Photo 34).*

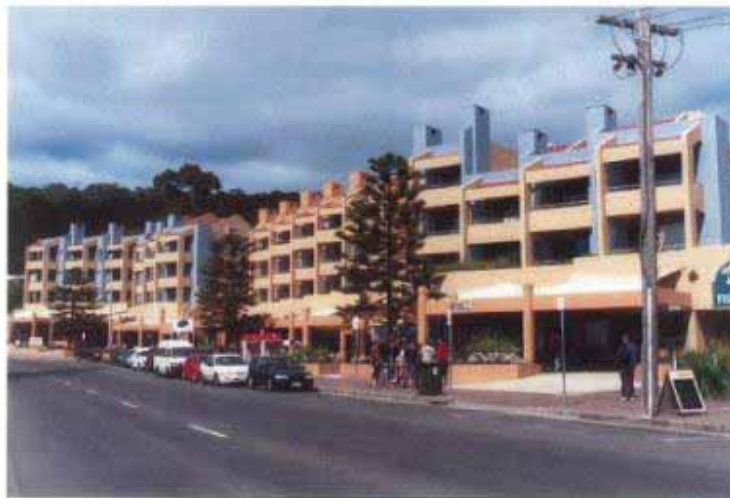
There were only two features that were rated as strongly incompatible with neighbourhood character. The photo rated as most strongly out of character depicts a line of particularly ugly power poles and lines in Neighbourhood One (Photo 37 –  $M = 6.51$ ,  $SD = 1.21$ ). The feature rated second most incompatible with neighbourhood character is the Cumberland Hotel (Figure 10) in Neighbourhood Three (Photo 49 –  $M = 6.12$ ,  $SD = 1.60$ ). This massive building is very dominant visually along the Great Ocean Road and visible from a long distance before entering the town. In the projective mapping mail questionnaire this development was identified by many respondents as being a feature considered to be very incompatible with neighbourhood character and was most frequently described as too big and not in keeping with Lorne; "like something one would find in Noosa".

Figure 10: The Cumberland Hotel Rated Strongly Incompatible with Neighbourhood Character (Photo 49).

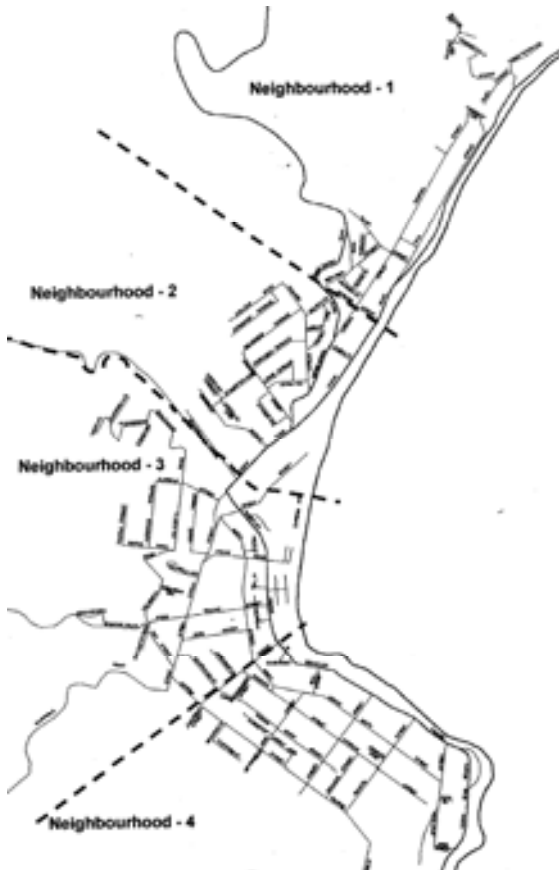
**Figure C1: Study Area Map with Neighbourhood Precincts**

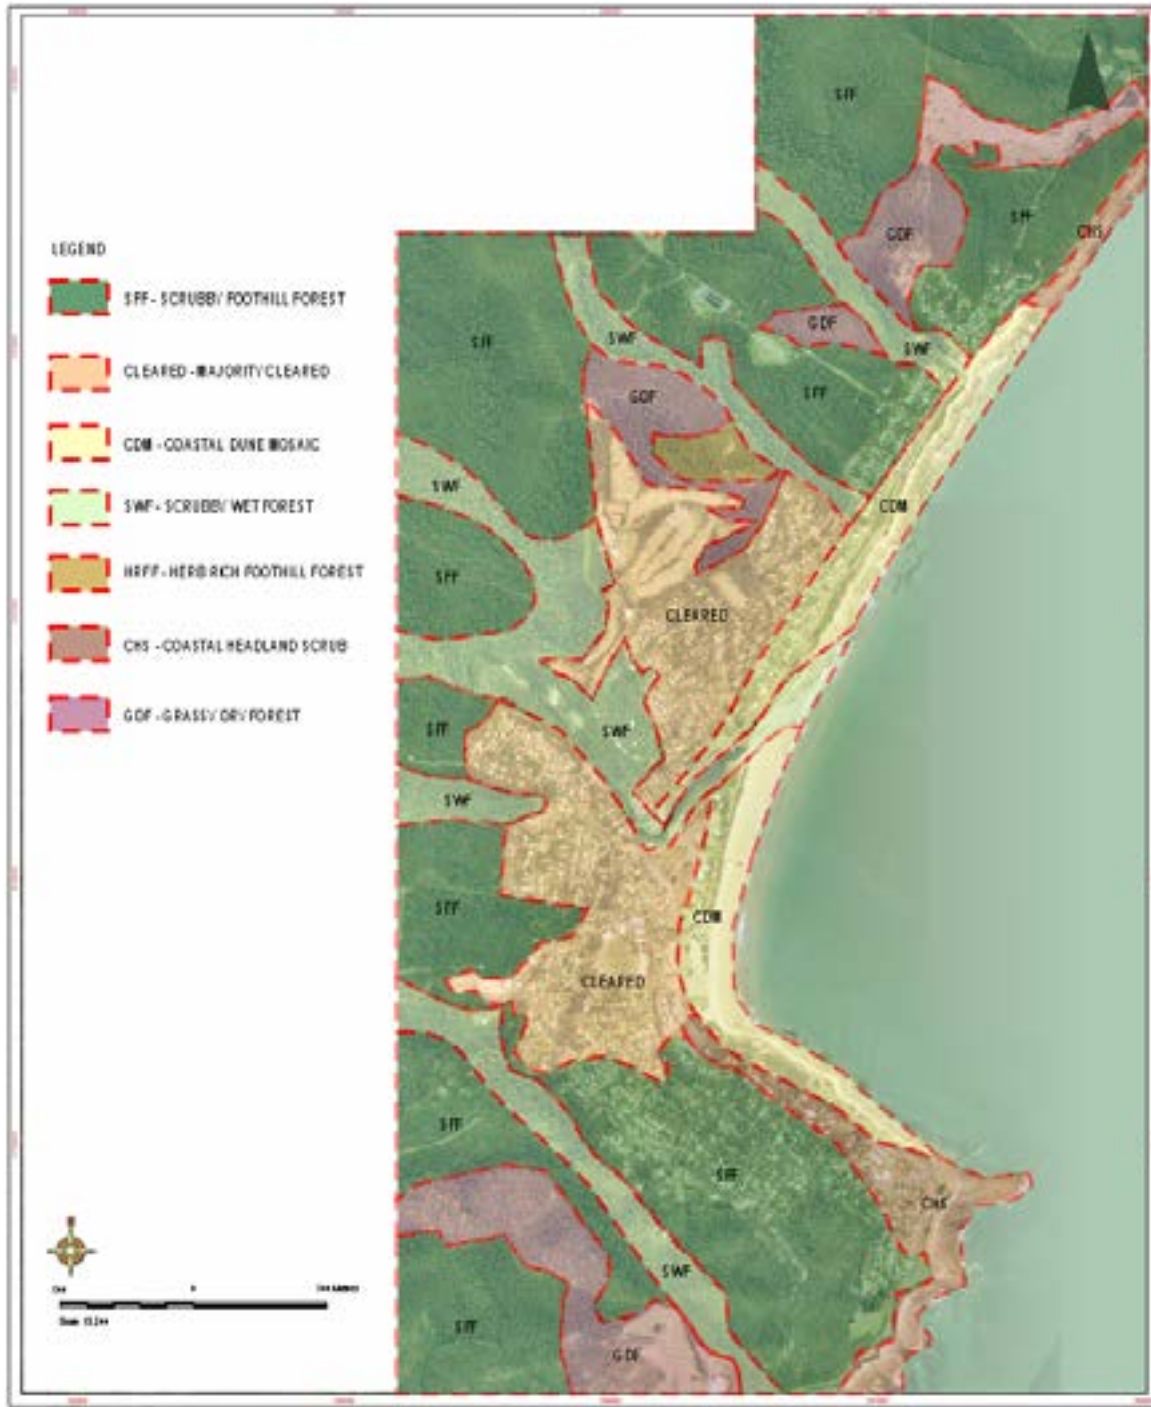
Figure C2: Ecological Vegetation Classes (2003)

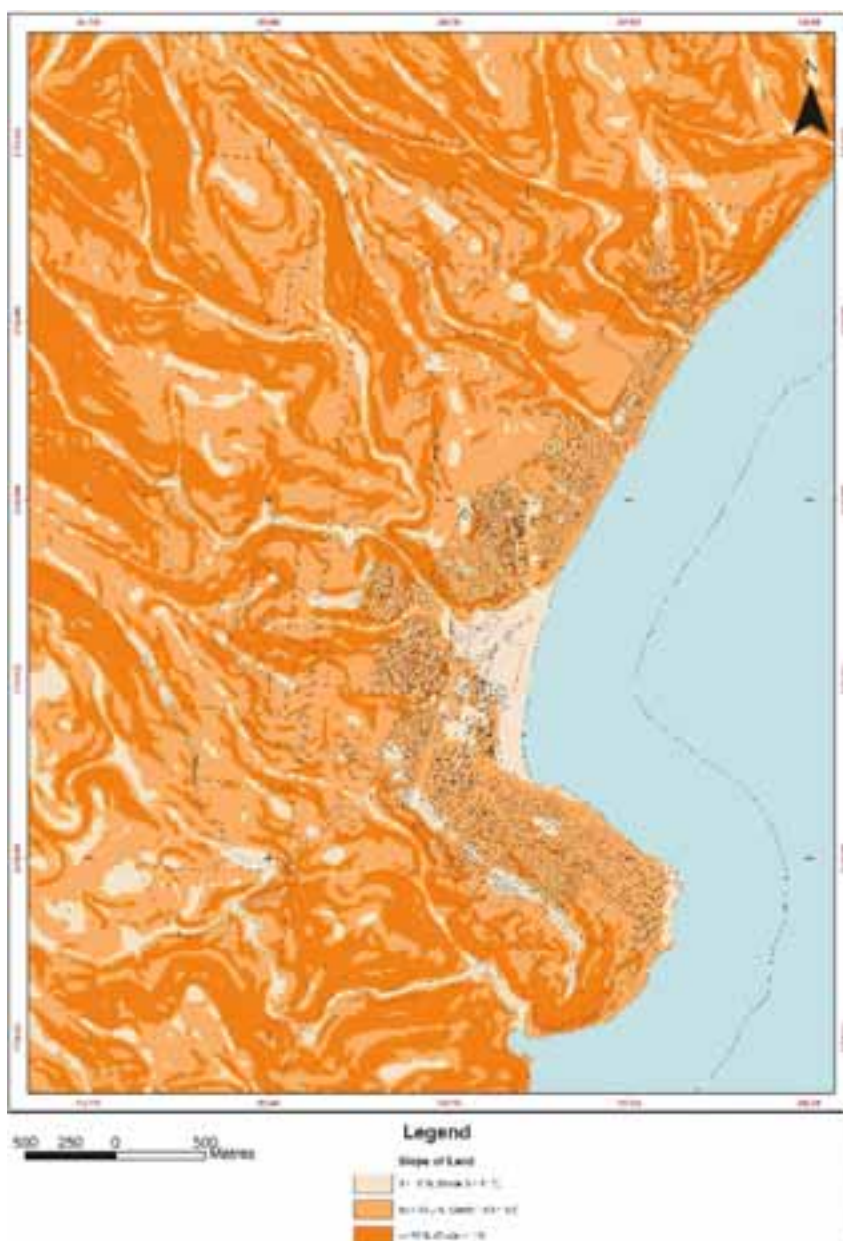
The crests of various ridgelines are also apparent as they flatten and crown before falling away to the valley on the other side.

**Figure C5: Slope**

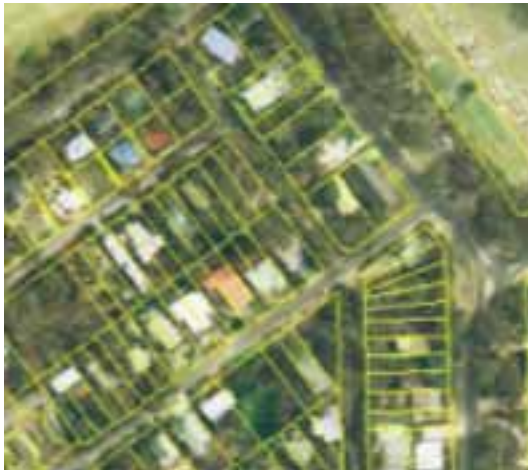
**Figure C7: Part aerial showing many houses spanning two allotments**

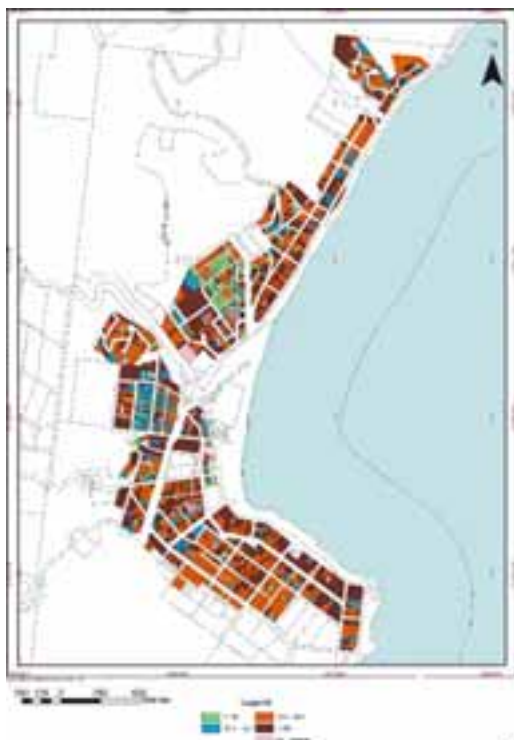
**Figure C8: Lot Frontages**

While the majority of allotments are approximately 15 metres wide (the red allotments in Figure C8 above, allotments with different frontages are relatively evenly distributed across the Lorne urban areas. Areas of smaller allotments or particularly allotments with narrower frontages have often one house spanning two allotments.

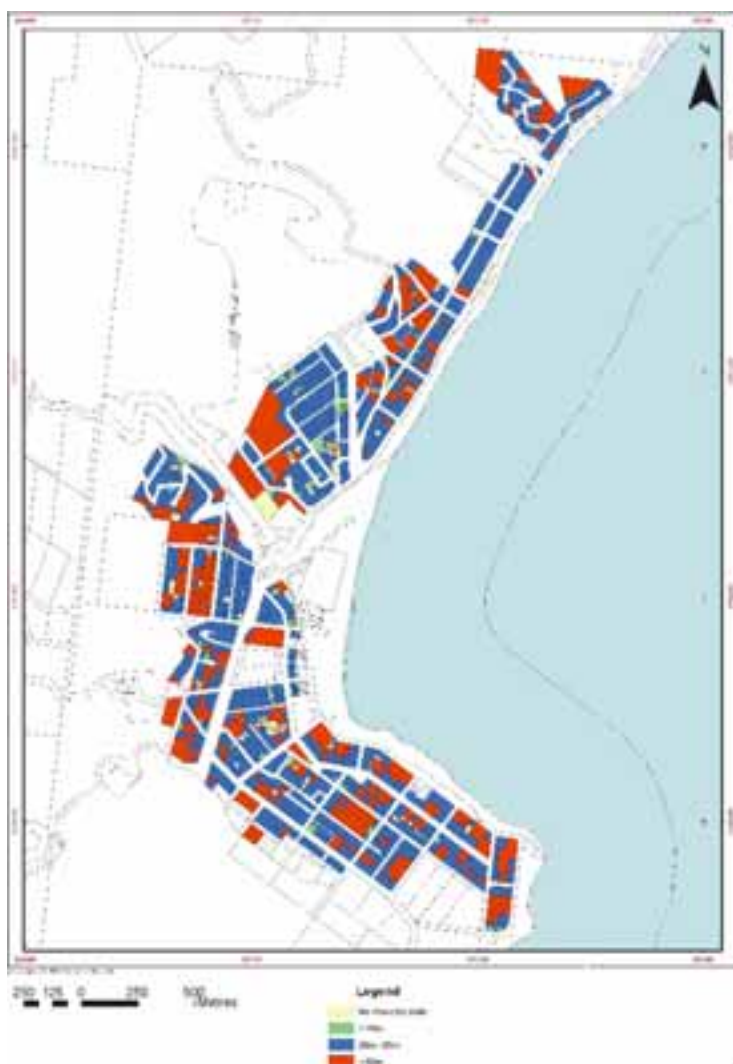
Utilising the GIS software an analysis of parcel depths was made to determine if concentrations of particular lot depths impact the main character elements of hills, vegetation, ocean and views.

**Figure C9: Lot Depths**

Very few lots with a depth of less than 20 metres occur in Lorne. Two small areas of this sized lot occurs near the corner of Howard St and Fernleigh Crescent. Another occurs near the intersection of Minapre Street and Alpha Terrace.

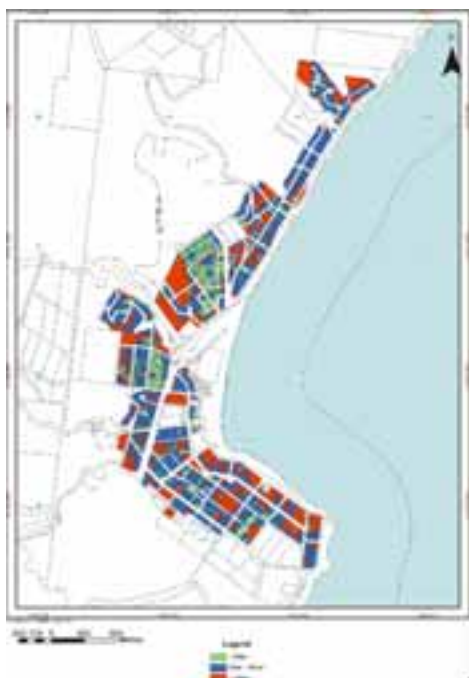
Figure C10: Lot Areas

The distribution of Lots with similar areas reflects the variation to Lot frontages previously discussed. Two pockets of development with smaller lot areas are discernible north and south of the Erskine Rive. However on site verification has shown that many houses span two allotments (refer lot frontage figure), therefore the visual difference is not sufficient to generate a different precinct or neighbourhood based on allotment size.

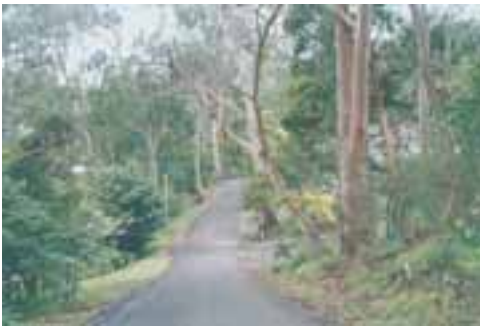
**Figure C12: Informal Road and Verge Treatment**

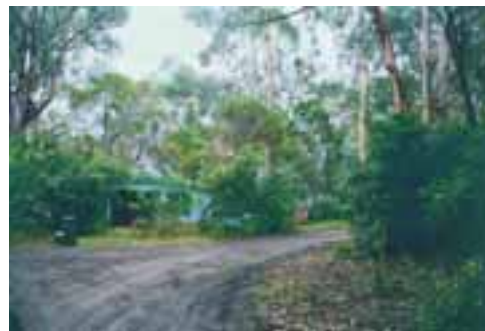
**Figure C13: Informal Road and Verge Treatment**

There are also various pedestrian path treatments that range from an unmade track on the grassed nature strip, to more formal concrete footpaths paralleling the kerb. In many areas pedestrians are required to walk on the roads, with the verges acting as a refuge for pedestrians if vehicles approach.

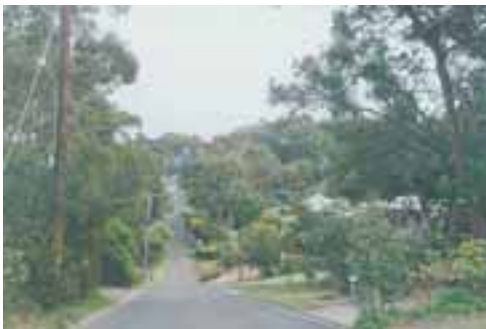
**Figure C14: Semi Formal Road and Verge Treatment**

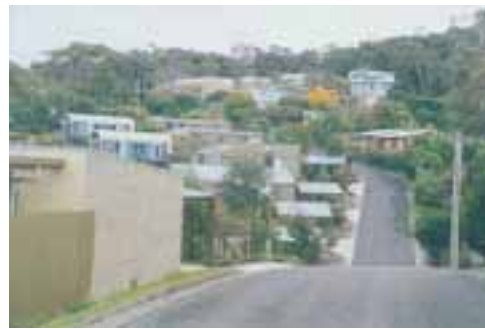
**Figure C15: Formal Road and Verge Treatment**

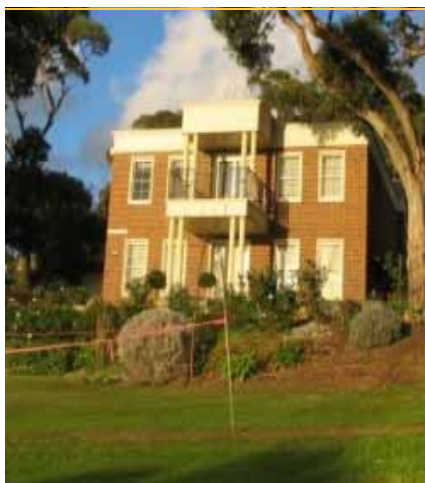
**Comment:** This building was rated negatively because of: Flat boxy shape; Generic urban style; Mock Georgian; Lack of screening vegetation; Dark brick; Flat surfaces with small windows; and Expanse of lawn

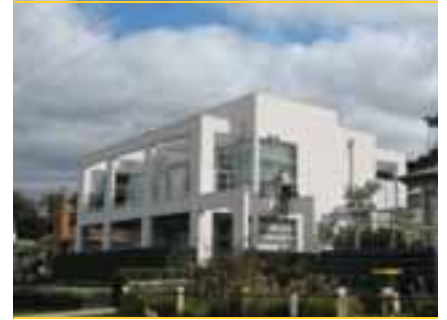
Comment: This building was rated negatively because of: Squareness of building—boxy; Formal, boxy foundation planting; Building dominates street; and Large scale.

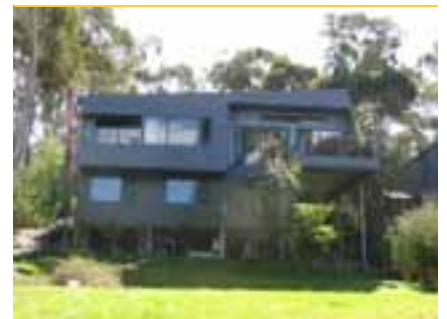
Comment: This building was rated negatively because of: Boxy; Little surface or mass articulation; Top heavy looking; Dark imposing colour; and No vegetation screening.

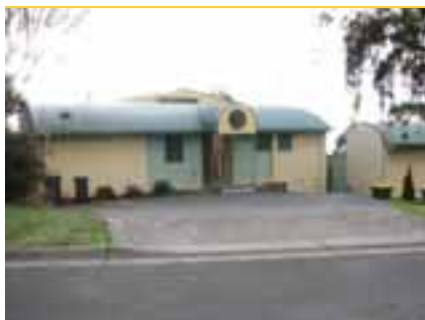
**Case 4**

Type: Two storey  
 NCCS: -  
 Permit No.: 98/7372  
 Land Area: 860m<sup>2</sup>  
 Height: 7.5m  
 Bld Site %: 30% (258m<sup>2</sup>)  
 Bld & H/S %: 36% (309m<sup>2</sup>)  
 Plot Ratio: 0.42 (390m<sup>2</sup>)  
 Minimum Setbacks: Street — 4.5m  
 Sides — 0m & 1.0m

Comment: The small street setback and large area of concrete driveway has limited the development of landscaping that might soften the appearance of the building. The building form has limited surface articulation and the street elevation has minimal fenestration.

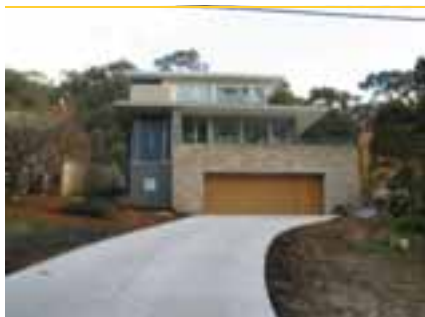
**Case 5**

Type: Three storey  
 NCCS: -  
 Permit No.: 00/0047  
 Land Area: 810m<sup>2</sup>  
 Height: 8.4m  
 Bld Site %: 36% (297m<sup>2</sup>)  
 Bld & H/S %: 49% (401m<sup>2</sup>)  
 Plot Ratio: 0.64 (518m<sup>2</sup>)  
 Minimum Setbacks: Street — 10.5m  
 Sides — 1.2m & 1.8m

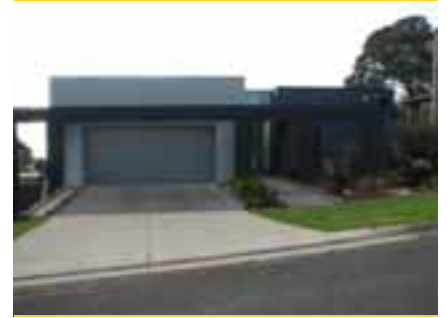
**Comment:** Set close to the street the garage dominates the street presence. Parapet walls add to the boxiness of the building. Small landscape areas and low vegetation do not soften the built form.

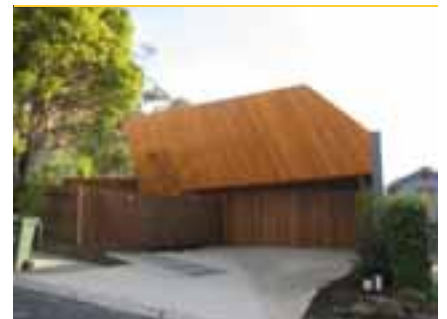
**Comment:** Blank walls fronting the street and parapet walls create a bulky presentation and lack of address. Wide concrete driveway. The footprint of the building is highly articulated but this creates small landscape spaces unable to accommodate larger vegetation

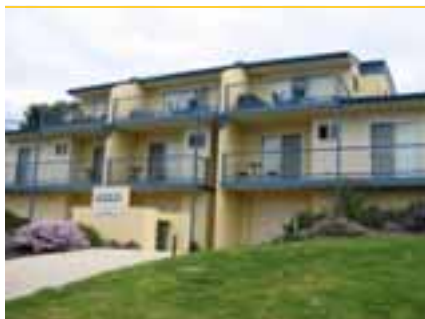
**Case 9**

Type: Three, two storey  
 NCCS: 5.79  
 Permit No.: 99/8237  
 Land Area: 626m<sup>2</sup>  
 Density: 1:208m<sup>2</sup>  
 Height: 7.3m  
 Bld Site %: 50% (313m<sup>2</sup>)  
 Bld & H/S %: 65% (407m<sup>2</sup>)  
 Plot Ratio: 0.6 (376m<sup>2</sup>)  
 Minimum Setbacks: Street — 4.0m  
 Sides — 1.14m & 1.2m

Comment: This building was rated negatively because of: Density of development; Repetition of buildings; High opaque fencing; Boxy, bulky buildings; Dull flat surfaces with small windows; Lack of screening; and Lack of vegetation.

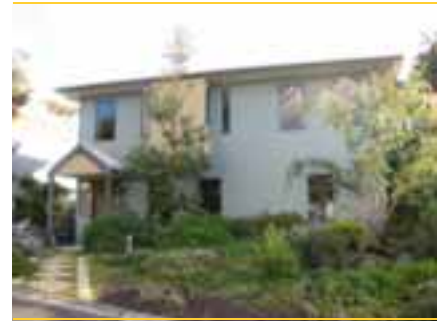
Comment: This building was rated negatively because of: Boxy architecture; Flat facades with small windows; Expanses of paved surfaces; Lack of screening; Lack of landscaping; and No trees.

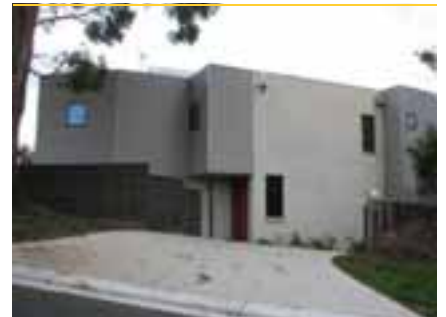
Comment: This building was rated negatively because of: Boxy form; Flat dull surfaces; Small windows; Lack of landscaping; Overpowering second storey; and Corrugated iron.

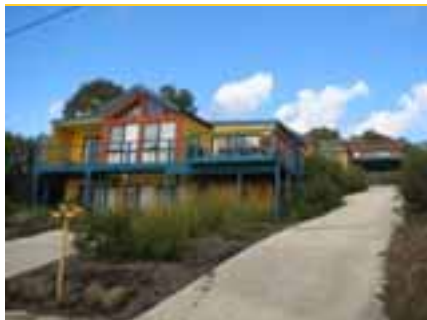
**Case 12**

Type: Two, two storey  
 NCCS: 4.79  
 Permit No.: 99/8037  
 Land Area: 852m<sup>2</sup>  
 Density: 1:426m<sup>2</sup>  
 Height: 6.55m  
 Bld Site %: 37% (313m<sup>2</sup>)  
 Bld & H/S %: 51% (430m<sup>2</sup>)  
 Plot Ratio: 0.43 (368m<sup>2</sup>)  
 Minimum Setbacks: Street — 6.5m  
 Sides — 1.37m & 6.4m

Comment: This building was rated negatively because of: Garish colours— too strong, too many; Dominated by driveways and concrete; No landscaping; and No screening.

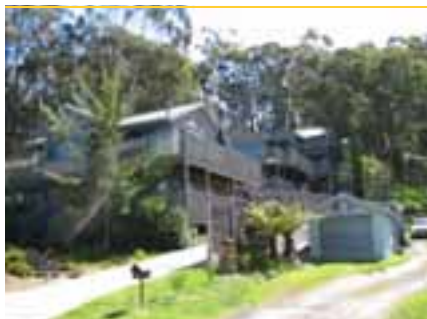
**Case 13**

Type: Four, two storey  
 NCCS: -  
 Permit No.: 01/0291  
 Land Area: 1992m<sup>2</sup>  
 Density: 1:498m<sup>2</sup>  
 Height: 7.5m  
 Bld Site %: 26% (520m<sup>2</sup>)  
 Bld & H/S %: 43% (865m<sup>2</sup>)  
 Plot Ratio: 0.27 (538m<sup>2</sup>)  
 Minimum Setbacks: Street —4.0m  
 Sides — 4.5m & 4.6m

Comment: Repetition of building style and close proximity of buildings create a sense of building mass. Large areas of concrete driveway and small setbacks limit landscaping.

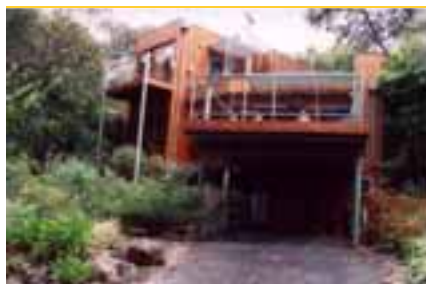
**Case 16**

Type: Two storey  
 NCCS: 3.14  
 Permit No.: 95/5970  
 Land Area: 454m<sup>2</sup>  
 Height: 7.5m  
 Bld Site %: 24% (108m<sup>2</sup>)  
 Bld & H/S %: 27% (123m<sup>2</sup>)  
 Plot Ratio: 0.29 (130m<sup>2</sup>)  
 Minimum Setbacks: Charles Street — 10.7m  
 Francis Street — 1.2m  
 Francis Lane — 5.0m  
 Sides — 1.37m & 6.4m

Comment: This building was rated positively because of: Smaller scale of development; House set into established garden; Timber construction; Articulated façade; Balconies; and House dominated by vegetation.

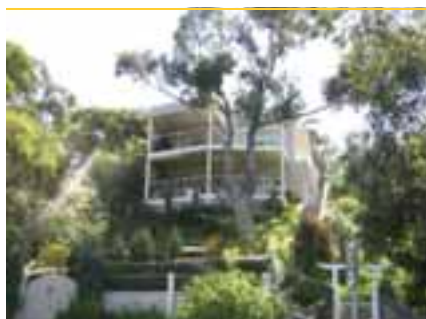
**Case 17**

Type: Two storey  
 NCCS: 3.63  
 Permit No.: 99/8175  
 Land Area: 488m<sup>2</sup>  
 Height: 7.5m  
 Bld Site %: 35% (171m<sup>2</sup>)  
 Bld & H/S %: 35% (171m<sup>2</sup>)  
 Plot Ratio: 0.5 (245m<sup>2</sup>)  
 Minimum Setbacks: Deans Marsh Road — 18.0m  
 Gwynnne Avenue — 0m  
 Sides — 1.2m & 1.85m

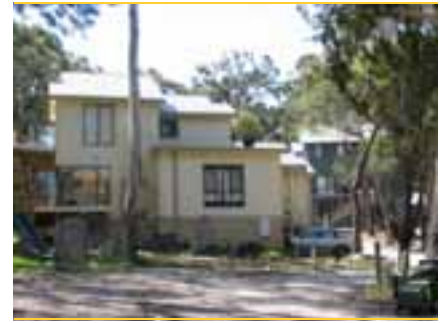
**Case 19**

Type:	Thre, Two storey
NCCS:	3.77
Permit No.:	99/8612
Land Area:	1344m <sup>2</sup>
Density:	1:448m <sup>2</sup>
Height:	8.8m
Bld Site %:	33% (444m <sup>2</sup> )
Bld & H/S %:	51% (688m <sup>2</sup> )
Plot Ratio:	0.39 (524m <sup>2</sup> )
Minimum Setbacks:	Street — 6.45m Sides — 1.2m & 3.0m

**Comment:** These buildings were rated positively because of: Retention of trees during construction; Surfaces articulated; Glass surfaces dominate; and Variety of colours.

These buildings were rated negatively because of: Expanse of concrete driveway; Density of development; and Building mass on hillside.

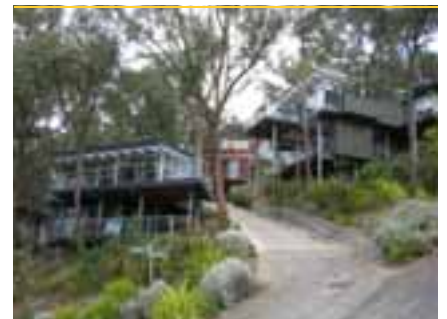
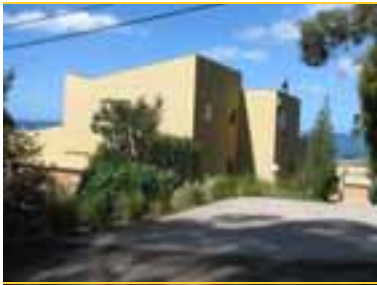
**Case 20**

Type:	Four, Two storey
NCCS:	3.95
Permit No.:	97/7104
Land Area:	1991m <sup>2</sup>
Density:	1:498m <sup>2</sup>
Height:	7.7m
Bld Site %:	34% (672m <sup>2</sup> )
Bld & H/S %:	48% (955m <sup>2</sup> )
Plot Ratio:	0.43 (847m <sup>2</sup> )
Minimum Setbacks:	Street — 4.5m Sides — 0m & 3.1m
