Loveridge Lookout

Anglesea

Conservation Management Plan

Dr David Rowe: Authentic Heritage Services Pty Ltd

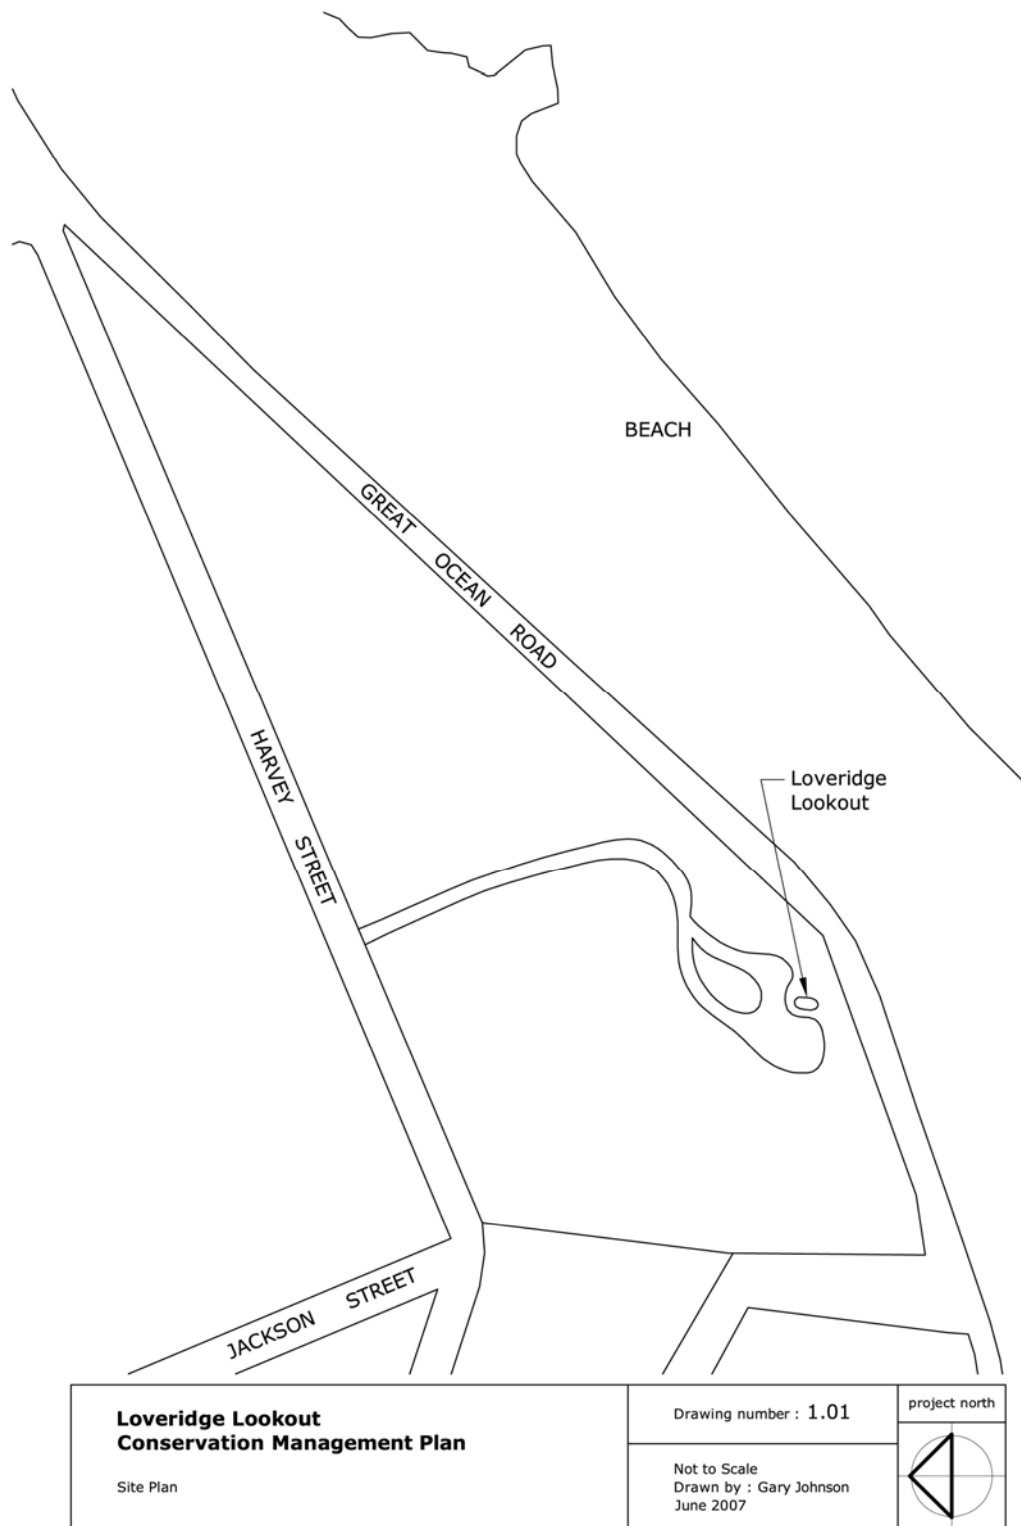
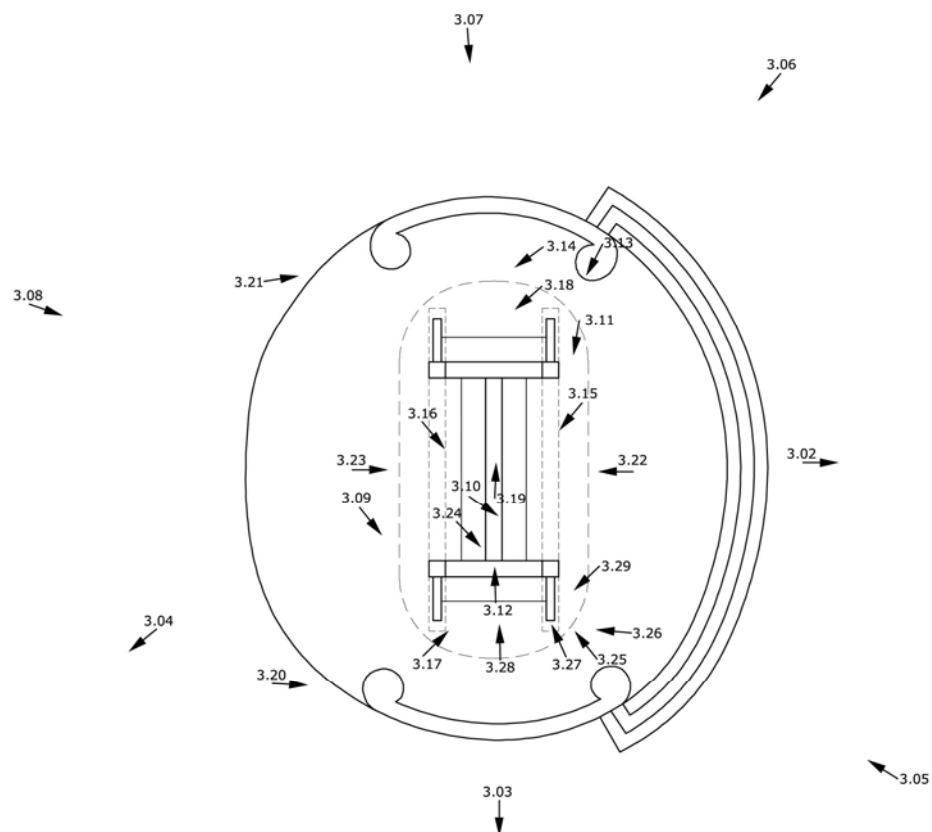
Drawing 1.02: Loveridge Lookout Floor Plan & Photographic Key

<p>Loveridge Lookout Conservation Management Plan</p> <p>Floor Plan & Photographic Key</p>	<p>Drawing number : 1.02</p>	<p>project north</p>
	<p>Not to Scale Drawn by : Gary Johnson June 2007</p>

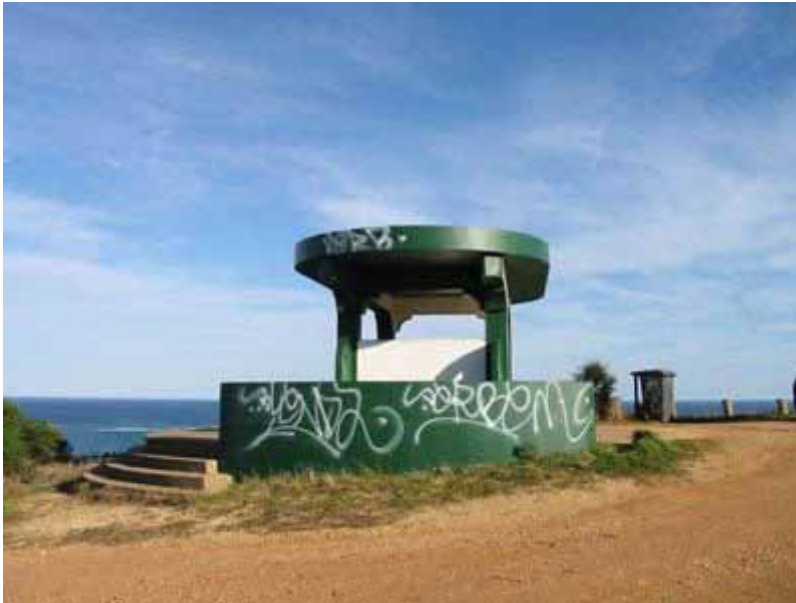
Figure 2.10: Loveridge Lookout, 2002, after graffiti attack (north face). Source: Anglesea On-line.

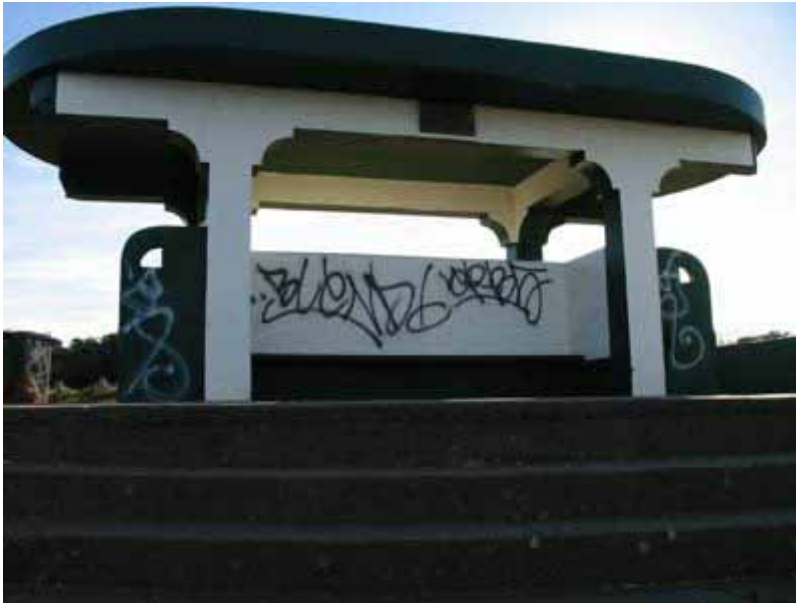
Figure 2.12: Loveridge Lookout, 2002, after graffiti attack (west face). Source: Anglesea On-Line.

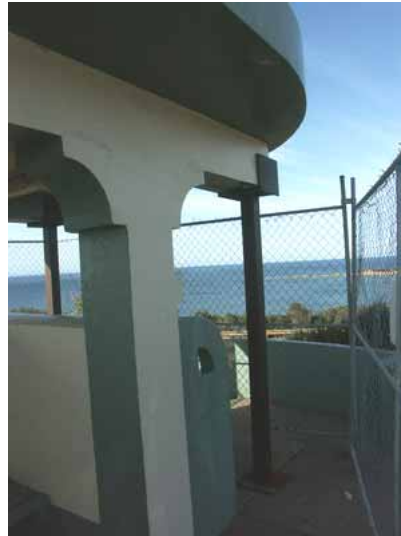
Photo 3.09: Detail of concrete pier and cantilevering beam, south-west corner. Note the temporary steel prop supporting the beam.

- Suitably prop the beams in stages while repairs are carried out.
- Remove all render and concrete from around all longitudinal reinforcing bars, remove all reinforcement bars and replace with 316 grade stainless steel bars.
- Remove all render and concrete from around all ligature bars, followed by grit blasting the bars and coating with an electrically insulating epoxy coating, or replace them with 316 grade stainless steel bars.

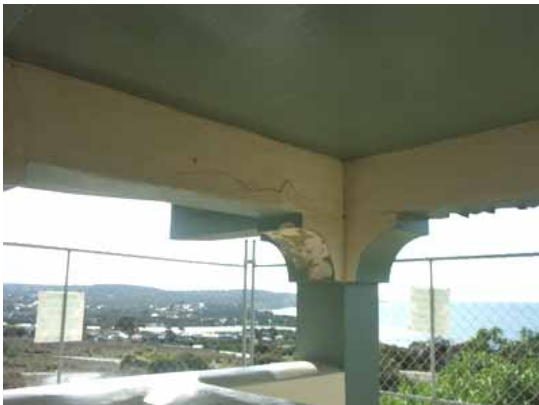
Photo 3.10: Detail of roof soffit and junction of beams with column. Note the cracking in the west beam and spalled bracket to the column.

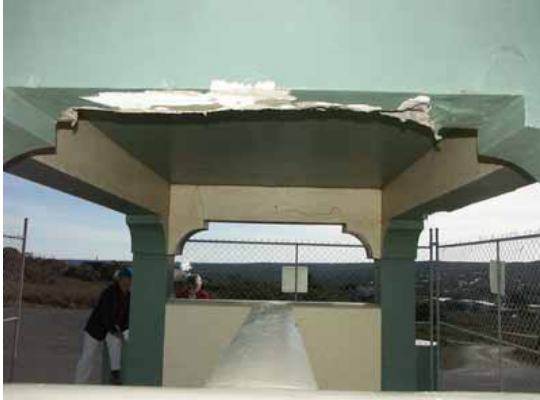
Photo 3.12: View looking west (from the east end) showing spalled beam (foreground) and dividing wall (that acts as a backrest for the bench seating on the east and west faces).

- The painted brick seat backrests/partition walls be retained. These walls appear to be in good condition.
- The missing timber slat to longitudinal seat (east side) be replaced in timber to match existing and painted.
- The steel brackets to the bench seats be treated with rust inhibitor and painted.
- The rotted timber slats in the bench seats be replaced to match existing and painted.

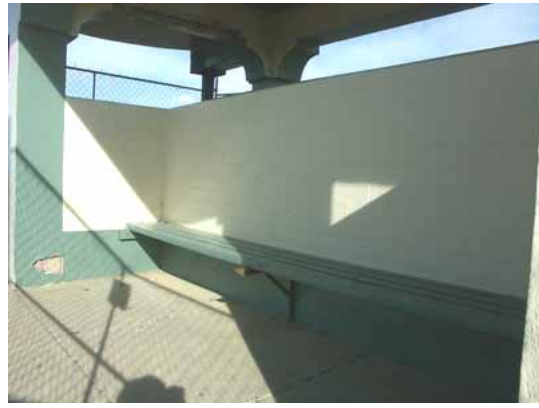
Photo 3.15: Detail of bench seat, east face. Note the missing timber slat to the seat and also the spalled concrete at the base of the column.

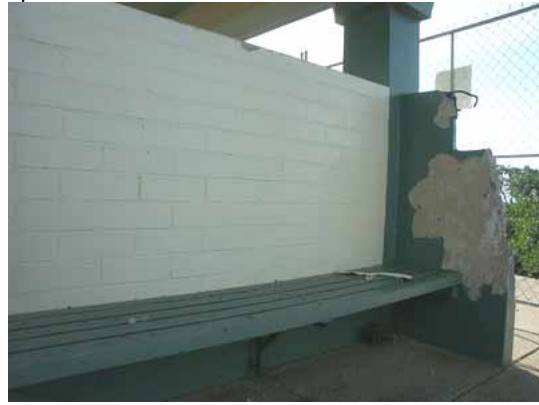
Photo 3.17: Detail of bench seat, south face. Note the substantially spalled concrete end to the seat.

- Prepare a measured drawing of the existing curved ends to the seats on the north and south faces, given their highly deteriorated state.
- Prepare a drawing of these curved seat ends to match the original design.
- Remove existing seat ends.
- Off-site fabricate the replacement precast walls using lightweight aggregate and corrosion resistant reinforcement, to match the original design.
- On-site install the walls into the original locations.

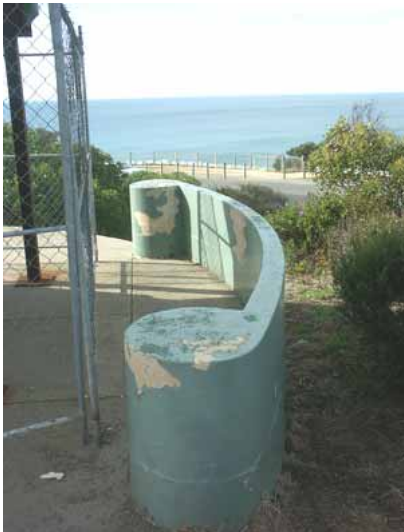
Photo 3.20: Detail of curved balustrade (south end) showing peeled paintwork and spalled concrete.

- Remove all render and roughen the entire concrete surface.
- Repair all localized defective concrete locations followed by high pressure water washing.
- Saturate the surface with a Migrate Corrosion Inhibitor for concrete.
- Re-render the surface to its original shape using polymer modified mortar with a high diffusion resistance.

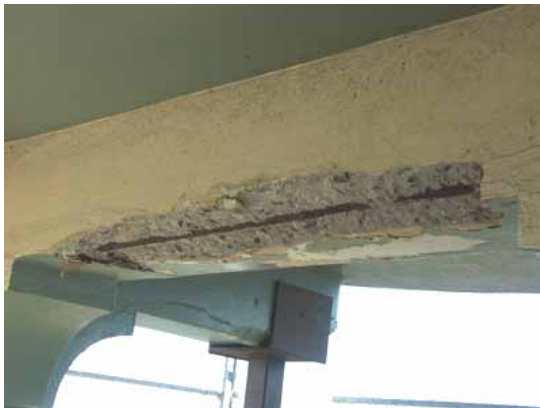
Photo 3.24: Detail of spalled south-facing beam exposing reinforcement.

- Prepare surface and rebuild the beams into their original shape using polymer modified repair mortar with a high diffusion resistance.

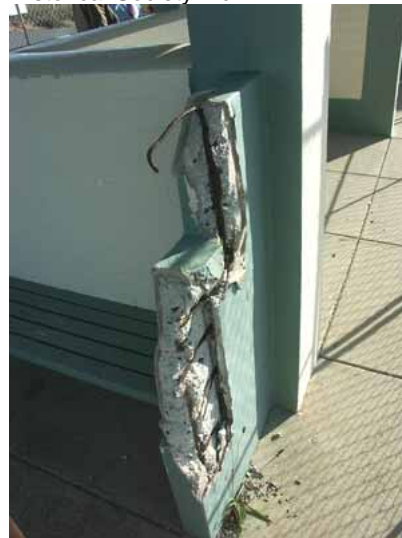
Photo 3.25: Detail of substantially spalled eastern end of south-facing seat.

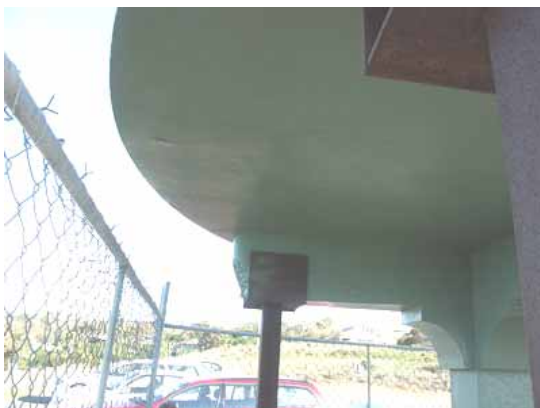
Photo 3.26: Detail of projecting southern portion of the roof showing supporting introduced steel props.

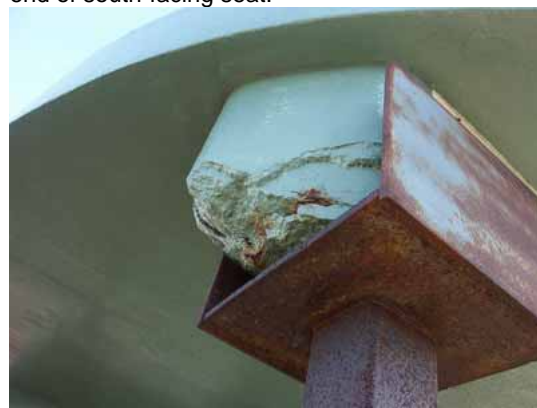
Photo 3.27: Detail of spalled southern end of the east-facing beam supported by an introduced steel prop.

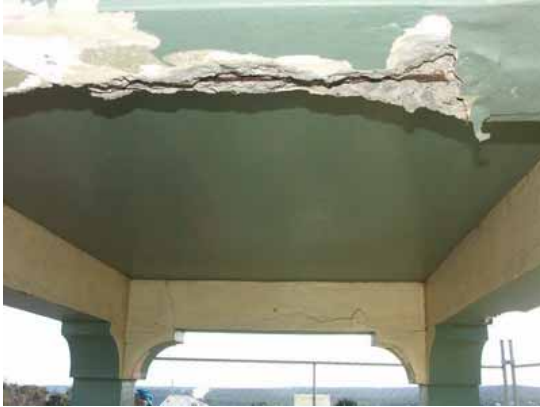
Photo 3.28: Detail of substantially spalled south-facing beam.

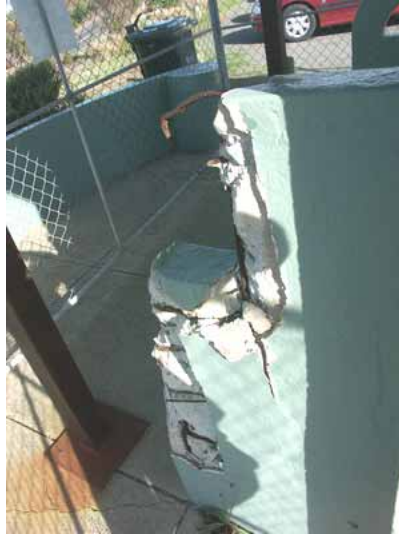
Photo 3.29: Detail of substantially spalled and cracked eastern end to the south-facing seat.
