Great Ocean Road Region Standing Advisory Committee

Referral of Bells Beach Elevated Walkway
Bells Beach Surfing Recreation Reserve
Wadawurrung Country

Written submission by the Committee of Management, Surf Coast Shire
Council

September 2020

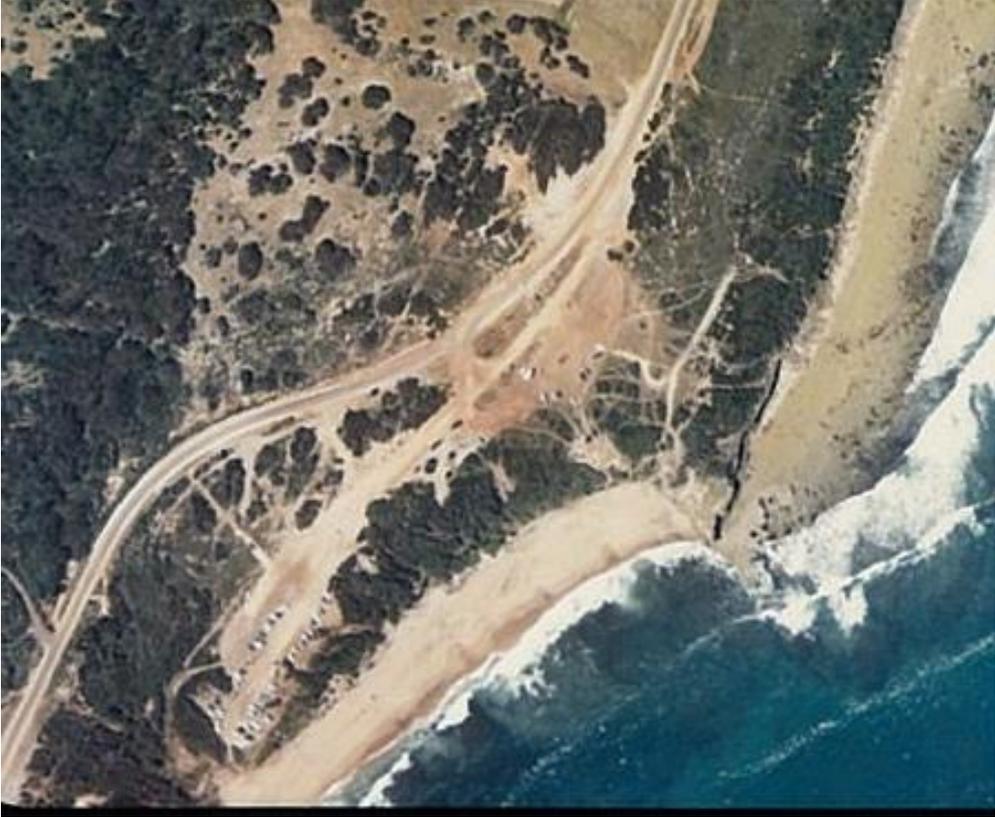
Figure 1 Aerial of main visitor areas at Bells Beach from 1974

Following clearing of an improved access track to Bells in 1960, the condition of the main use areas experienced significant decline (Figure 1). Council has successfully improved management arrangements and infrastructure since that time and worked with community groups restoring the condition of the reserve (Figure 2). Ninety-two% of reserve users surveyed in 2018 rated their experience of the reserve as 'Very Good' or 'Excellent'. There has been strong community support and involvement in these works. For example, the first conservation surfing contest was held in 1971, Surfers Appreciating the Natural Environment formed in 1988, Rip Curl staff have staged their annual Planet Days in the reserve for the past 20 years and Surfrider Foundation (Surf Coast Branch) has held clean-up days.

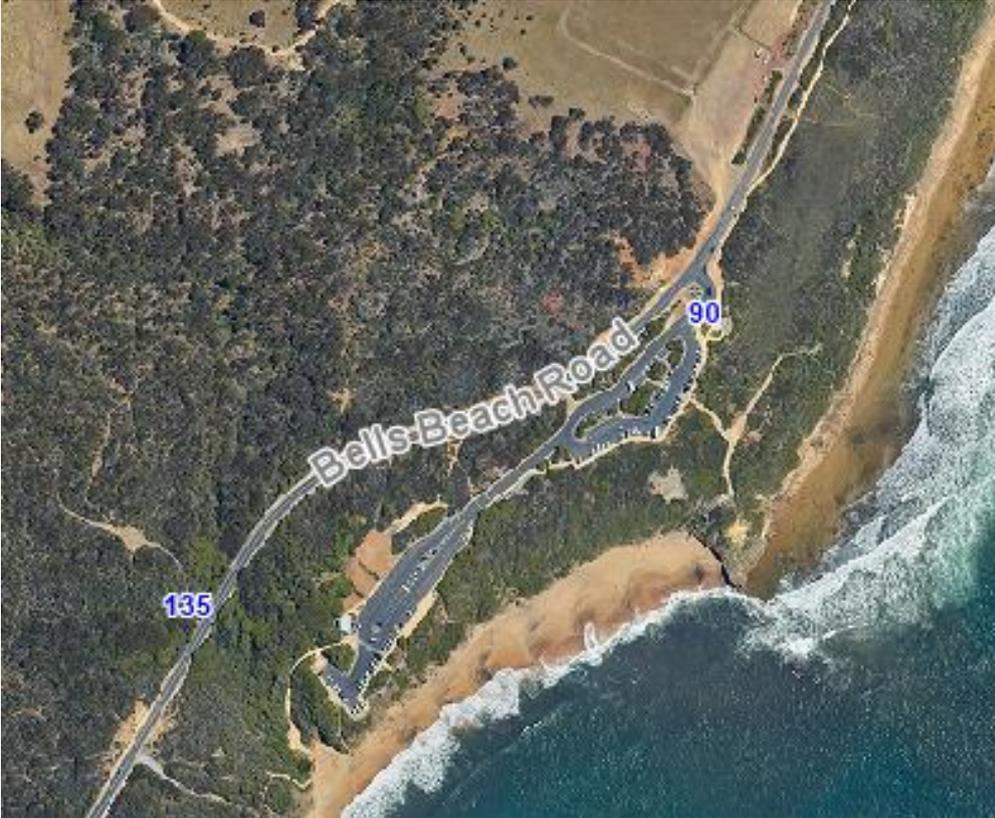
Figure 2 Aerial of the same area from January 2020 showing significant improvements in the condition of the reserve

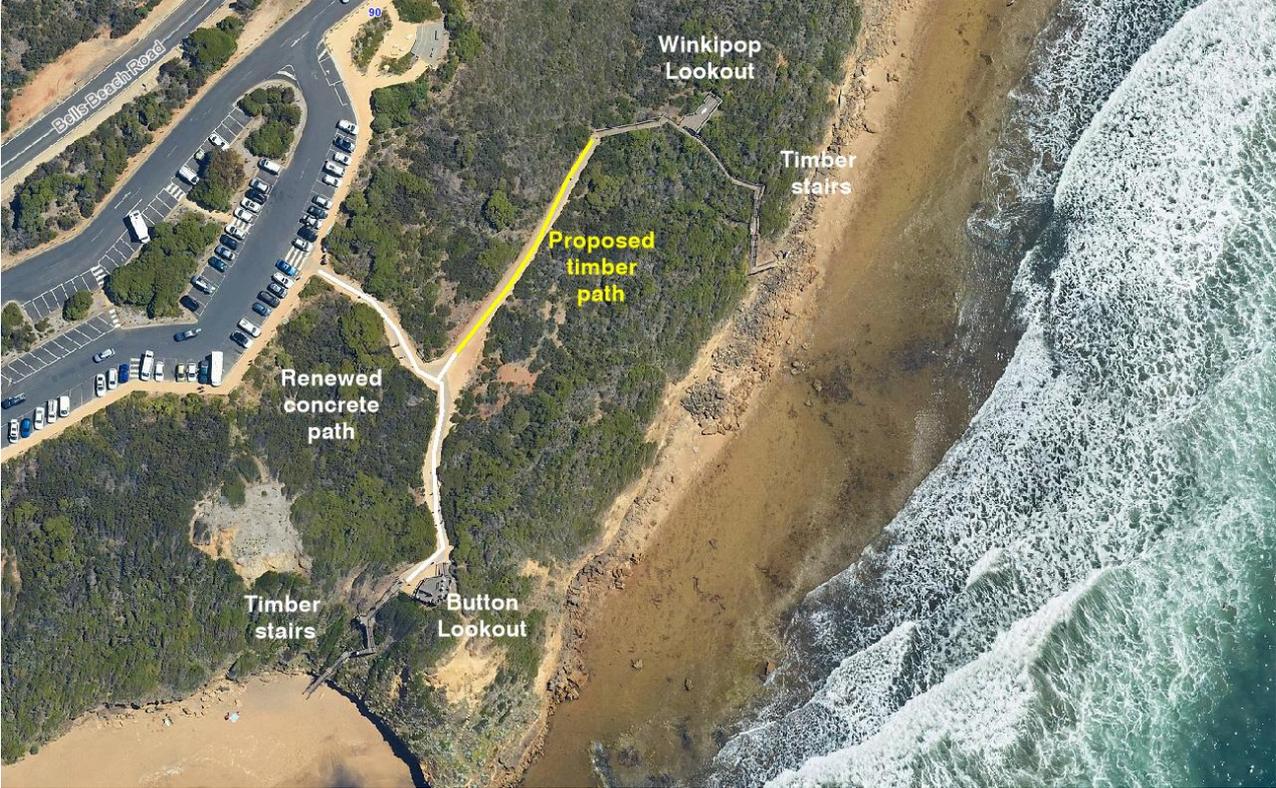
Figure 3 Overview of the paths in the Winkipop area

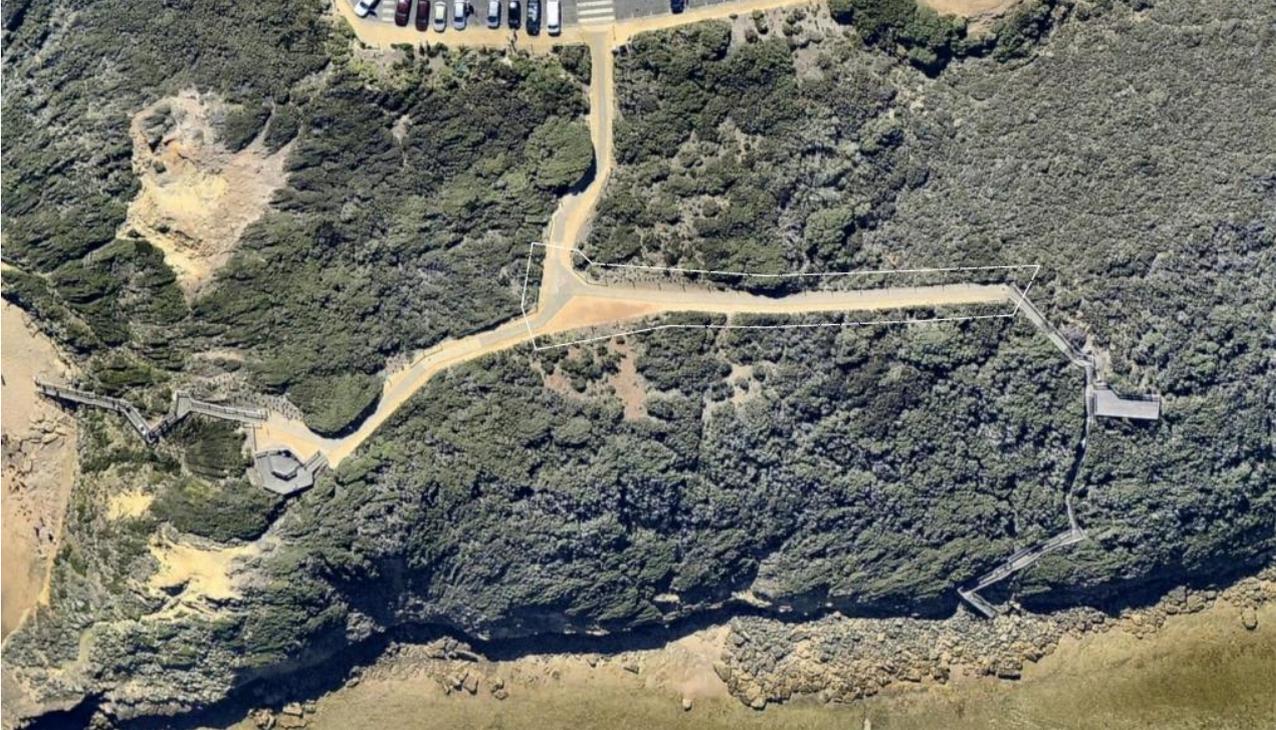
Figure 4 Close up of the site of the proposed elevated timber pathway, replacing concrete

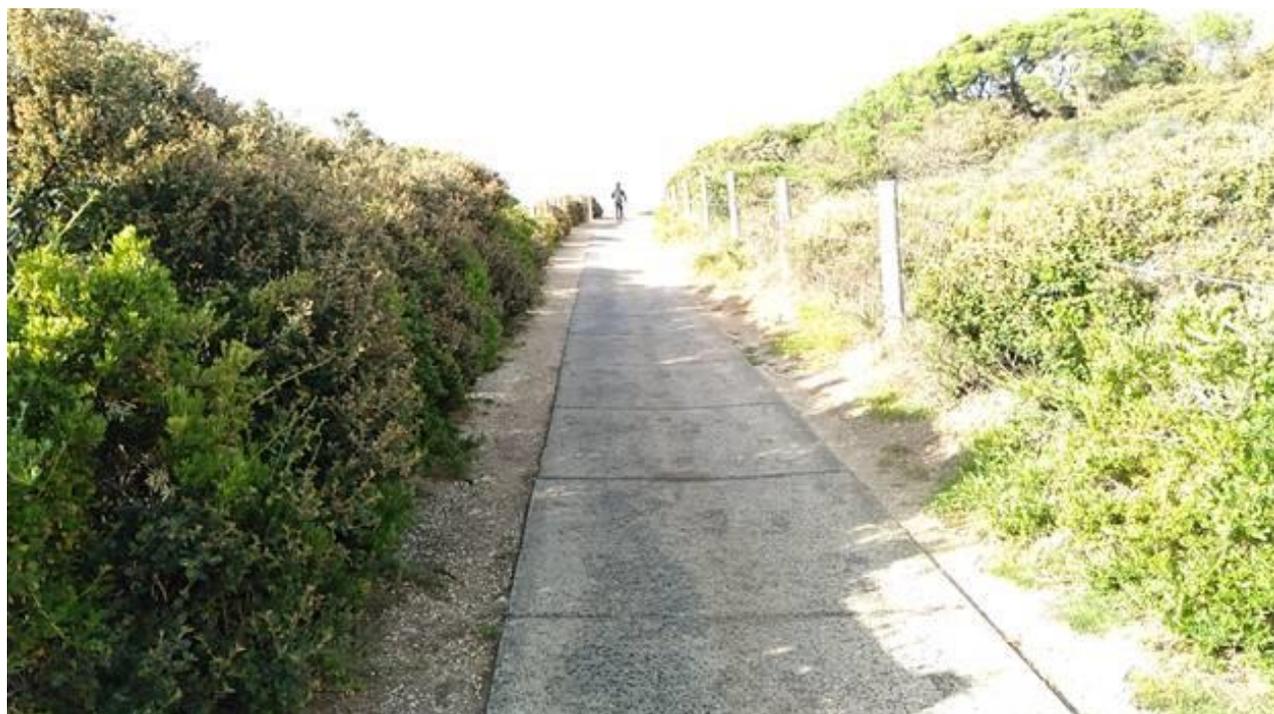
Existing infrastructure proposed for replacement (Figure 5)

- Ground level concrete pathway constructed in the 1980s.
- Approximate width (some variations) 1.5m
- Pathway edging – Gherang gravel
- Fencing – treated pine post and ringlock wire, approximate post height of 1.1m

Figure 5 Existing concrete pathway and fencing

Built in the 80s, the original concrete pathways to the Winki and Button lookouts were deteriorating. Issues included:

- pathways were too narrow at approximately 1.5m to cater for people passing carrying surfboards
- pebbles from adjoining gravel edging washed onto the path, creating slipping hazards
- cracks had appeared in the pathways
- the adjoining fencing was deteriorating.

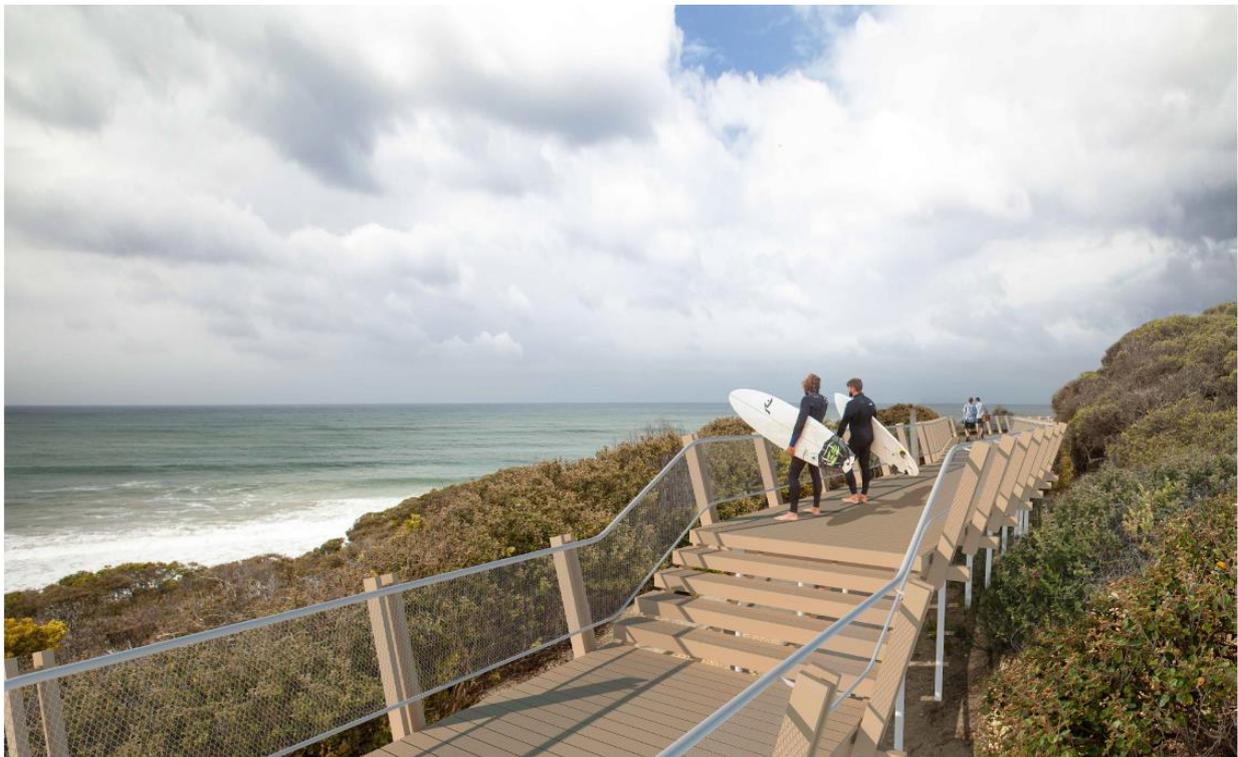
Figure 6 Concept design, artist impression

Proposed replacement pathway (Figures 6 to 9)

- Materials – timber and potential metal handrail and balustrade to minimise visibility
- Width – decking width of 2.4m, distance between angled handrails/balustrade 3m
- Height – with the naturally sloping ground surface, it is proposed that the replacement timber pathway would:
 - start at ground level near the junction with the concrete path to the Button lookout,
 - have a timber ramp to a deck height of 0.55m above the ground surface,
 - then have a level length of pathway which, because of the fall in ground level to the north, ends with a maximum deck height of 1.53m above ground level,
 - then timber stairs until it connects with the existing raised timber stairs leading to the foreshore at the Winki surf breaks (Figure 10)

- Balustrade height – 1m above the deck height
- Length - including the timber ramp, pathway and steps, the total length of concrete that would be replaced is 59.3 m in length (Figure 9)
- Fencing – not required where there is handrail and balustrade – existing fencing to be removed
- Supports – metal screw piles

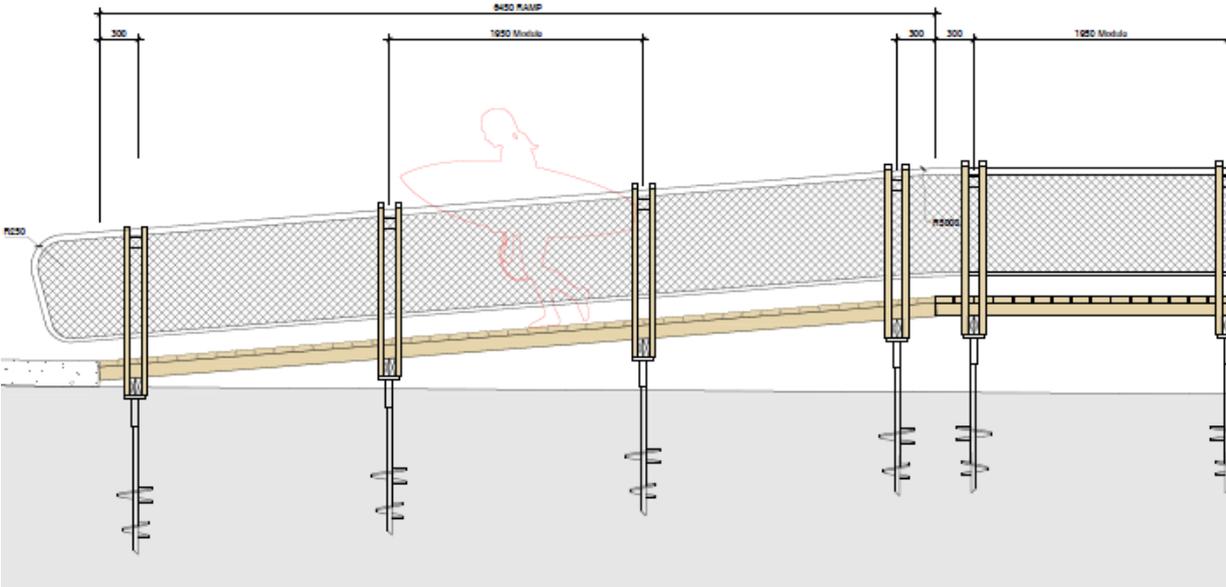
Figure 7 Concept design, side view with dimensions

- Length: 59.3 m (including access ramp & timber steps)
- Pathway Height: Graduated height from 0.55 m at ramp, 0.8 m near mid-point, to maximum height of 1.53 m at Winki steps
- Balustrade height: 1 m above deck height
- Deck Width: 2.4 m
- Handrail distance: 3m between angled handrails/balustrade

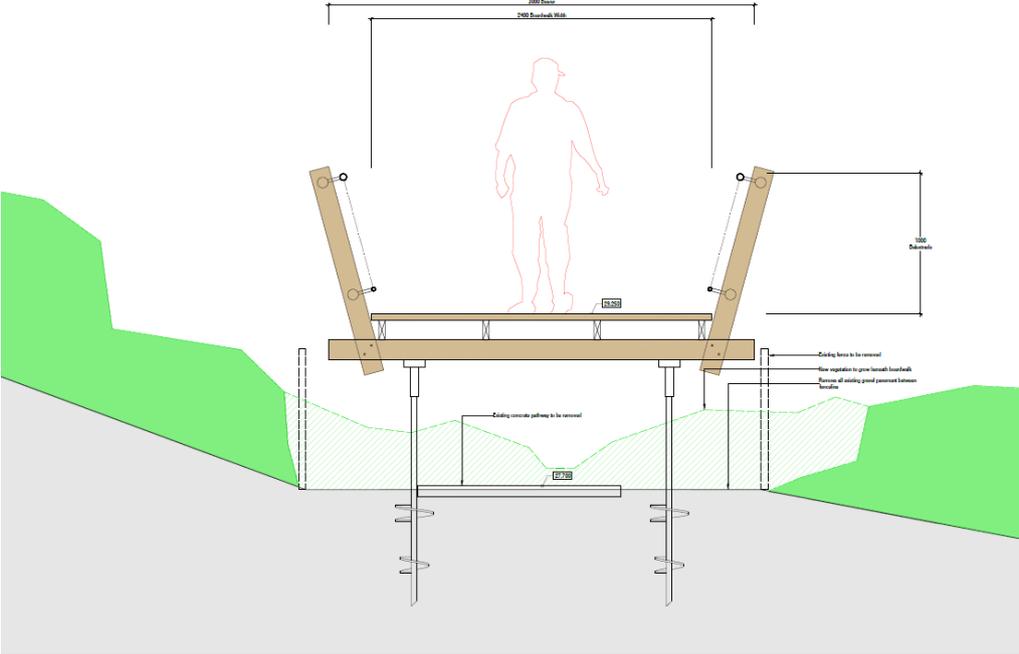
Figure 8 Concept design cross section

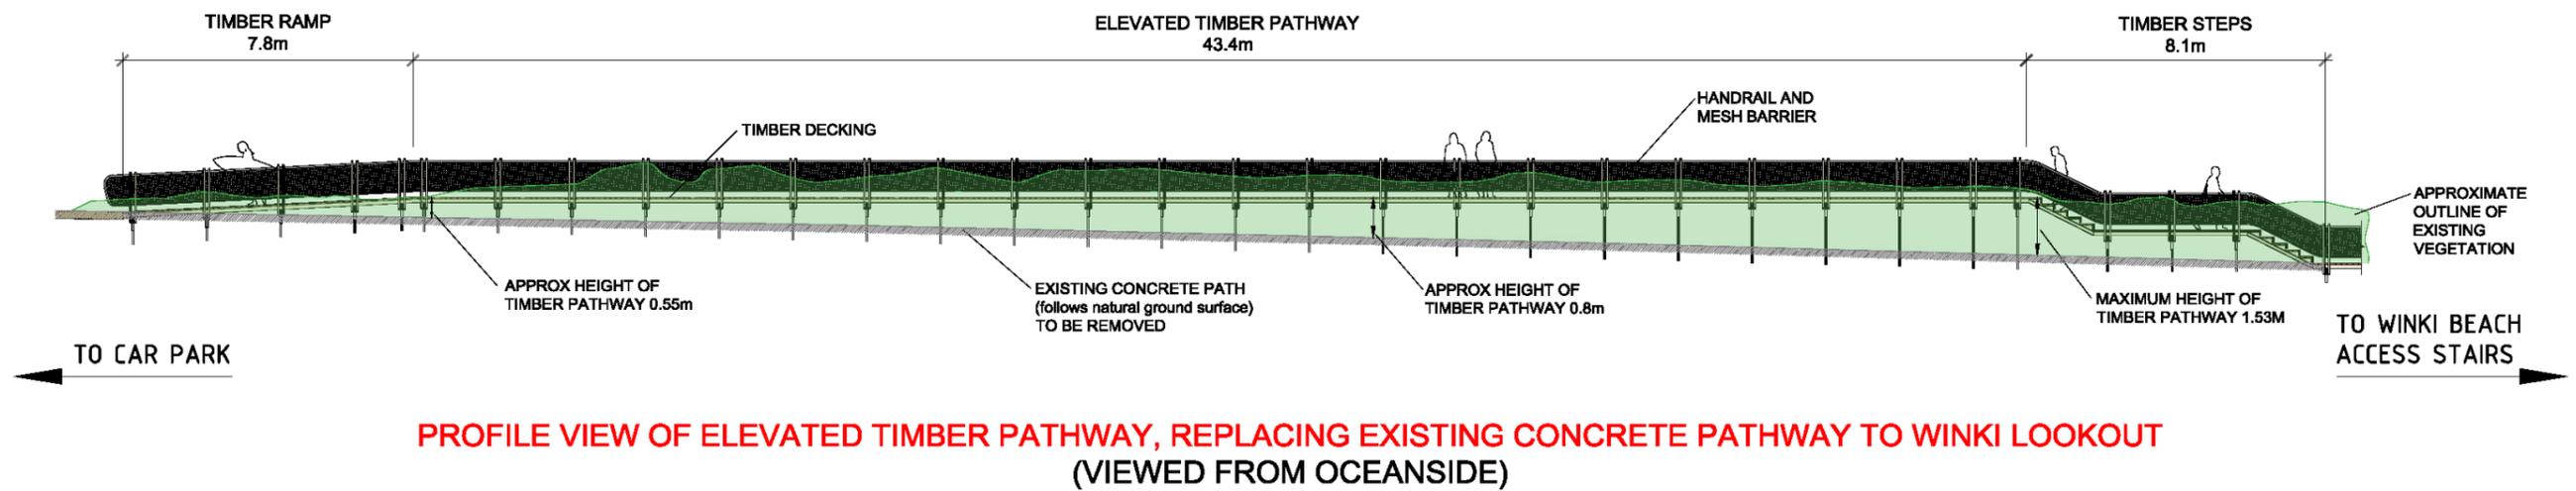
Figure 9 Profile view of proposed replacement elevated pathway, including adjoining vegetation height on the ocean side

Note – Zoom in to see measurements or see PDF file of this profile view to enlarge - provided separately to GORRSAC.

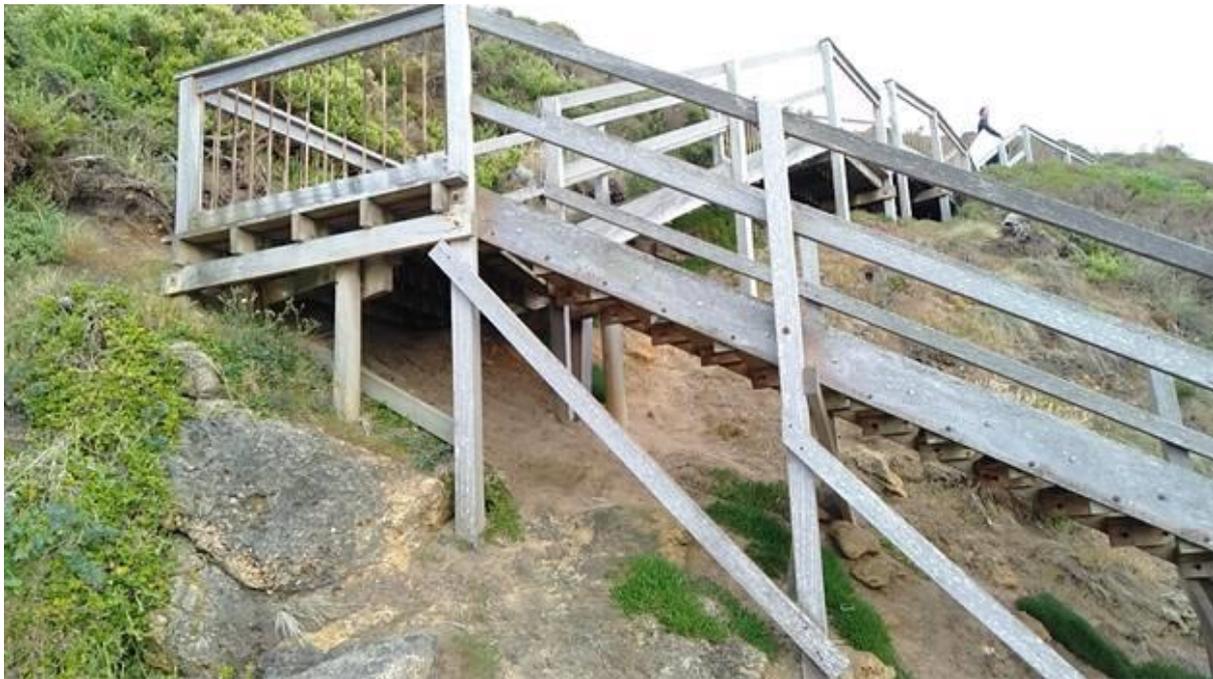
Figure 10 Existing raised steps between the proposed replacement section of pathway and the Winkipop surf breaks

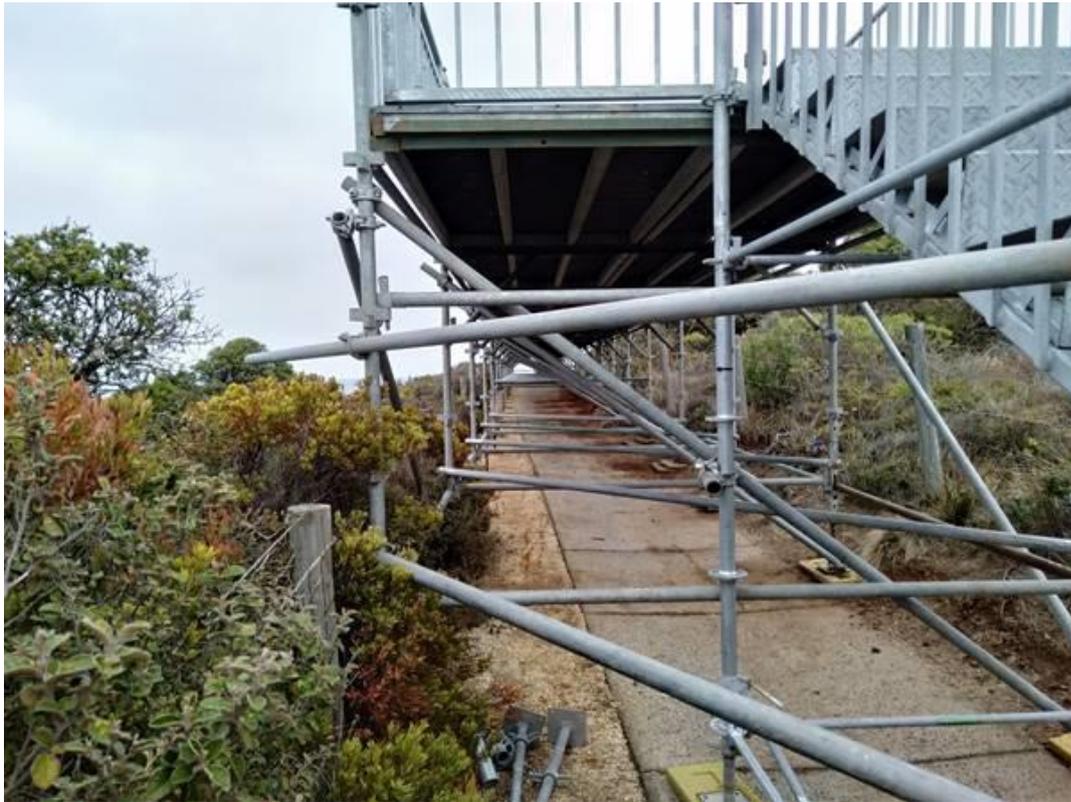
Figure 11 Temporary elevated walkway erected for the Rip Curl Pro

Phillip Island, as occurred in the past, presents difficulties to the staging and viability of this international, professional sporting event. The last part of the run into shore of the Winkipop surf breaks is not visible from the concrete path, and to enable surfers and their coaches to see the entire break before they enter the water for their heat, the organisers constructed a temporary elevated pathway above the concrete path in 2018 and 2019 (Figure 11). The temporary pathway stays in place for around four weeks. Issues related to the temporary pathway include:

- Set up takes a full day as does dismantling (impacting the bump in/bump out)
- Keeping the access track open for surfers during set up and dismantling was trialled in 2018 but it is difficult to meet safety requirements while doing this. The event site is considered a work place and must adhere to Work Safe standards.

- The temporary pathway has steps at each end and is not as easy to use by barefoot surfers and other reserve users.
- The event organisers can attempt to set up and take down the temporary pathway when the surf is poor, but as the infrastructure comes directly from the Grand Prix it is not always possible to coordinate.

- The scaffolding for the pathway is transported to and from the erection site with a vehicle via the concrete path from the car park. Council officers are concerned that the construction vehicle and scaffold footings may damage upgraded concrete pathways.
