# North Torquay Constructed Wetland Assessment

Version 2.3

DesignFlow

The purpose of this investigation was to review existing stormwater treatment wetlands located in the north Torquay catchment.

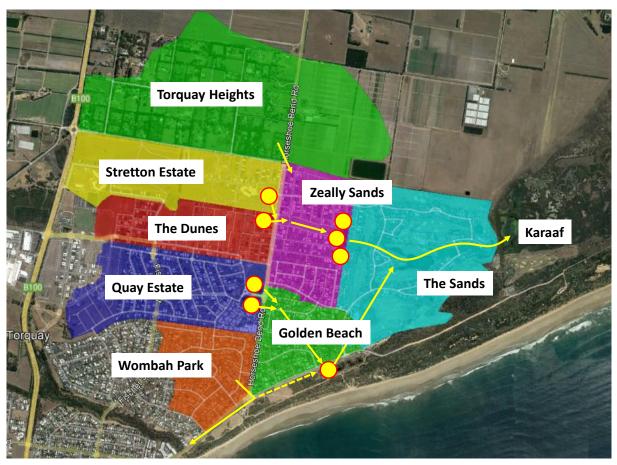
All runoff from the north Torquay residential catchment area is discharged to the Karaaf via The Sands lake system (Figure 1). Stormwater from Stretton, Dunes and Zeally Sands Estates is discharged to The Sands northern lake system, whereas stormwater runoff from the Quay Estate combines with runoff from the Golden Beach Estate and flows into the Sands southern lake system. A proportion of the stormwater (low flows only) from the Wombah Park catchment are diverted to the Esplanade wetland, with high flows from this catchment discharging to Deep Creek.

Figure 1 North Torquay catchment and treatment summary.

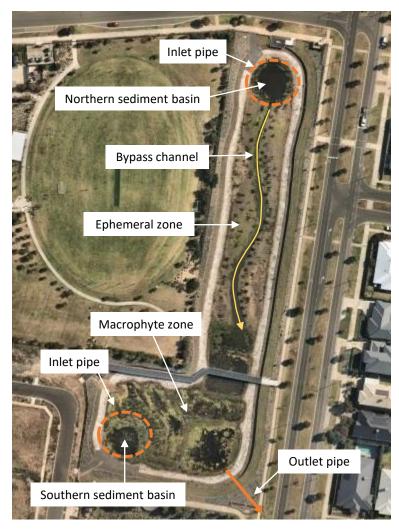
Figure 3 Stretton east wetland.

- 1. The wetland outlet is built higher than designed resulting in a deeper which limits plan growth
- 2. The deeper water causes the bypass channel to backwater and provides a short circuit route from the northern sediment basin to the outlet the bypass channel should be reprofiled to avoid short-circuiting ad support emergent plants
- 3. There is no EDD which limits the volumes of storm flows being treated a structure could be installed in the outlet pipe to control outflows and regulate an EDD
- 4. The sediment ponds are too small and shallow meaning they overflow sediments into the macrophyte zone these should be cleaned
- 5. Some Typha was observed establishing in the wetland this should be removed as apriority before it establishes further.

| Component | Issue | Action |
|---|---|--|
| Normal water level | It is noted that the As Constructed plans for<br>the wetland indicate that the NWL for the<br>wetland has been set at 14.43 m AHD, not<br>14.30 m as per the design plans (because of<br>the downstream road culvert levels). | No action required. Increasing the wetland<br>water level has resulted in the ephemeral<br>areas between the north sediment basin<br>and main wetland macrophyte zone being<br>permanently inundated, notably increasing<br>the overall shallow marsh area. The<br>ephemeral water plants planted in this zone<br>appear to be thriving well in the shallow<br>water. |
| By-pass channel | A bypass channel is present between the<br>north sediment basin and the southern<br>section of the wetland macrophyte zone. It<br>should be noted that the channel was<br>original designed to convey flows from the<br>sediment basin the wetland macrophyte<br>zone, however due to the increase in NWL,<br>the channel now functions to bypass flows<br>through the large shallow marsh zone.<br>This provides a short circuit for flows and<br>reduces treatment efficiency. | The bypass channel should be infilled,<br>topsoiled (min 150mm depth) and planted<br>with shallow marsh water plant species.<br>This will ensure that all flows from the north<br>sediment basin are distributed across the<br>entire wetland profile and get treatment.<br>This will significantly improve the treatment<br>function of the wetland system. |
| Bathymetry | The bathymetry of the wetland generally<br>appears to be complicated, excessively deep<br>and leads to short circuiting.<br>A significant area of the wetland<br>macrophyte zone is more than 350mm<br>deep, which is considered to be the<br>maximum planting depth for emergent<br>water plants. The increase in NWL (noted<br>above) has also increased the depth of the<br>wetland planting zones. Generally, no more<br>than 20% of the wetland macrophyte zone<br>should be more than 350mm depth, as this<br>ensure that the majority of the wetland has<br>dense emergent water plant cover.<br>Extensive areas between 0.35-0.6m depth<br>are likely to promote Typha growth, as most<br>emergent plants cannot permanently grow<br>within this depth range.<br>Incoming flows short circuit to the outlet<br>and do not interact with water plants. | The wetland is currently well vegetated with<br>a broad range of water plant species,<br>particularly in the deeper planting zones of<br>the wetland.<br>Many of these species are unlikely to persist<br>when extended detention is provided. Plant<br>health and coverage should be monitored<br>when EDD is introduced.<br>Options to reduce the depth of macrophyte<br>zone should be considered if 75-80%<br>vegetation cover is not achieved.<br>It is recommended that submerged water<br>plants are planted in all planting zones<br>deeper than 0.35m depth.<br>Filling of the bypass channel will also<br>increase the area of water plants. |

| | When the wetland is full, water flows over<br>the earthen berms to the wetland outlet.<br>The earthen berms between each of the<br>planting zones reduces the overall wetland<br>planting area and provides areas for<br>waterbirds to roost/loaf. It was noted<br>during the site inspections that the berms<br>are now permanently inundated due to the<br>increased NWL, and have effectively<br>transitioned to shallow marsh zones. | |
|---|--|--|
| Weeds | Juvenile Typha sp. Seedlings were observed growing within the sediment ponds and inlet areas to the macrophyte zone. | All Typha seedlings should be removed<br>immediately, as this species is very difficult<br>to control once established and has the<br>capacity to dominate the wetland<br>vegetation cover. |
| Safety bench | The sediment basins and open water areas<br>within the wetland macrophyte zone do not<br>have submerged safety bench to prevent<br>unauthorised access to deep water areas.<br>Best practice wetland design standards<br>require that a 1:8 submerged safety bench to<br>0.35m depth be provided adjacent to all<br>deep water areas of a wetland. | It is noted that the wetland is fully fenced,<br>and it would be impractical to retrofit<br>submerged safety benches. It is<br>recommended that the margins of all deep<br>water areas are densely vegetated with tall,<br>dense emergent water plants or edge<br>vegetation to prevent unauthorised access. |

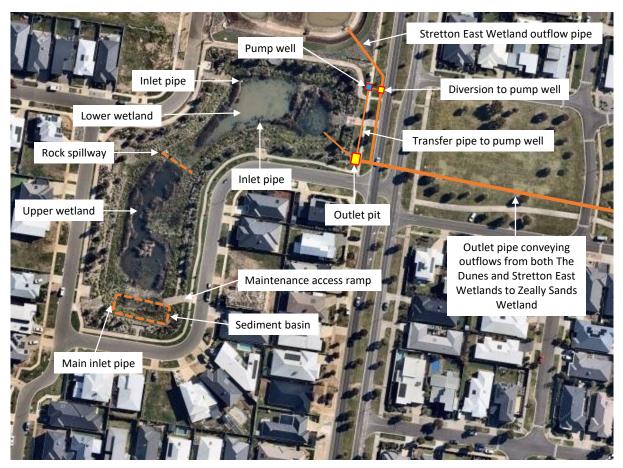
Figure 4 The Dunes Wetland.

- 1. The sediment pond is too shallow consider deepening to increase sediment capture storage and reworking connection to the wetland (e.g. remove existing pit/pipe and replace with simpler weir)
- 2. Inlet pipe blockages on small inlets remove vegetation and sediment build up around the inlet and install cement treated rubble to prevent future growth
- 3. There are more open water pools than best practice plant more robust submerged plants to improve treatment
- 4. Remove some stands of Typha.

| Component | Issue | Action |
|---|--|--|
| Sediment basin | The sediment basin is approximately 0.95m<br>deep. This is too shallow to effectively trap<br>course sediments, particularly considering<br>the size of the catchment draining to the<br>sediment basin (42 ha). The lack of storage<br>capacity will result in course sediments<br>being conveyed to the wetland macrophyte<br>zone.<br>Notable backwatering of the inlet pipe<br>observed. This appears to be a permanent<br>condition. | The depth of the sediment basins should be<br>increased to minimum 1.5m depth<br>(preferably 2-2.5m depth), and where<br>possible the overall area of the sediment<br>basin increased. It is noted that there has<br>been recent works to re-instate the rock<br>weir between the sediment basin and the<br>wetland macrophyte zone, and to provide<br>maintenance access from both sides of the<br>sediment basin. The rock weir could be re-<br>configured to enable the sediment basin to<br>be both deepened and widened.<br>Alternatively the rock weir could be replaced<br>with a narrower earth bank and weir to<br>convey flows to the wetland. The transfer<br>pit and pipe could be decommissioned<br>allowing more space for sediment capture. |
| Blocked inlet pipe | The NW inlet pipe to the lower wetland was<br>blocked with vegetation and sediment.<br>Consider clearing the inlet pipe opening but<br>where possible retaining the sediment as it<br>is enabling emergent water plants cover to<br>extend into the open water zone.<br>It was noted that Council have recently<br>installed a screen below each of the lower<br>inlet pipes to trap sediment. The growth of<br>emergent water plants into this zone would<br>raise the question as to whether there is<br>merit in removing the sediment given the<br>scale of the adjacent sub catchments and/or<br>the benefit that the vegetation cover will<br>provide to wetland function. | Unblock the pipe entries, remove sediment<br>and plants and install cement treated rubble<br>to prevent future plant growth at the pipe<br>outlet. |
| Bathymetry | The design of the wetland comprises of a series of interconnected deep pools ranging between 0.7-1.2 m depth. This design provided for shallow zones around the margins of the pools for water plant growth, however the majority of the wetland comprised of submerged/open water areas (nearly 60%). Wetlands with interconnected open water zones are generally | While the wetland design has too many<br>deep pools and not enough shallow<br>vegetated areas compared to best practice it<br>is not recommended to make wholesale<br>changes. Rather it is recommended to plant<br>robust submerged water plants to improve<br>treatment (e.g. Valiseneria australis). |

| | characterised by short circuiting, as the<br>water rapidly passes from pond to pond<br>before being discharged via the wetland<br>outlet.<br>It appears that many of the open water<br>areas within the wetland have filled with<br>sediment, enabling the growth of emergent<br>water plants across the wetland. This is | |
|---|---|---|
| Weeds | Notable stands of <i>Typha</i> sp. are present<br>throughout the wetland.<br>A potentially invasive introduced species,<br><i>Leucanthemum aestivum</i> , was observed<br>growing on the edges of the spillway<br>amongst a native groundcover ( <i>Hydrocotyle</i><br><i>verticillata</i> ?). | All Typha growth should be immediately<br>controlled, as this species is very difficult to<br>control once established and has the<br>capacity to dominate the wetland<br>vegetation cover. |

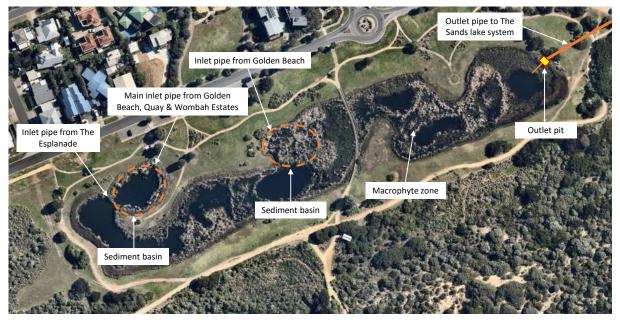
At the time of the site inspections, extensive works to remove *Typha orientalis* infestations from the wetland had been recently undertaken, resulting in substantial disturbance to the wetland batters and internal bathymetry.

A diverse suite of water plant species were observed growing around the margins of the wetland. The removal of Typha from the wetland has notably disturbed the remaining beneficial water plants and removed almost all of the vegetation cover from the macrophyte zone. The health and vigour of the remnant water plants indicates that the wetland was likely to be functioning well, despite the excessive growth of Typha throughout the wetland.

Figure 6 The Esplanade Wetland

| Component | Issue | Action |
|---|--|--|
| Bathymetry | It was observed during the site inspections<br>that many sections of the wetland<br>macrophyte zone appear to be excessively<br>deep (i.e. more than 0.5m depth).<br>The Craigie and Condina (2001) report<br>indicated that the wetland base is 3.0m<br>AHD, which would indicate a depth of 1.7m.<br>This is too deep for water plants.<br>The majority of emergent water plants are<br>adapted to growing in shallow water (i.e.<br>less than 0.35m depth).<br>The current wetland bathymetry is not<br>conducive to emergent water plant growth,<br>except for the shallow areas along the<br>wetland margins. | It is recommended that sections of the<br>wetland macrophyte zone are infilled to<br>enable a range of water depths less than<br>0.35m to be established. This will enable<br>beneficial range of water plant species to be<br>established throughout the macrophyte<br>zone.<br>The establishment of dense bands of<br>emergent vegetation will substantially<br>increase the functional performance of the<br>wetland. Note: Ideally, at least 80% of the<br>macrophyte zone should be covered with<br>emergent water plants.<br>Providing extensive shallow areas<br>throughout the wetland will also enable the<br>wetland to be more readily accessible,<br>enabling maintenance staff to safely access<br>the wetland to undertake weed control. |

| Contamination<br>Riser pipe | A notable biofilm of fungus is present on the<br>PVC riser pipe and walls of the outlet pit.<br>The fungus appears to bear resemblance to<br>'sewer' fungus commonly associated with<br>sewage pipes. | It is recommended that the fungus be tested<br>to ascertain whether there are potential<br>sewer inflows to the wetland. |
| Maintenance access | There is no formal maintenance access to<br>either of the sediment basins. This makes it<br>very difficult for the basins to be accessed<br>for sediment removal. | It is recommended that formal maintenance<br>access ramps are constructed into each of<br>the sediment basins.<br>The basins should also have a hard base to<br>enable entry for cleaning. |

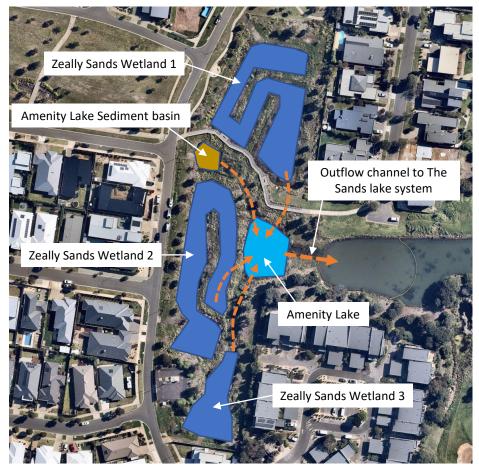
The Zeally Sands wetlands has three treatment wetlands and a sediment basin that flow into an "amenity lake". Outflows from the amenity lake discharge to The Sands lake system. An overview of the layout is shown in Figure 7.

Figure 7 Layout of the Zeally Sands wetland complex.

- 1. Wetland designs seem overly complex leading to a lot of area given up to batters
- 2. Generally in healthy condition with robust vegetation cover
- 3. All wetlands are designed with very deep (600mm) EDD that is likely to affect plant health (it is likely it is not currently operating as designed this should be investigated and reconfigured to achieve 350mm if possible
- 4. Wetland 3 is very small for its catchment but still in good condition
- 5. Inlets ponds all need cleaning (particularly the amenity pond sediment basin)
- 6. There appears to be backwater from the lakes in The Sands which may affect wetland levels and outflows- needs further investigation.

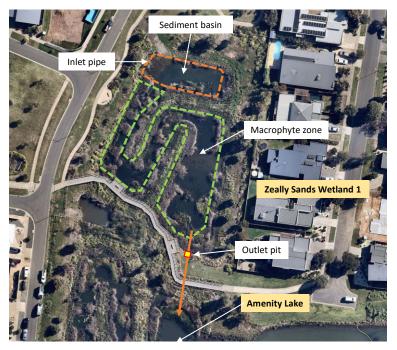
Figure 8 Zeally wetland 1

A more detailed description of the issues identified during for each of the wetland components is described below and more detailed diagram of their operations are shown in Figure 8 and Figure 9.

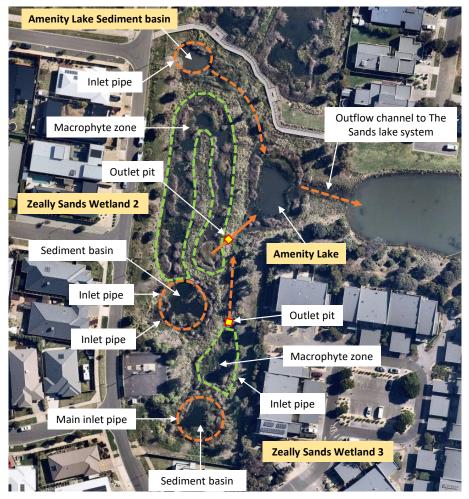
Figure 9 Zeally wetlands 2 & 3

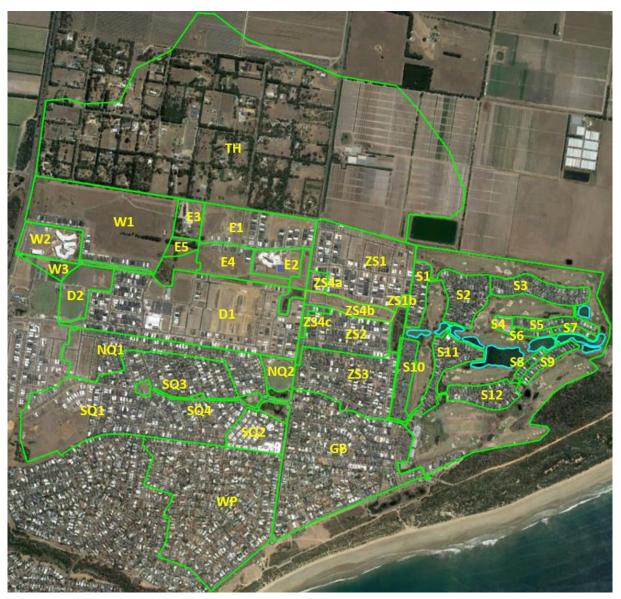
*Figure 15 Sub-catchment layout used in the MUSIC model*
