LANDFILL GAS RISK ASSESSMENT

25 Cressy Road

Winchelsea, Victoria

May 2021
Report No. J1214-R2.0

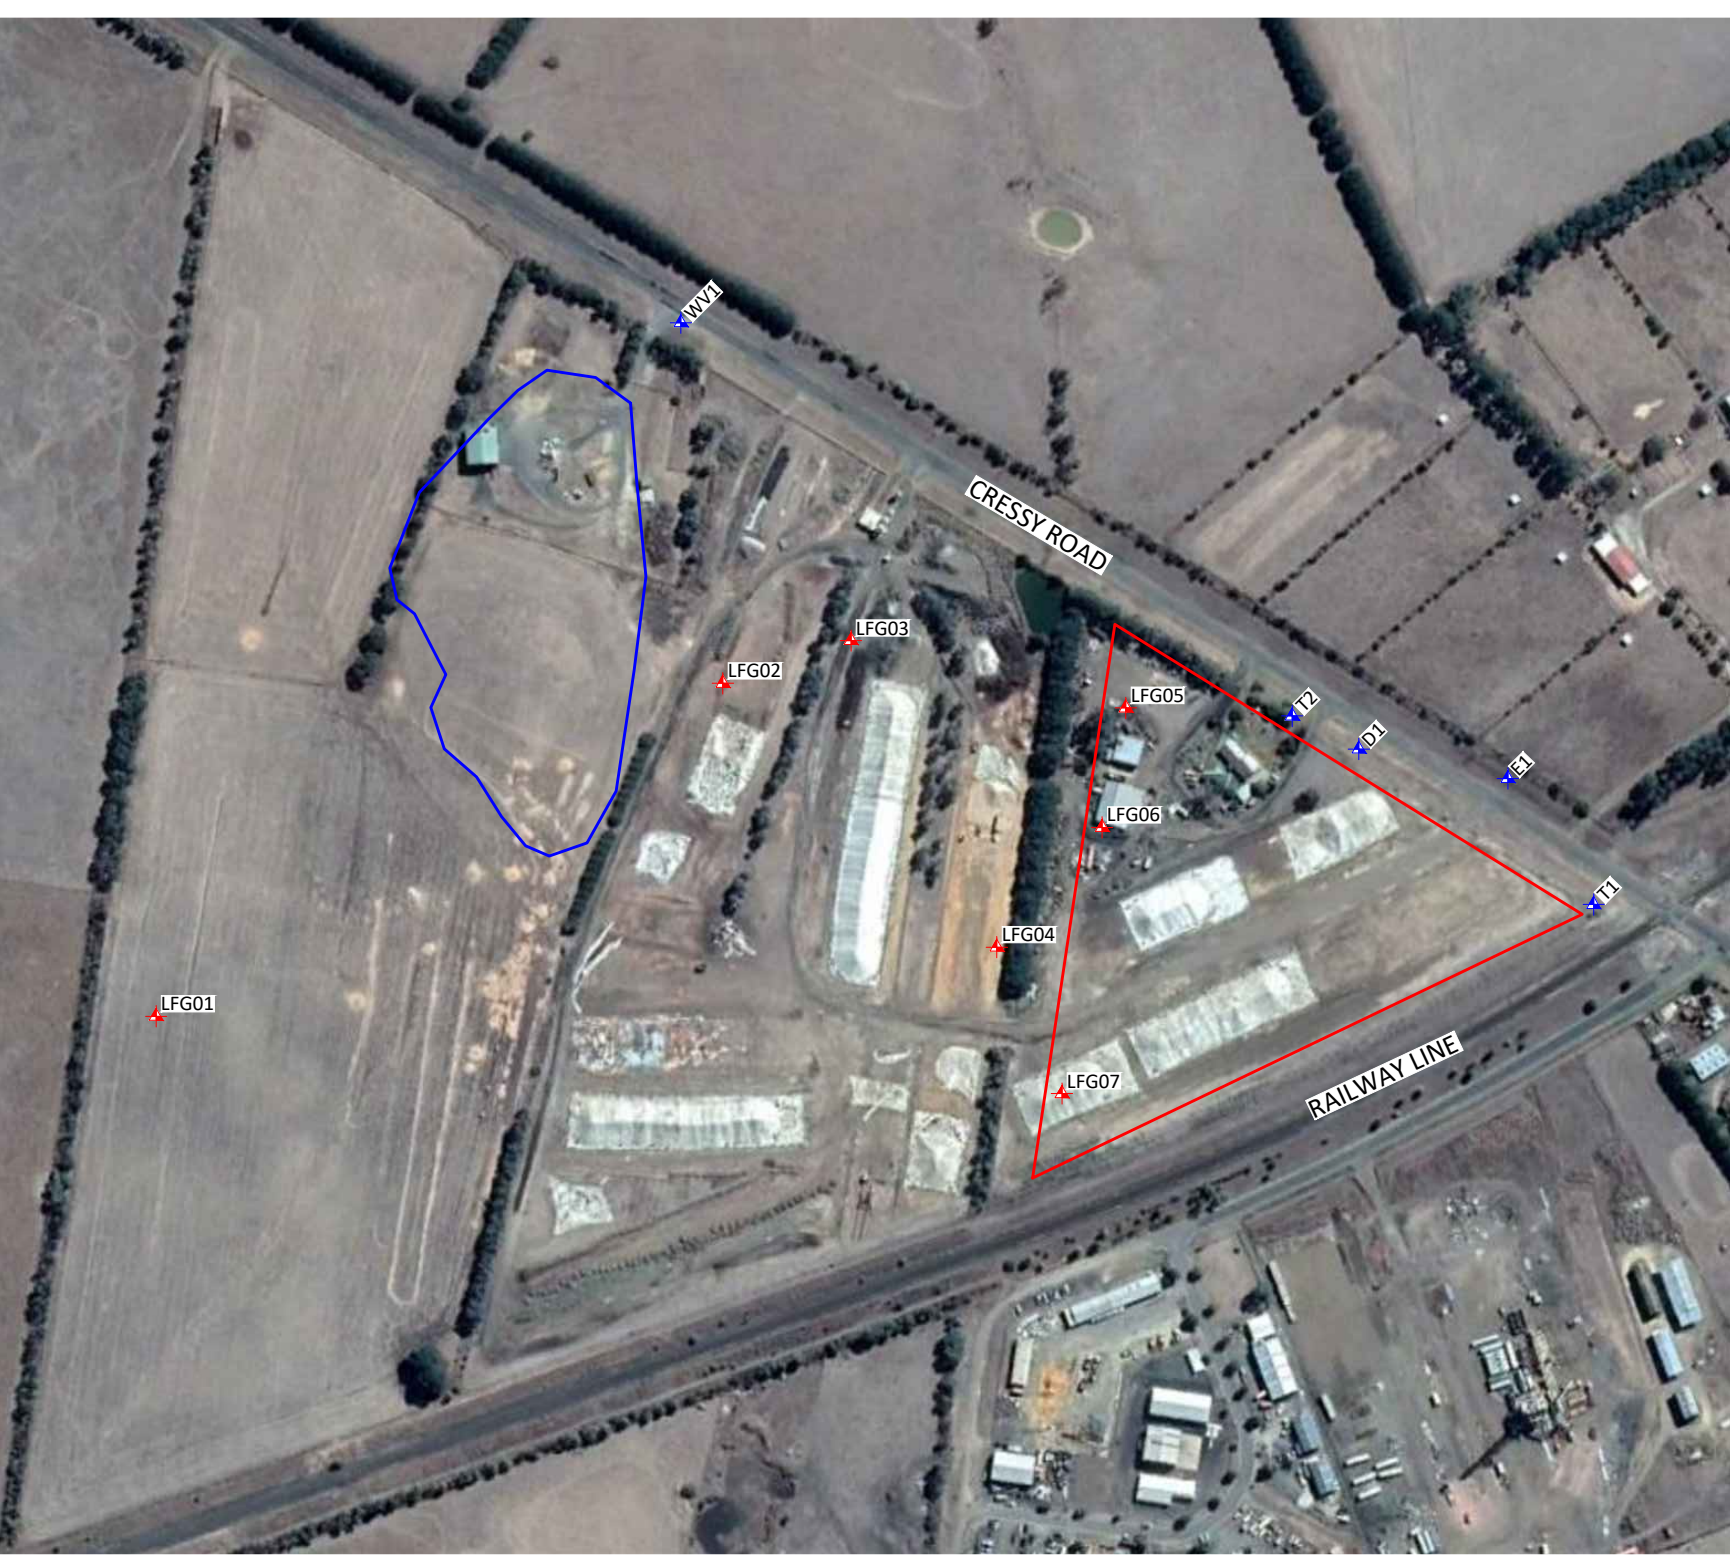
Site Plan

The location of the site, and nearby closed landfill, is presented in the attached Site & Landfill Location Plan (Figure 1 - Appendix I).

The location of the site is depicted on the Site & Landfill Location Plan (refer Figure 1 - Appendix I) and relevant site details are tabulated in Table 2-1.

A landfilled former quarry, now forming part of the Winchelsea Waste Transfer Station, was identified to be within a 500 m radius of the subject site, with its approximate location depicted on the Site & Landfill Location Plan (Figure 1 - Appendix I).
