## LANDFILL GAS RISK ASSESSMENT

25 Cressy Road  
Winchelsea, Victoria

August 2020  
Report No. J1214-R1.0

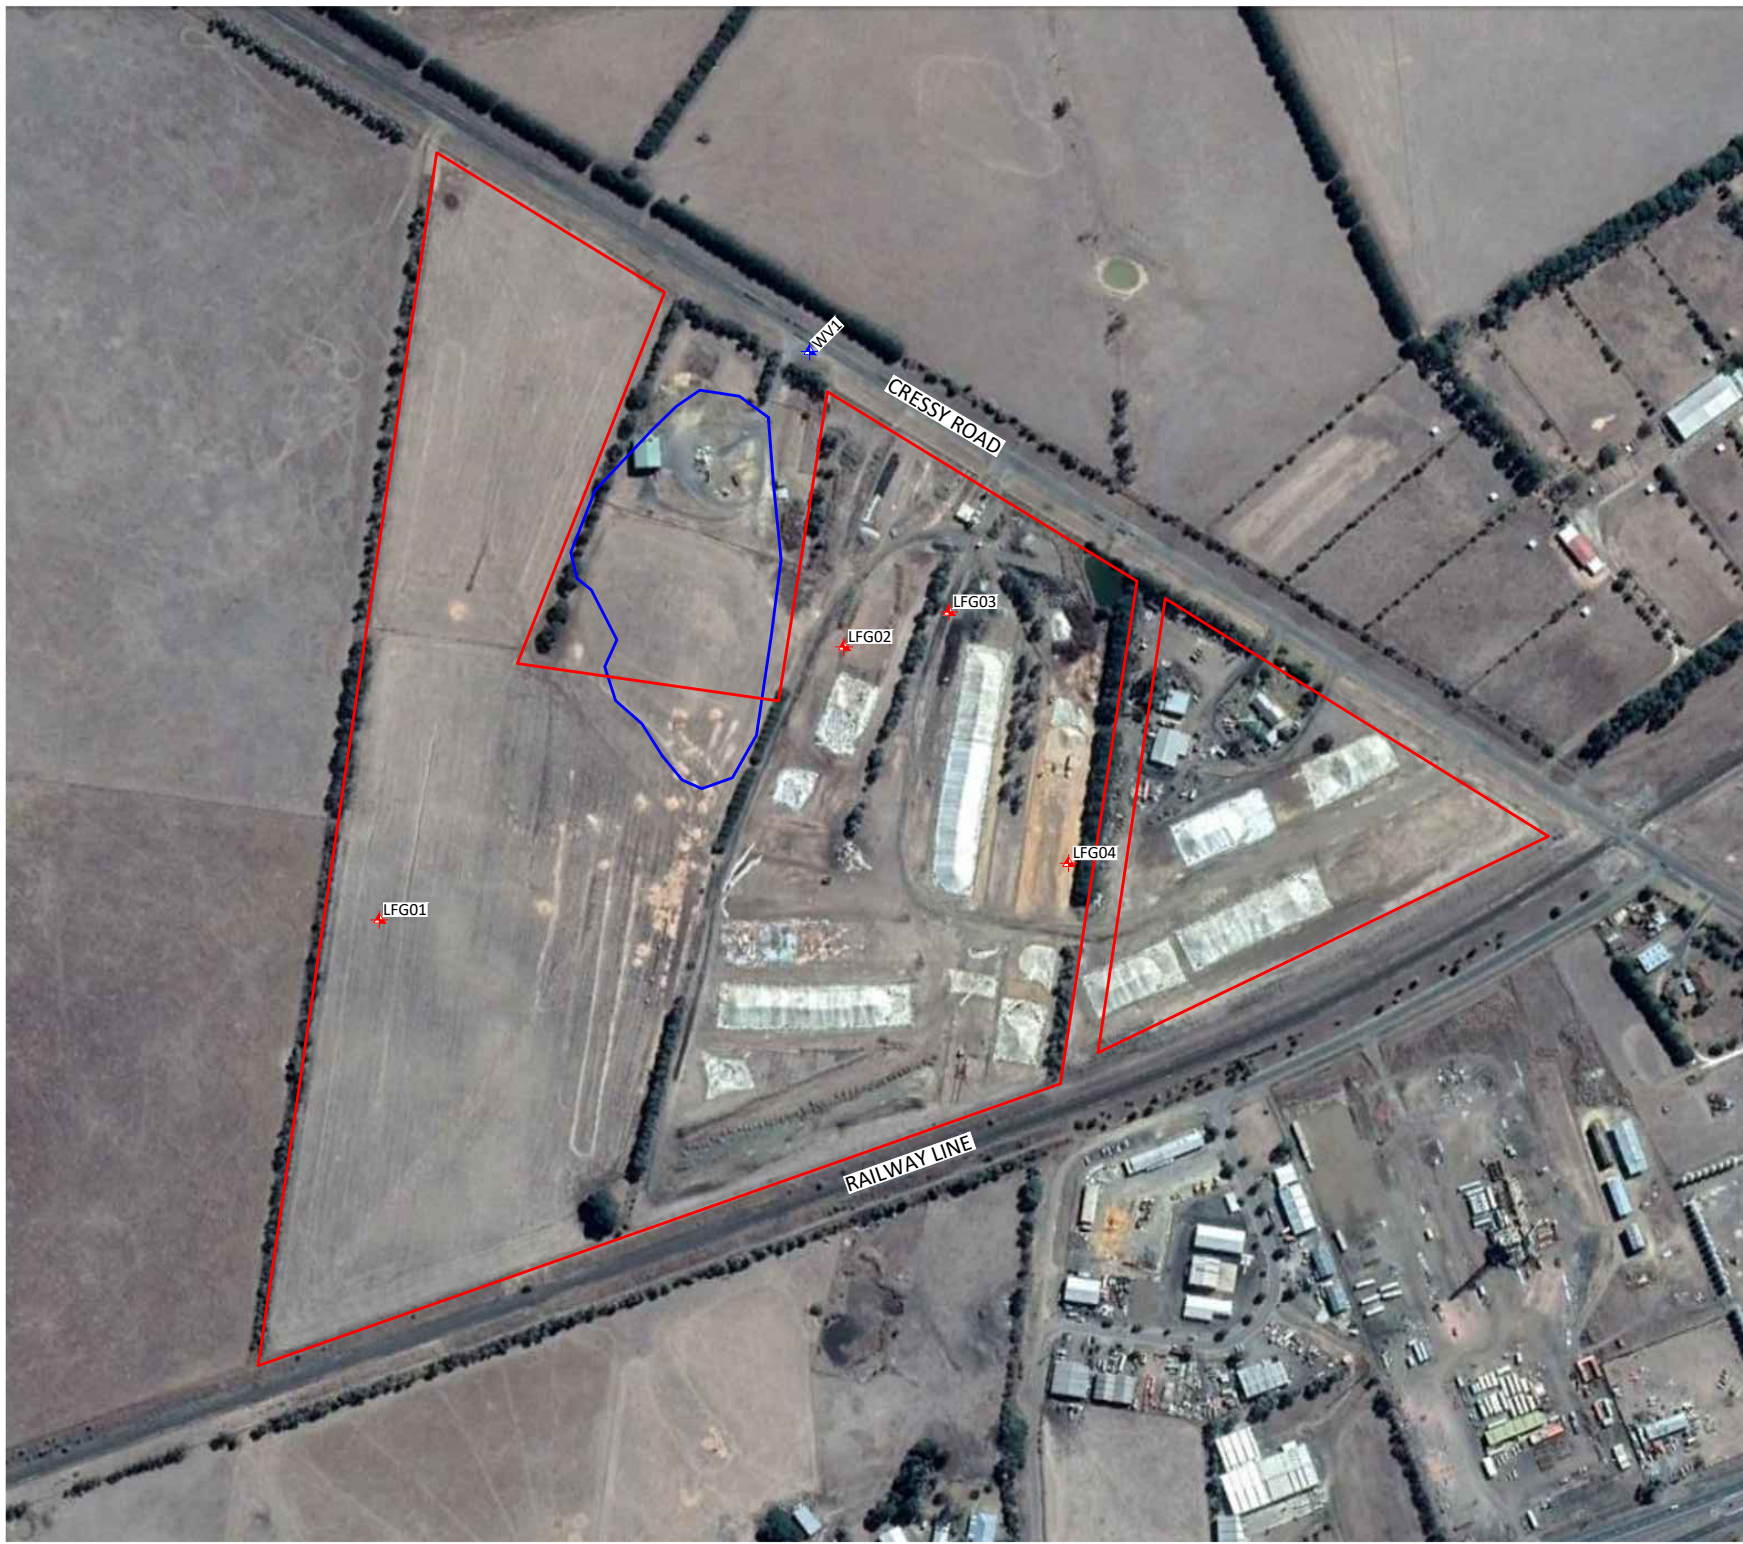
The location of the site, and nearby closed landfill, is presented in the attached Site & Landfill Location Plan (Figure 1 - Appendix I).

The location of the site is depicted on the Site & Landfill Location Plan (refer Figure 1 - Appendix I) and relevant site details are tabulated in Table 2-1.

A landfilled former quarry, now forming part of the Winchelsea Waste Transfer Station, was identified to be within a 500 m radius of the subject site, with its approximate location depicted on the Site & Landfill Location Plan (Figure 1 - Appendix I).

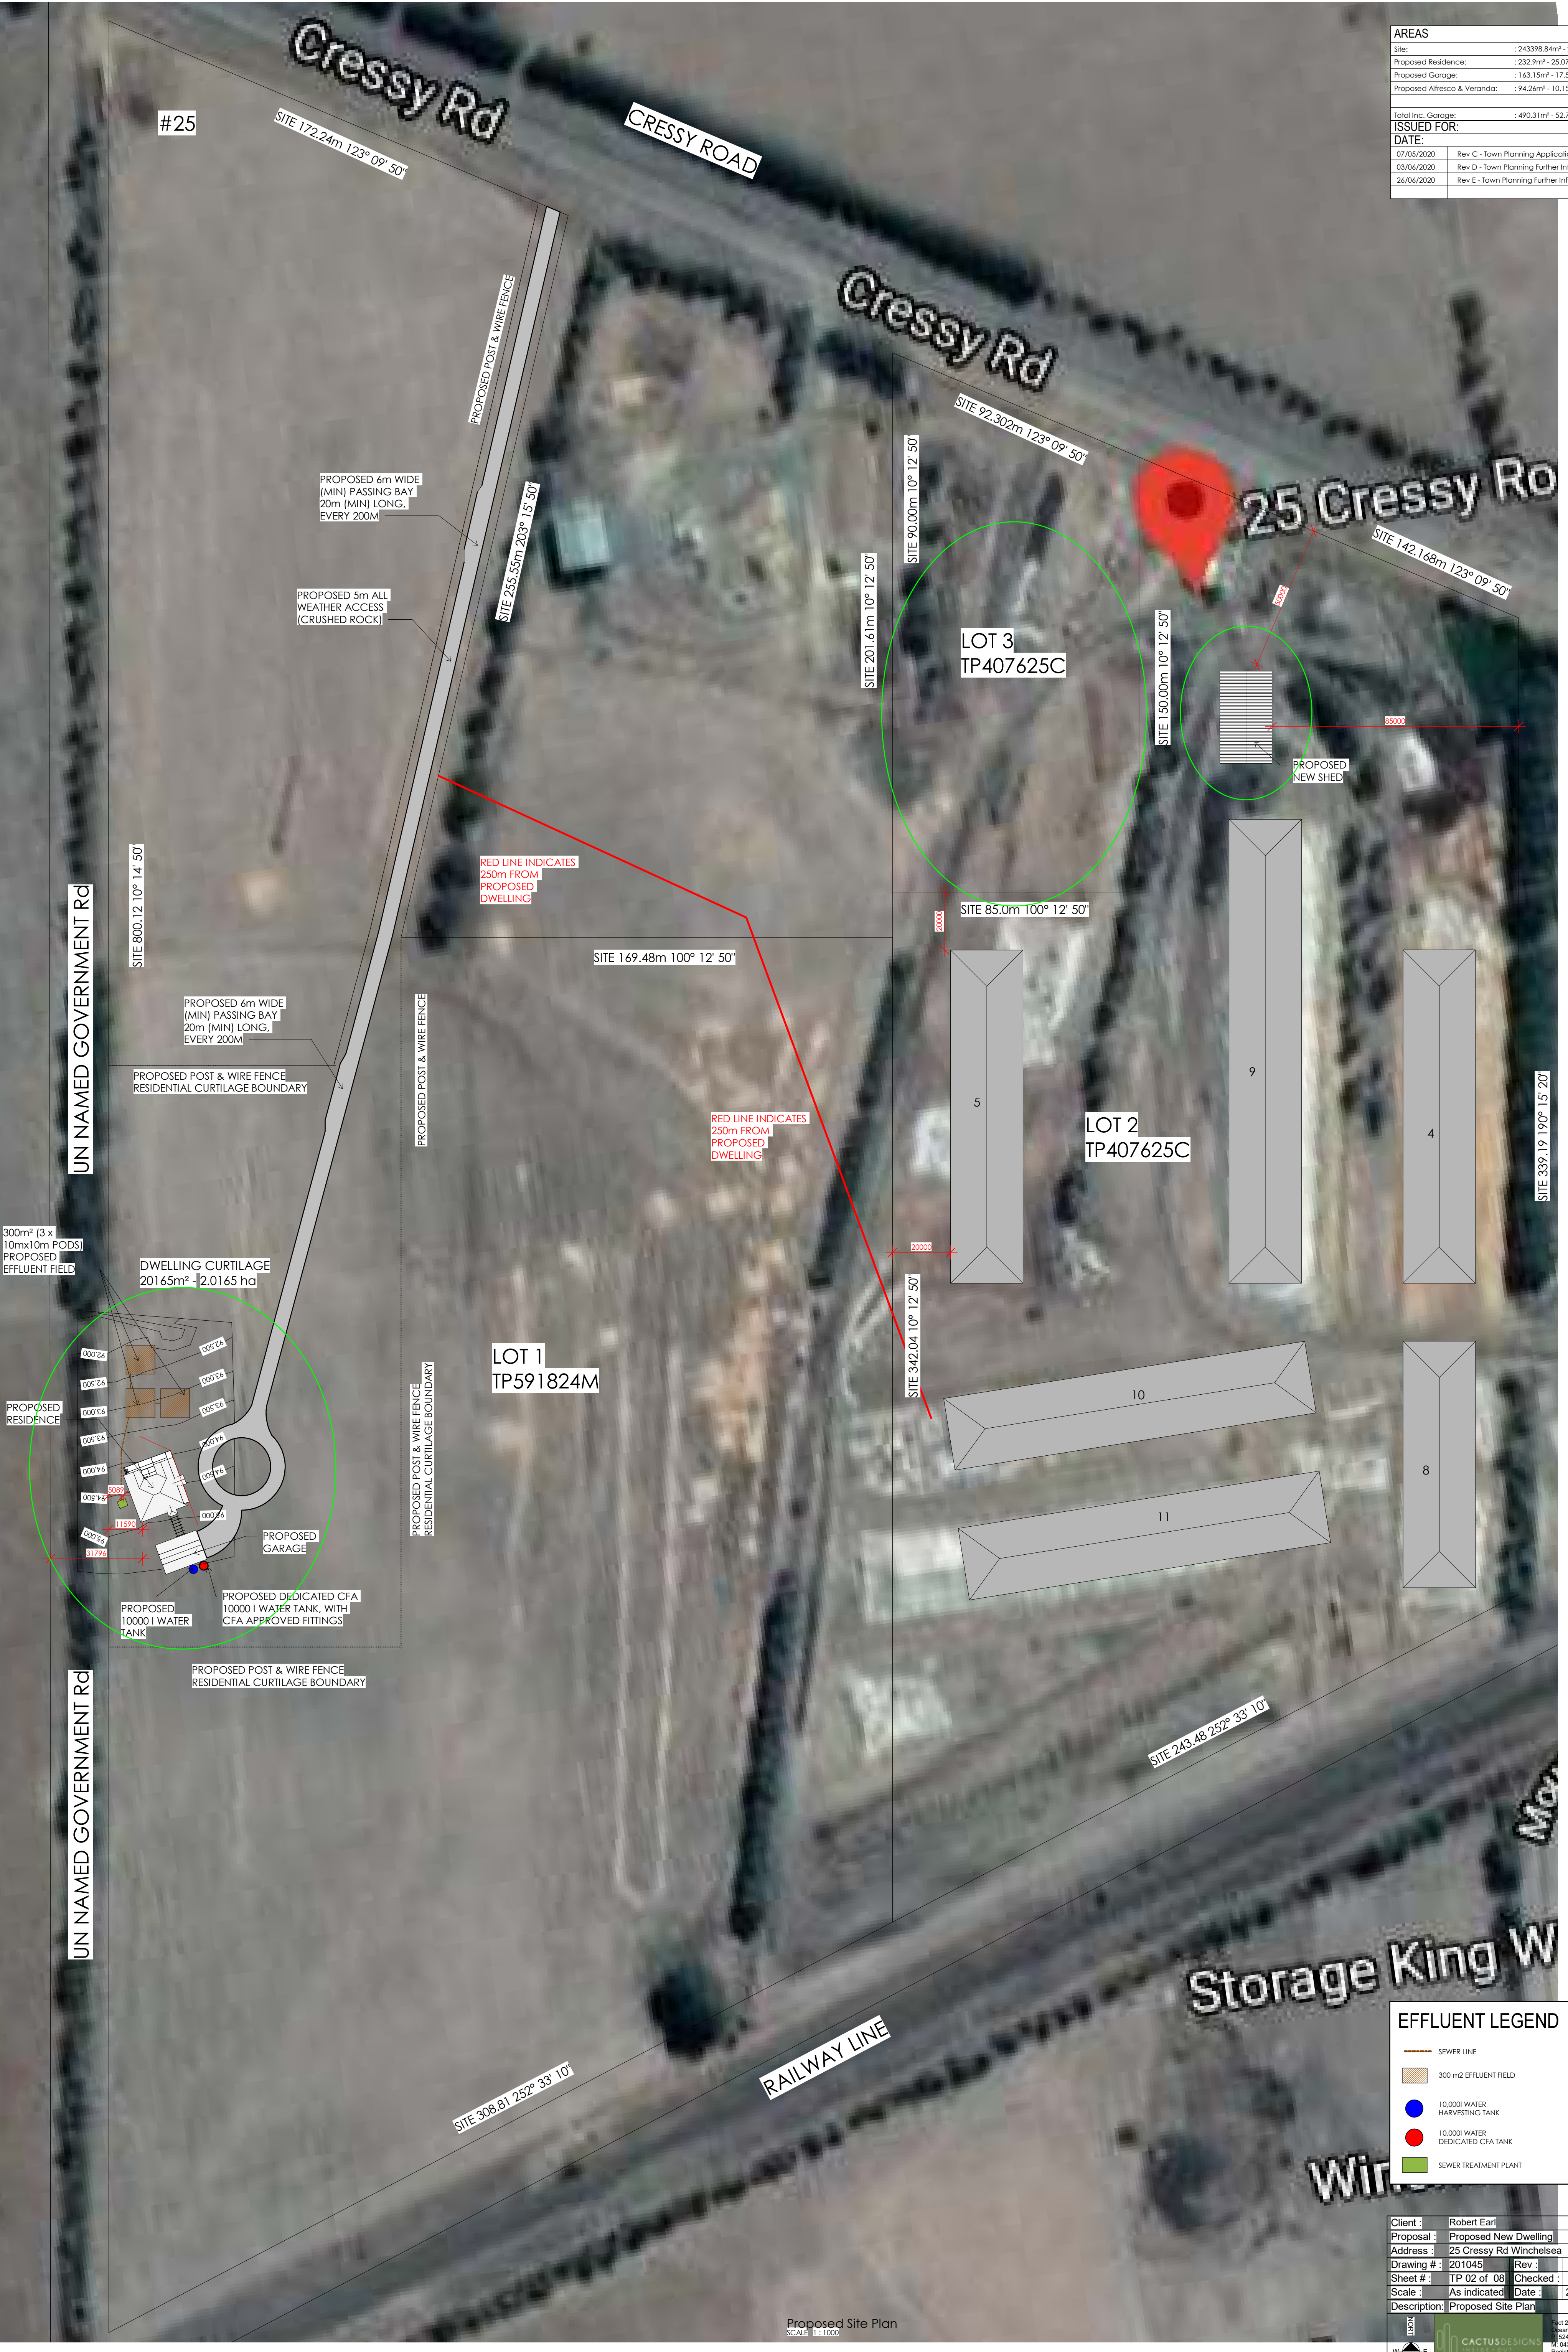
Proposed Site Plan  
SCALE 1:1000

EFFLUENT LEGEND	
	SEWER LINE
	300 m2 EFFLUENT FIELD
	10,000L WATER HARVESTING TANK
	10,000L WATER DEDICATED CFA TANK
	SEWER TREATMENT PLANT

Client :	Robert Earl	
Proposal :	Proposed New Dwelling	
Address :	25 Cressy Rd Winchelsea	
Drawing # :	201045	Rev : E
Sheet # :	TP 02 of 08	Checked : GM
Scale :	As indicated	Date : 26/06/2020
Description:	Proposed Site Plan

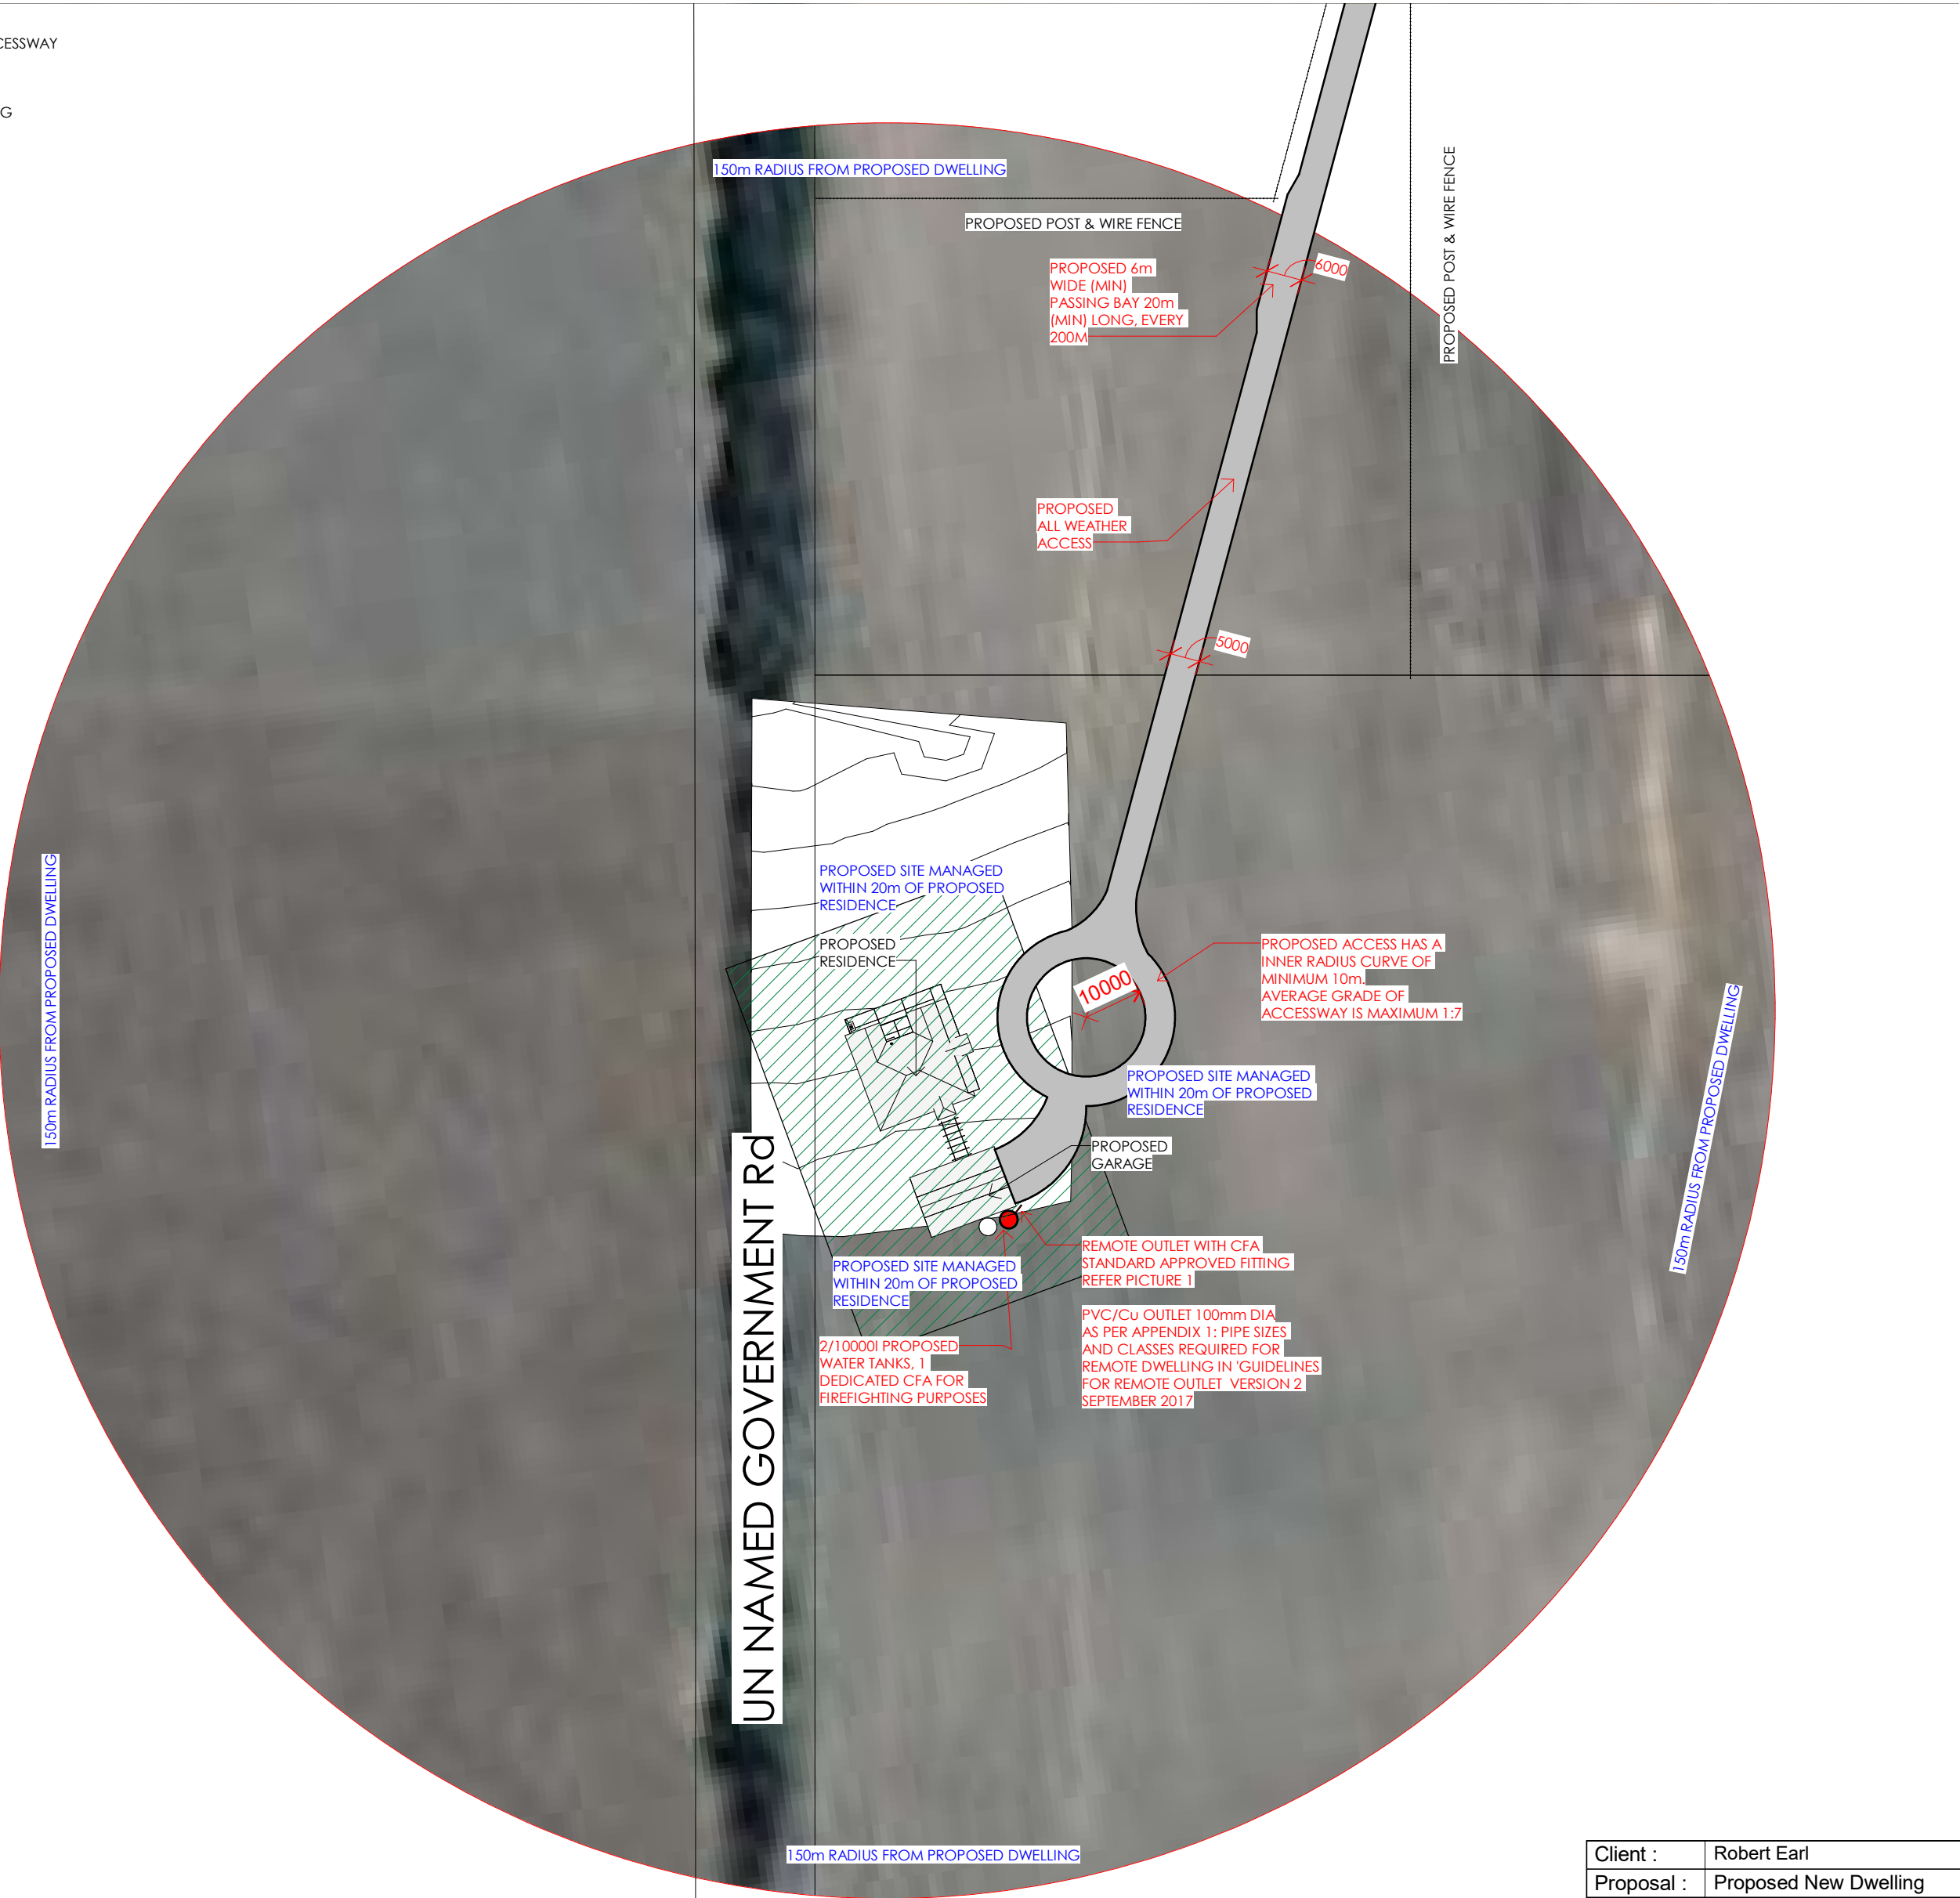
BAL LEVEL (BUSH FIRE ATTACK LEVEL)  
BAL 19

**BAL 19 -** Increasing Levels of Ember Attack and burning debris ignited by windborne embers together with increasing heat flux Constructed as per Construction requirements, Sections 3 & 6 of AS 3959 - 2009

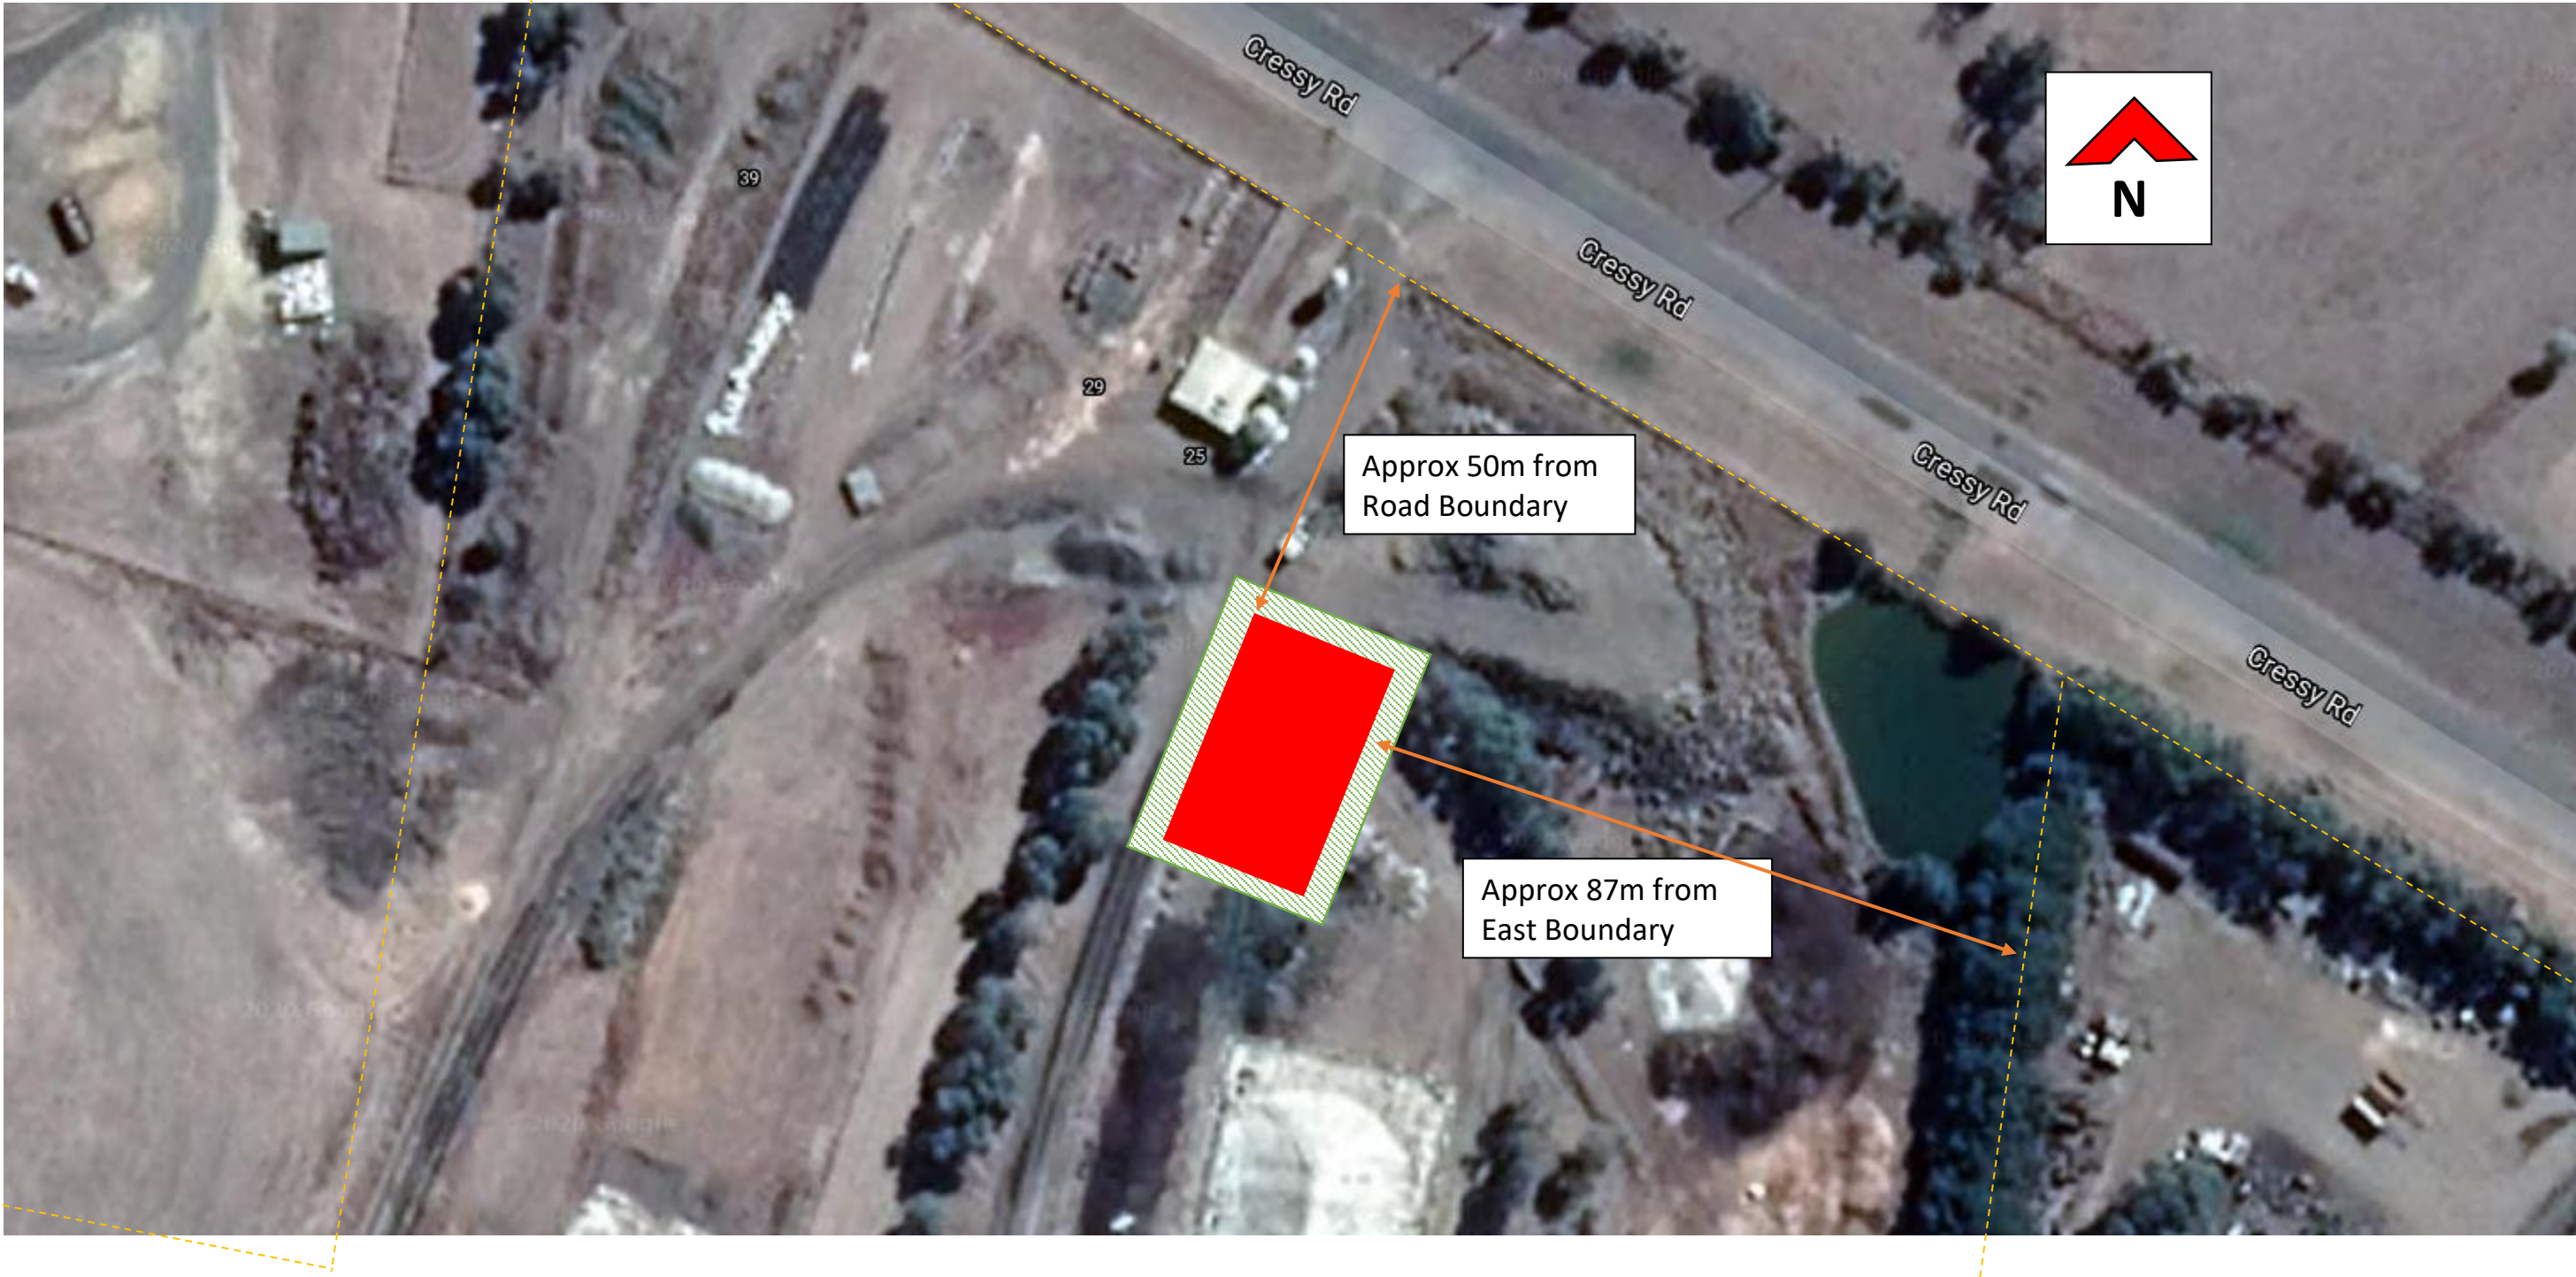
SITE PLAN

Robert Earl, 18m x 32m x 6m, 25 Cressy Rd, Winchelsea VIC 3241

- Stormwater to disperse into paddock away from shed
