FINAL REPORT:

BRIODY DRIVE - DEEP CREEK GEOMORPHIC ASSESSMENT

December 2023

Client: Summerset Torquay
Contact: Harry Mohan
Project: Briody Drive Geomorphic Assessment

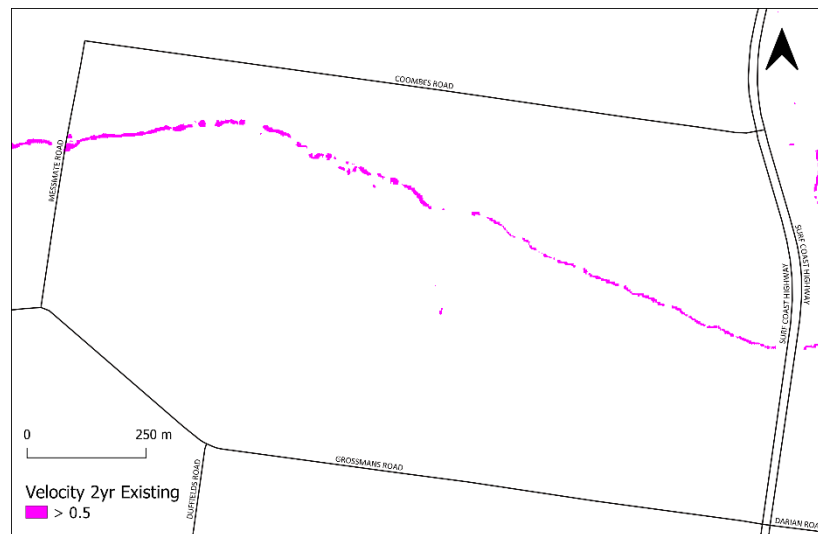
Figure 6. Velocity above a threshold of 0.5 m/s for a 2-year ARI flood event for existing conditions

- Upstream of the culvert under a 2-year ARI event, locations where the erosion threshold of 0.5 m/s is exceeded are reduced for developed conditions compared to current conditions whereas downstream of the culvert there is a slight increase in length of channel affected by flows above this threshold (Figure 6 and Figure 7). The length of channel impacted aligns with the section between the culvert and Yellow Gum Drive. This occurs because of the reduction in the overland flow path extent from the east catchment for developed conditions.

To further mitigate against potential erosion risks, it is recommended that all stormwater outlet designs ensure peak flow velocities measured at the downstream of the outlet are less than 0.5 m/s. This would limit the

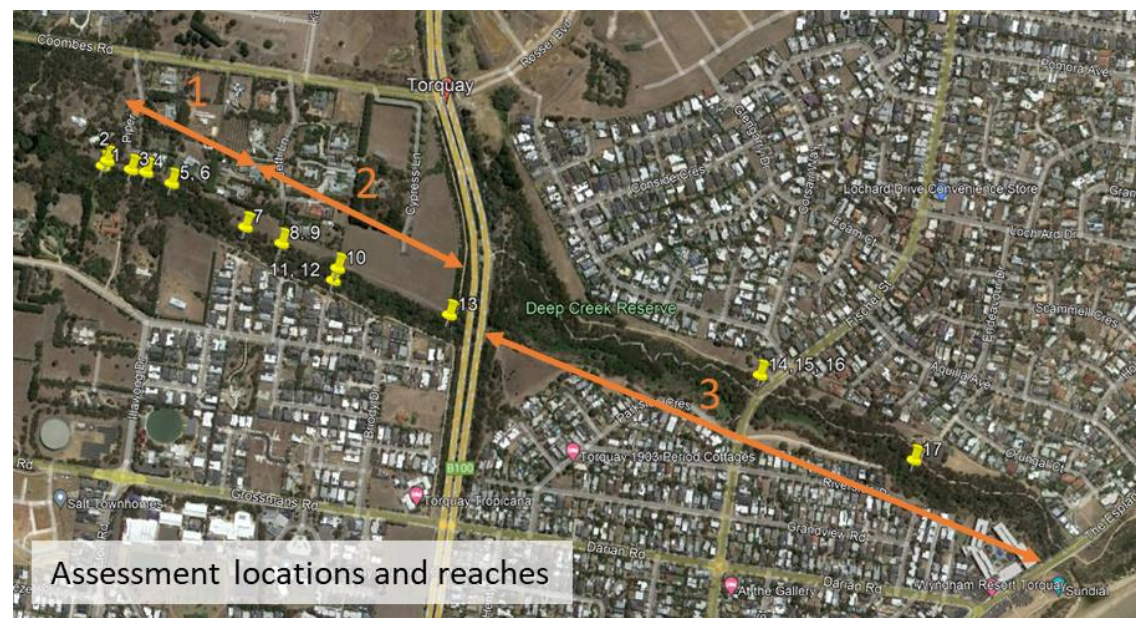
Figure 18 Assessment locations and reaches along Deep Creek

The field assessment reach of Deep Creek was from Piper Lane (upstream) to The Esplanade (downstream) as shown in Figure 18. The proposed stormwater outlet for the east catchment is located at approximately pin 3 in the figure.

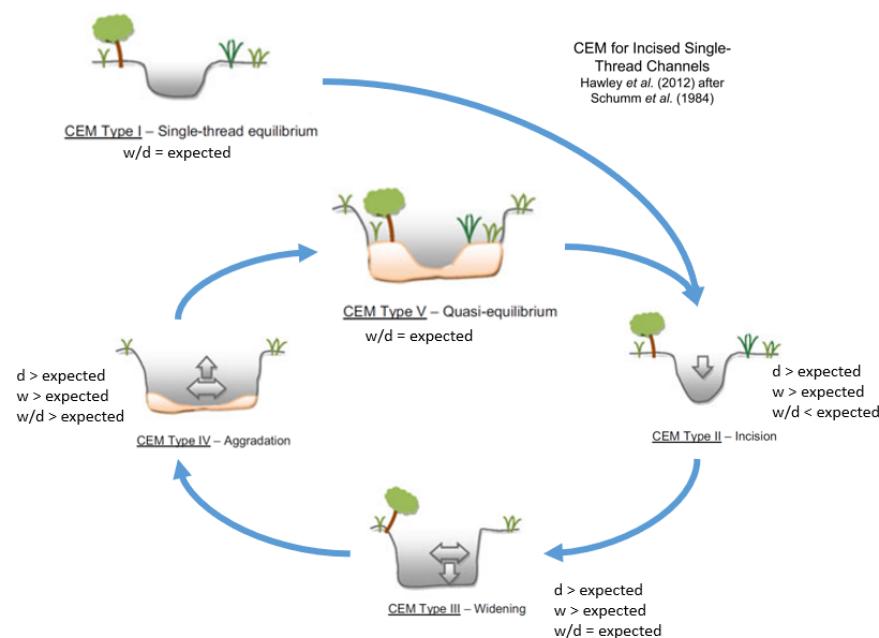
Figure 20 Channel evolution model (Hawley et al. 2012 after Schumm et al. 1984)

The physical form of a channel can be related to condition through the Channel Evolution Model (CEM). We know that channels undergoing change due to increased catchment stressors are likely to undergo channel incision. This means they deepen, then widen, and this may continue through various stages (Figure 20). The first stage of the CEM sees waterway channels that are typically stable (Type I). The second stage (Type II) is the incision stage where the channel bed lowers, followed by channel widening (Type III) where failure of banks occurs as they become over-steepened. A recovery stage (Type IV) occurs when the channel widens to a point where it can accommodate incoming flow energy without further erosion and receives sediment from upstream to rebuild in-channel features. If recovery occurs, then a low-flow channel is re-established (Type V) within the new broader stable channel.

- Upstream of the dam structure, the channel retains its original form (Type 1).
- From the dam to the culvert structure, the channel is in the process of deepening and widening (Type II to III) with instability along the channel itself in the form of head cuts, and gully formation.

- From the culvert to approximately Yellow Gum Drive, it appears that the incision process is slowing and widening is becoming more dominant.
- The reach from Yellow Gum Drive to the Surf Coast Highway has already deepened and widened, and then aggraded, putting it in a Type IV to V category.

Based on the current geomorphic condition of Deep Creek, the section of waterway between the existing dam structure and culvert is likely to be the most sensitive to changes in the hydrologic regime, followed by the reach downstream of the culvert to around Yellow Gum Drive.
