BUILDING CONDITION REPORT

**AT: DEANS MARSH COMMUNITY HALL
20 PENNYROYAL VALLEY ROAD,
DEANS MARSH**

REPORT NO.: 23688 F1 REV 1

P.J. YTTRUP & ASSOCIATES PTY LTD

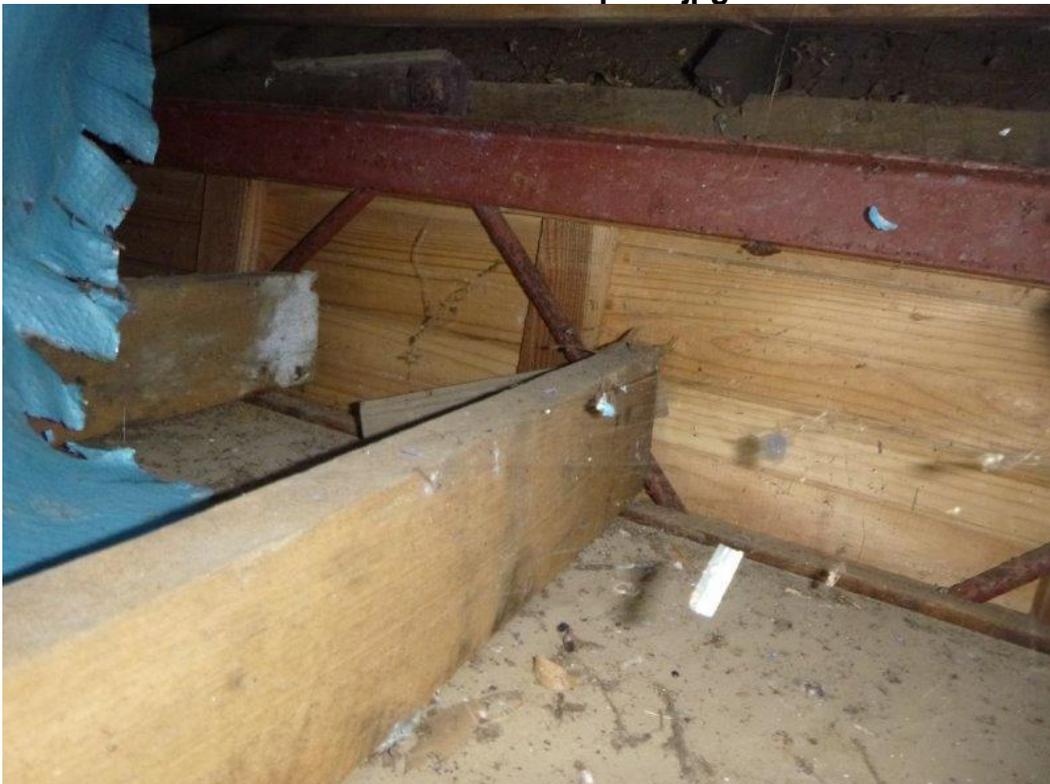
Photo 42 - Roof Space.jpg

- The southern kitchen roof consists of prefabricated trusses (Photo 40);
- The junction between the higher pitched roof and the “lean to” roof of the main hall is supported by a steel truss (TR1). There was rust present on much of the truss (Photo 42). Access to accurately measure the truss was limited however approximate dimensions are provided on the attached drawings. This truss spans approximately 10.5m. Columns, likely timber, are visible internally at the ends of the truss with two exposed bolt heads to the underside of the truss bulkhead. The timber panelling to the truss bulkhead appeared to be pine when viewed from the roof space;

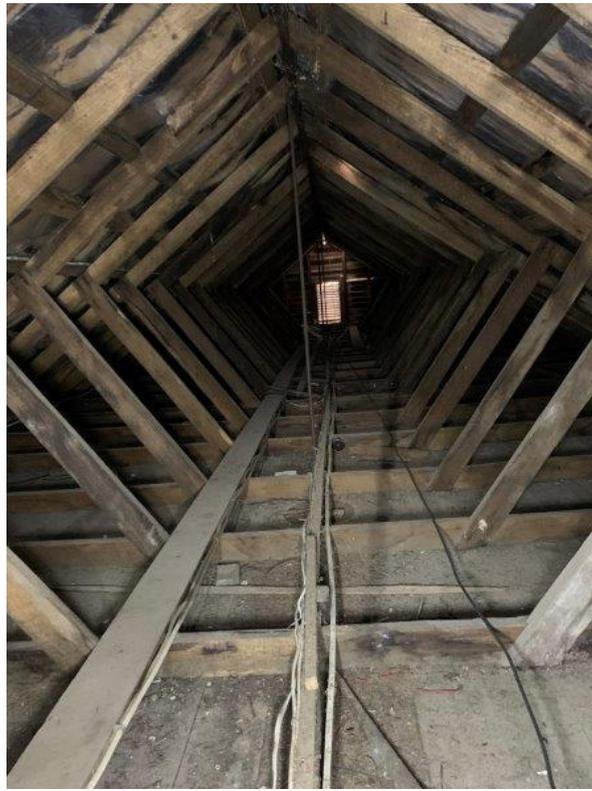
Photo 43 - Roof Space.jpg

The remainder of the central hall roof was framed with struts/web members to create a series of trusses. Horizontal tie rods (TB1) and vertical sag rods (SR1) between the ends of the rafters were visible at discrete locations (Photo 43). Rust was noted on vertical sag rods (SR1) within the roof space. Connections typically consisted of two nails between members.

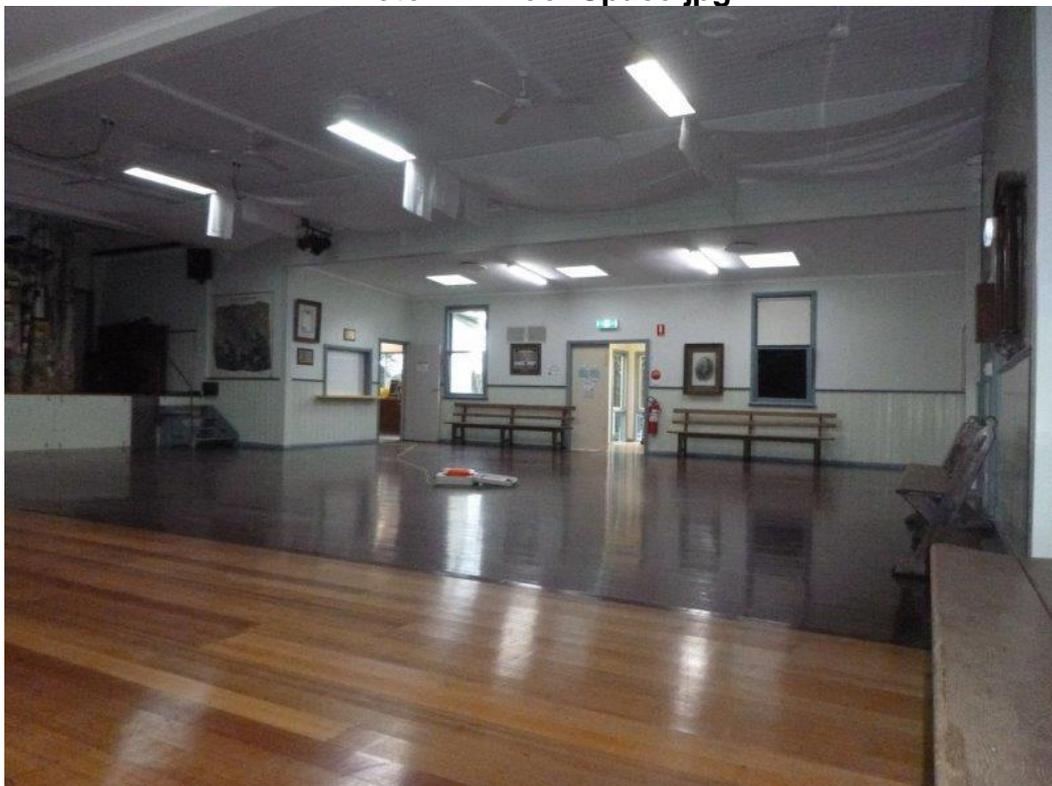
Photo 50 - Internal.jpg

The floor boards to the original hall do not appear to be original. The technology to achieve the machined edges visible from the underside would not have existed at the time the hall was originally constructed (over 130 years ago). It appears the floor boards may be tongue and grooved (Photo 34). The southern wing of the hall has different lighter coloured floor boards to the rest of the hall (Photo 50). The northern kitchen has chipboard flooring underlay with a vinyl finish.

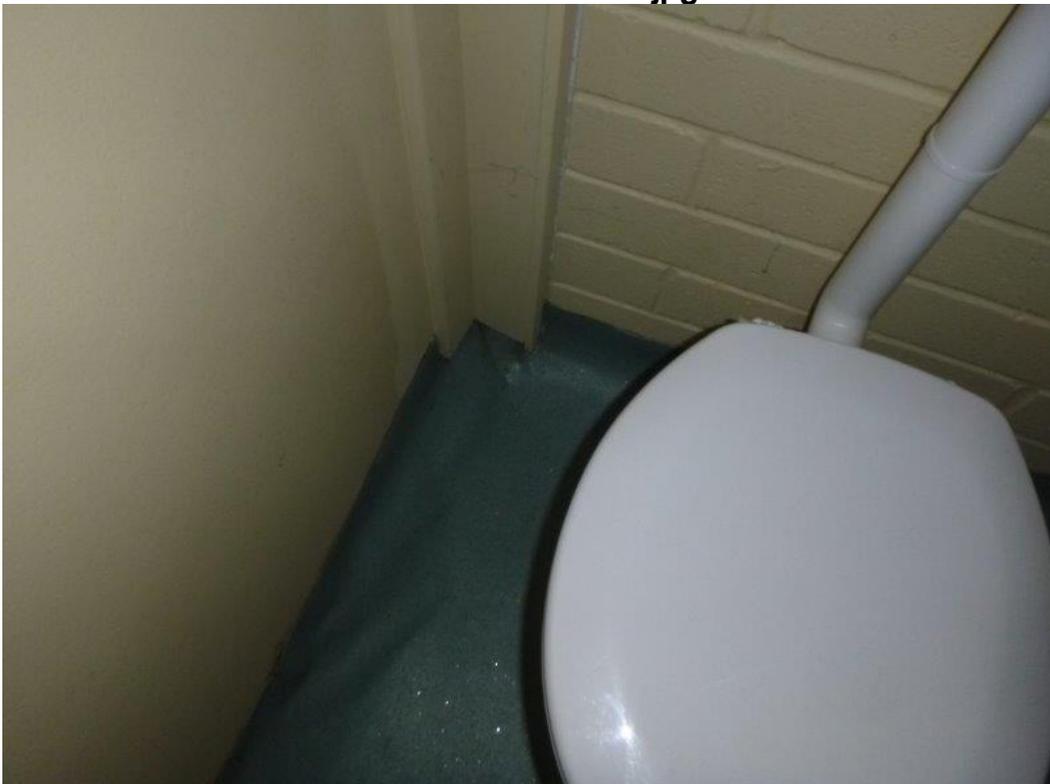
Photo 56 - Internal.jpg

Roof seals, screw rubber seals and flashing were in fair to poor condition with many poorly constructed. Roof sheeting was corroded in places (Photo 04, 22, 25-27). Signs of water ingress were noted internally in several locations (Photo 54, 56, 59-61, 66).

Internal wall lining to the main hall area was a mixture of timber panelling (some possibly original) and plasterboard (unlikely original). Elsewhere the internal lining was typically plasterboard with exposed brickwork to the toilet area. Some minor cracking to brickwork and plaster was noted in some locations (Photo 55, 57, 58, 60, 62- 64). There were no other obvious signs of any major structural issues other than some localised signs of moisture ingress (Photo 54, 56, 59-61, 66).
