SPLIT POINT LIGHTSTATION

CONSERVATION ANALYSIS
AND
MASTERPLAN

**Prepared for the
SURFCOAST SHIRE**

Allom Lovell & Associates Pty Ltd
Conservation Architects
35 Little Bourke Street
Melbourne 3000

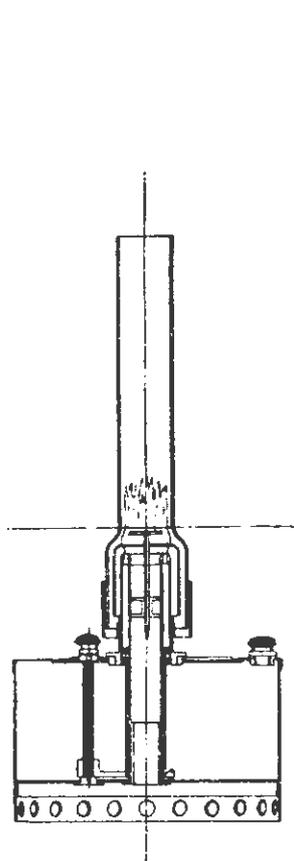
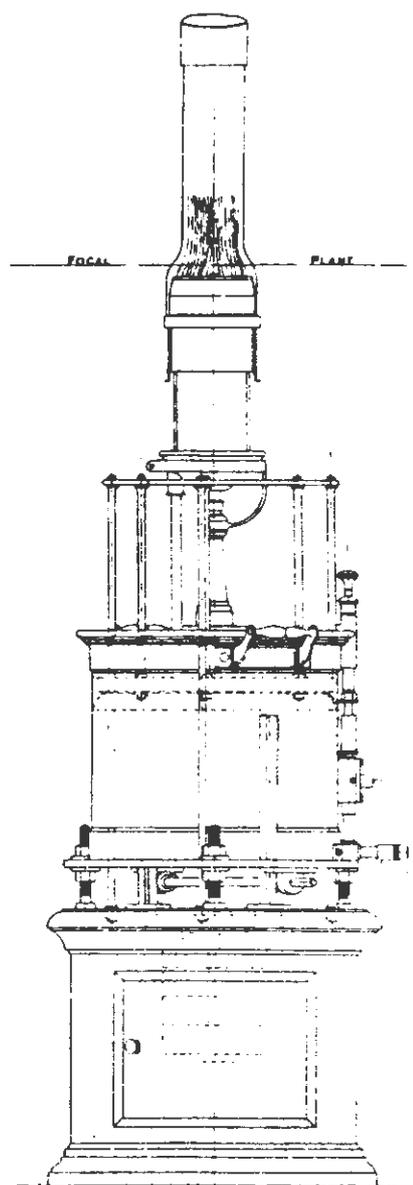
Figure 10 A Chance Bros. Lantern (right) and ancillary lamp (left), such as those that would have been used at Split Point. Source: The White Queen.

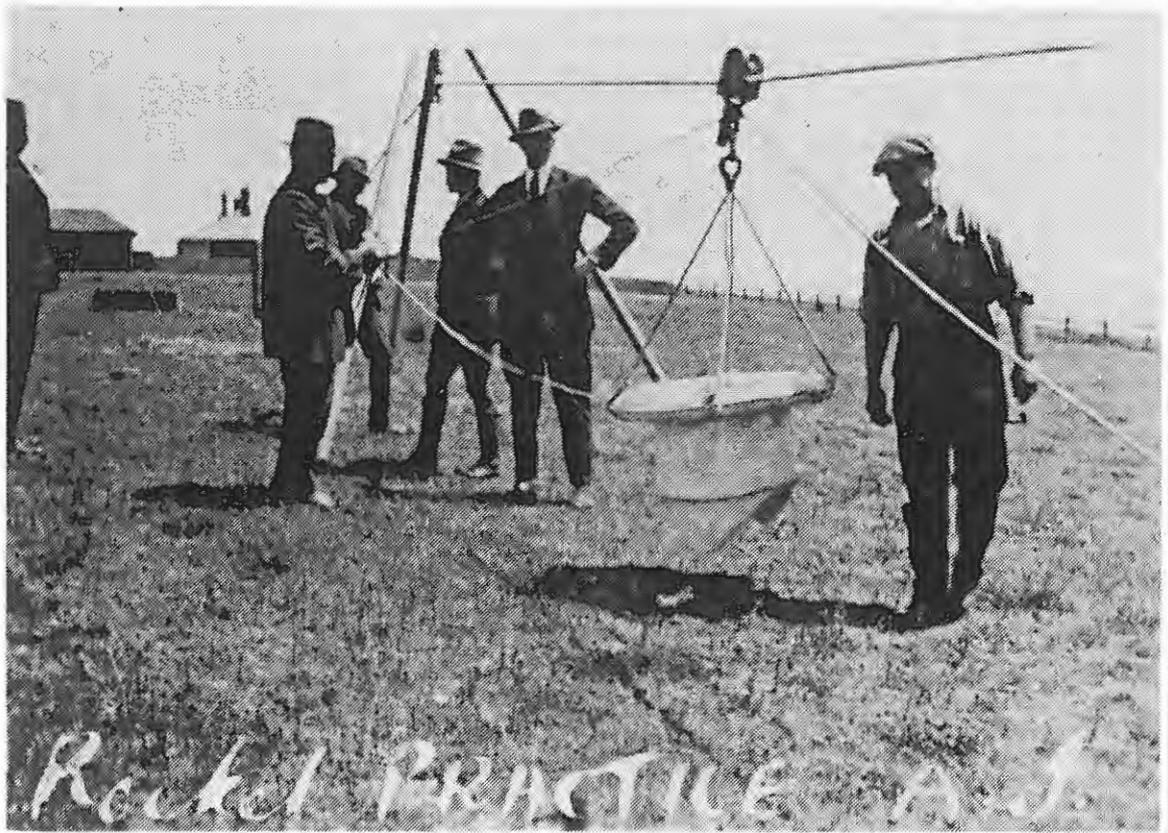
Figure 13 Testing the rocket equipment (date unknown). Source: The White Queen.

The lighthouse rocket (Fig. 13), for saving shipwreck victims, was described in the summer of 1893-94 in the *Geelong Advertiser*, by an unknown source:

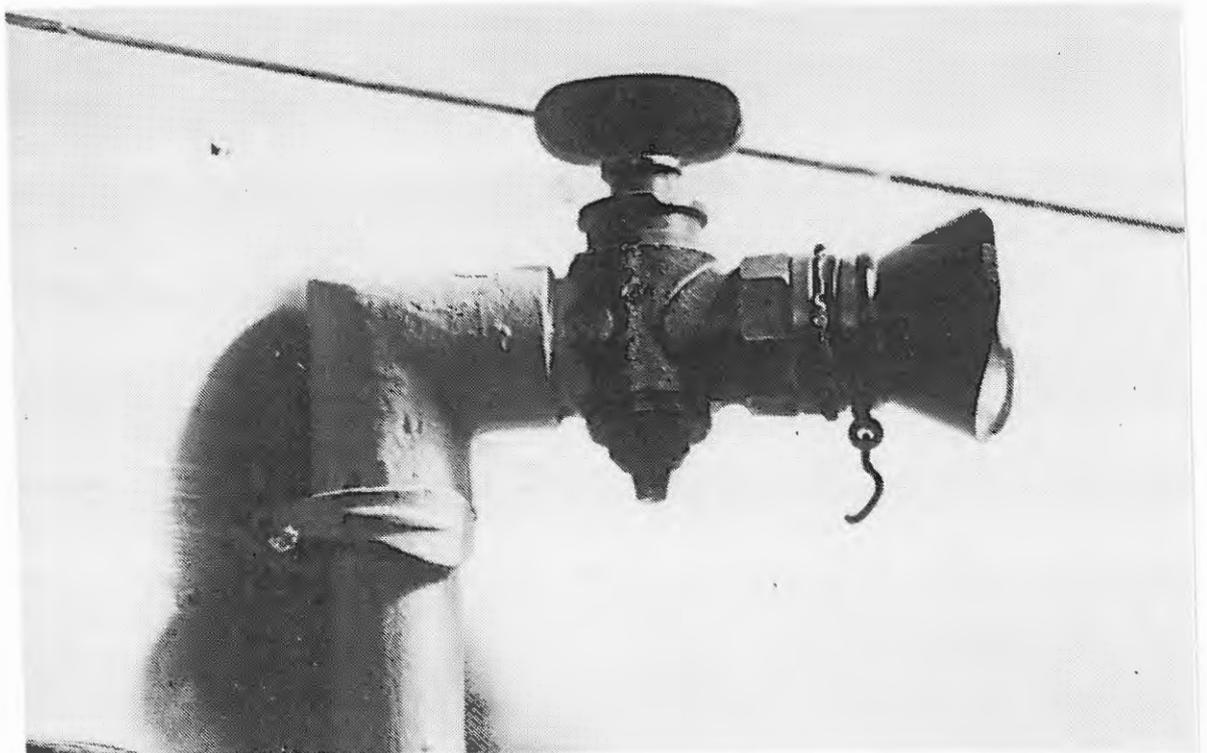
Figure 16 *The speaking tube in the head lighthouse keepers cottage (1985).*
Source: The White Queen.

A speaking tube extended from the lighthouse to both lighthouse keepers cottages. A whistle was blown down the tube when the keepers wished to contact with one another. An extant tube is in the bedroom of the head lighthouse keeper's cottage and also the assistant keeper's cottage (Fig. 16).

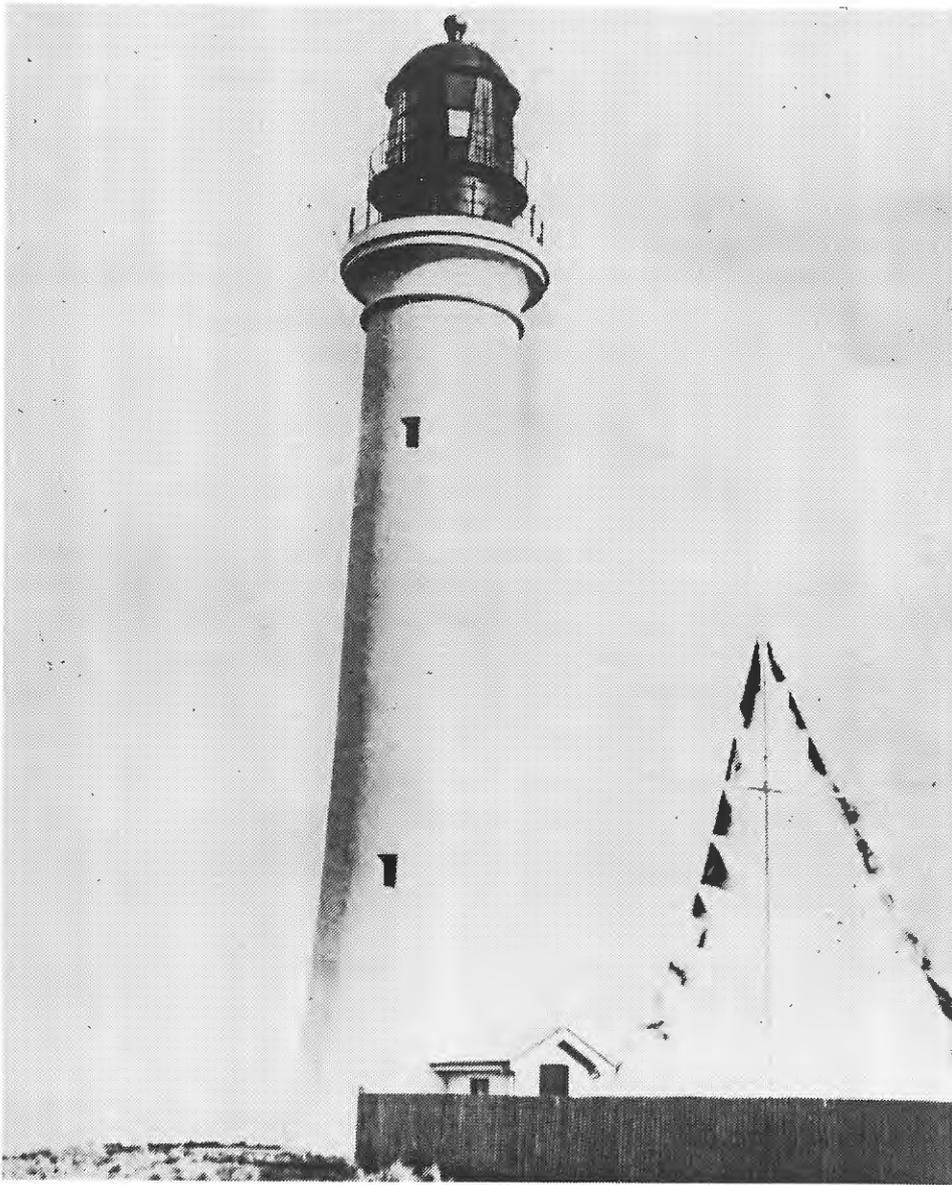
Figure 17 The lighthouse with its signal tree (date unknown). Source: The White Queen.

The lighthouse communicated to passing ships in one of two ways. At night an acetylene Morse lamp was used, with a signal tree by day, a T-shaped flagpole system (Fig. 17). The Split Point Lighthouse did not have a Lloyd's Signal station, nor a storm signal system, which could be found at other towers such as Gabo Island, Cape Otway and Cape Nelson.⁵⁹ Instead, lighthouse keepers had to be conversant with signals as they were detailed in the British Signal manual.⁶⁰

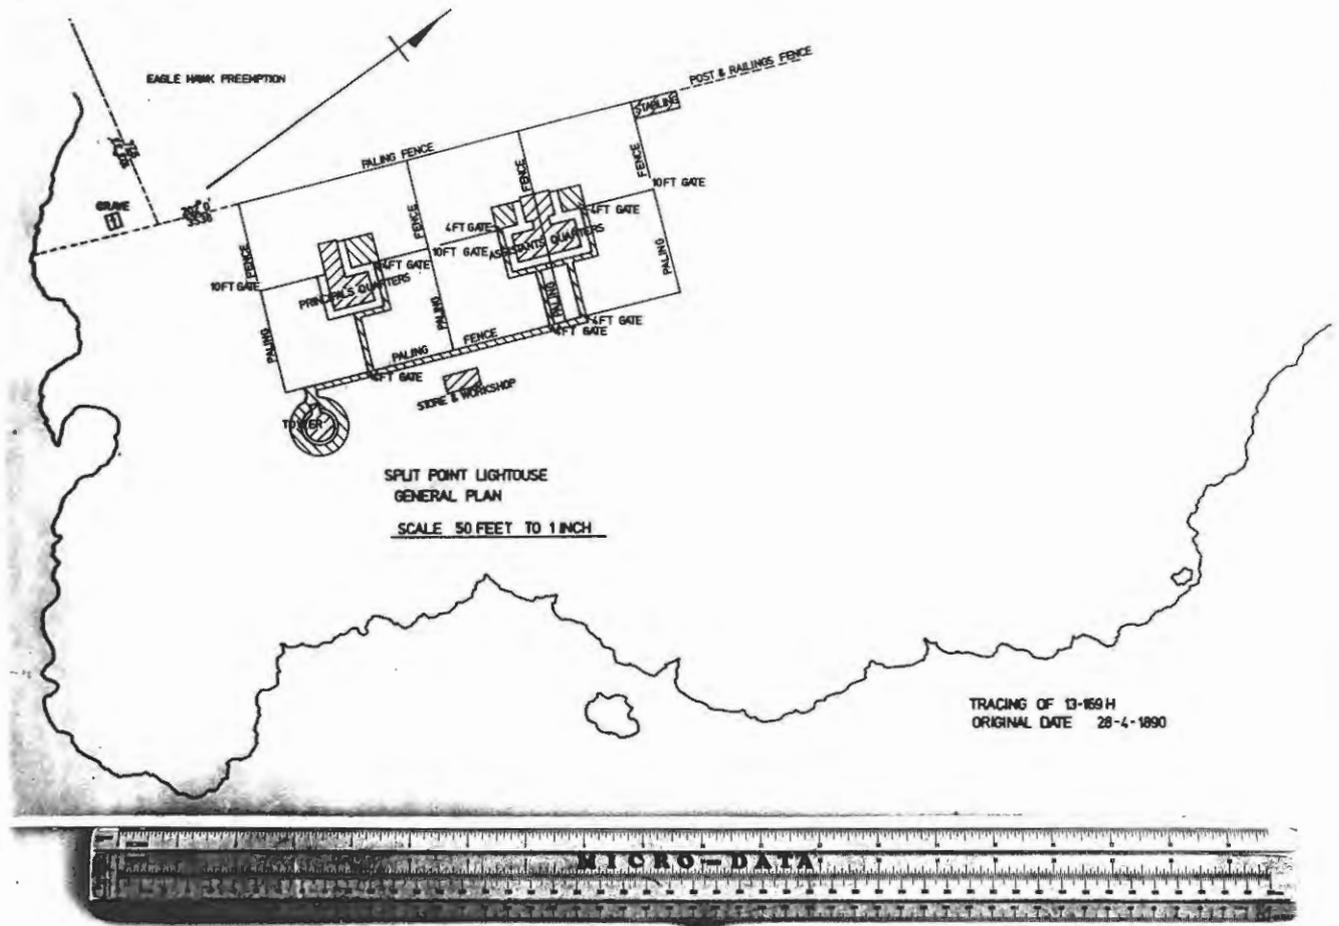
Figure 19 The lighthouse precinct, based on the original 1889 site plan

The lighthouse precinct at Aireys Inlet comprises the lighthouse and temporary generator shed, the former head keeper's cottage, the former assistant keepers' cottage, the former stables, and the lighthouse reserve; a narrow strip of land along the eastern coastline, bounded to the west by Eagle Rock Parade (Fig 19).

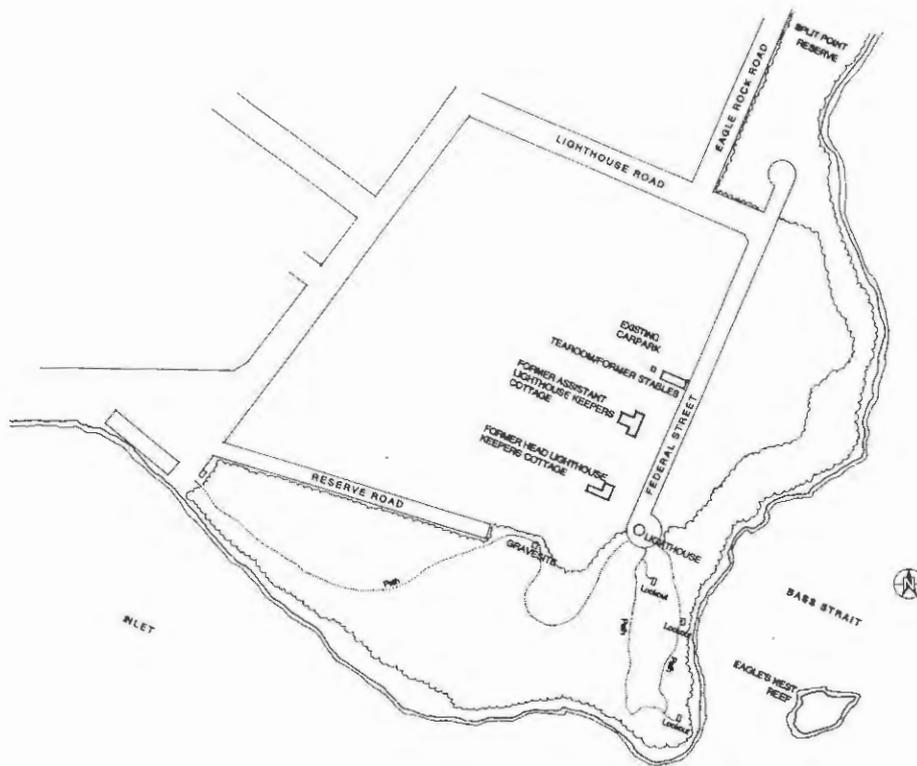
Figure 20 The present lighthouse precinct.

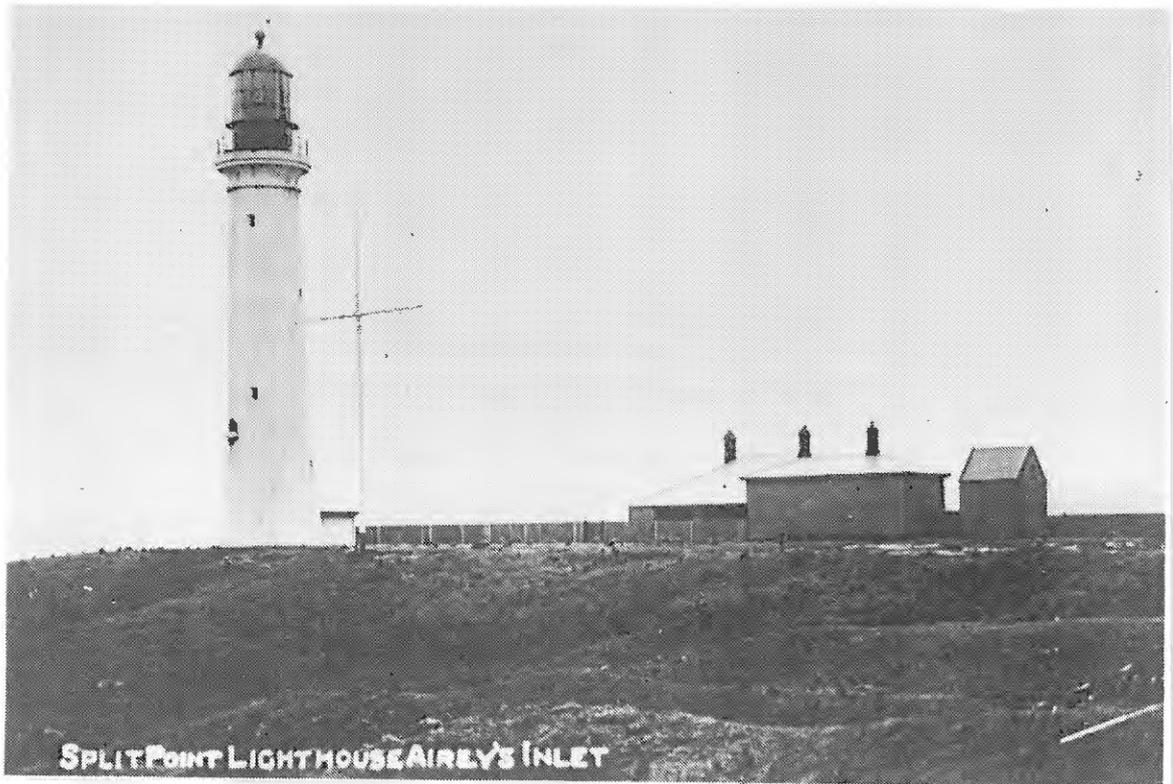
Figure 21 Undated photograph of the lighthouse, showing the red-painted lantern.

Split Point Lighthouse is situated on the southern tip of Split Point, facing Eagles Nest Reef. The 25 metre circular shaft is of concrete rubble construction, rendered and painted white, and is constructed on a concrete foundation. The original drawings show that the tower was originally intended to be constructed of stone; the reason for the change of construction method is unknown.² The building tapers as it rises, terminating with a coved cornice. Above this is a cast iron balustraded gallery and the cylindrical glazed lantern house. The lantern house has a hemi-spherical copper clad roof, painted red, and is surmounted by an orb and weathervane. Early photographs show that both the lantern house and the domed roof were painted a dark colour, most probably red (Fig 21). A mobile telephone tower has been recently fixed to the base of the lantern house.

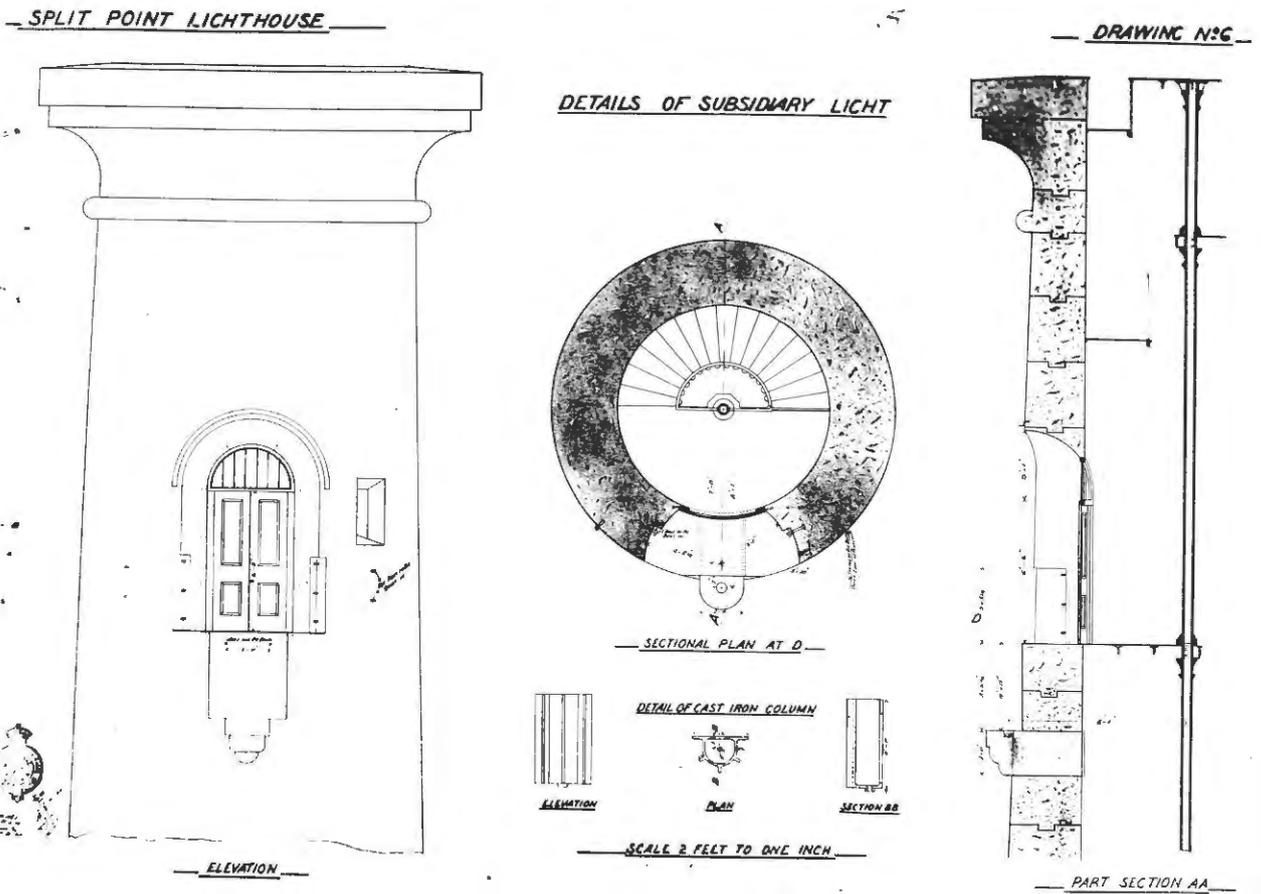
Figure 22 1889 detail construction drawings of the auxiliary light opening, originally intended to be located at the upper level of the tower.

The tower is punctuated by small rectangular windows which are set within deep splayed openings, which internally lights the stair in addition to affording spectacular views of the coast. The location of auxiliary light opening differs from that shown on the construction drawings, where it is shown at upper tower level, but was constructed at the first landing level (Fig 22). The arched opening for the auxiliary light has been blocked off externally,

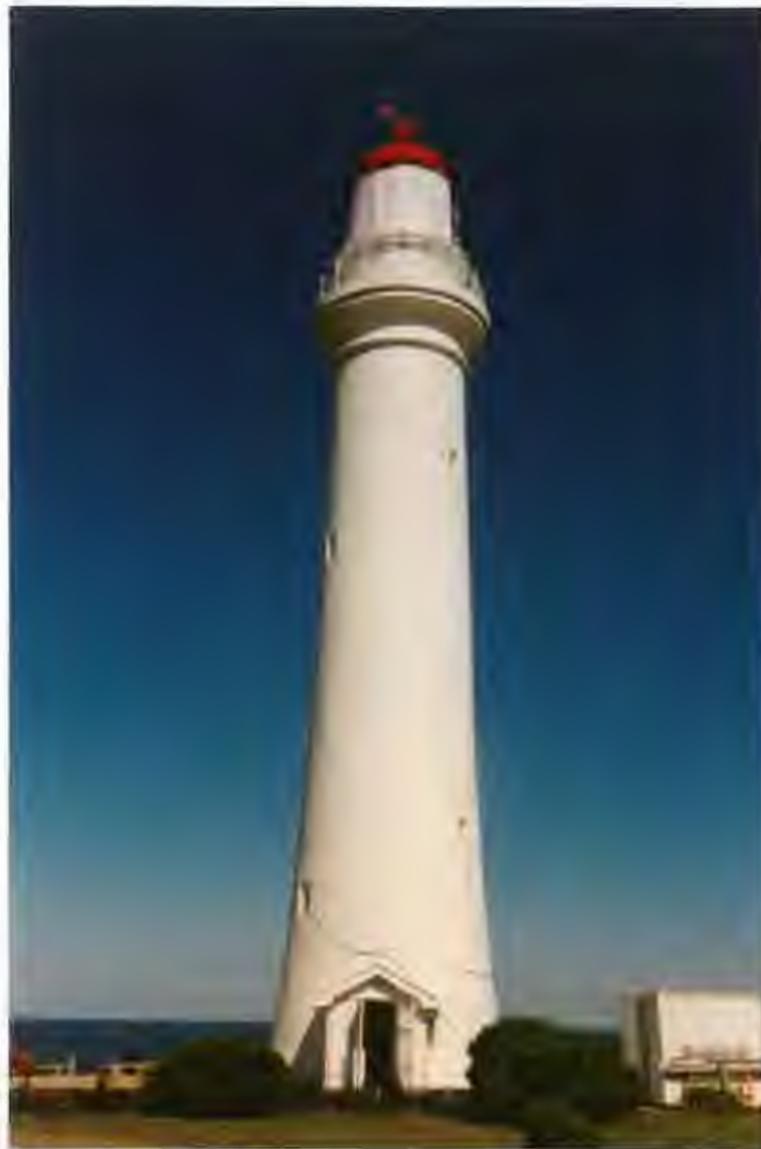
Figure 23

The lighthouse from the east, showing the entry porch at the base of the tower.

A small projecting entry porch abuts the north-west face of the tower, and has a slated gabled roof. (Fig 23)

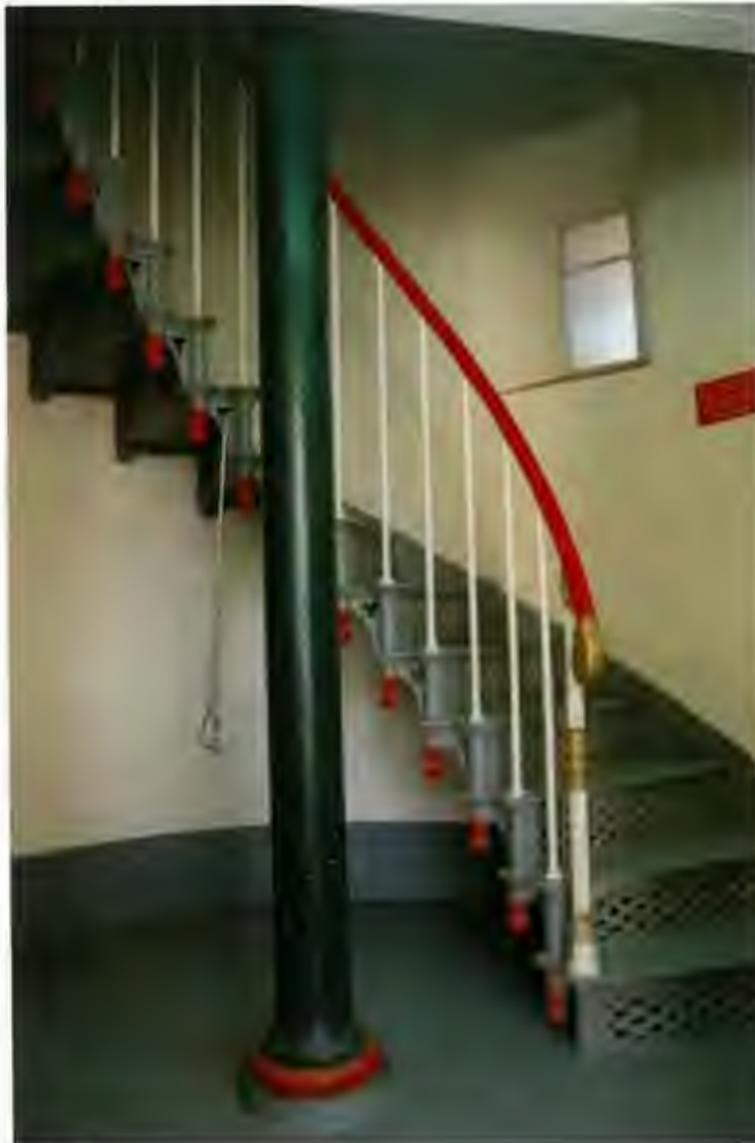
Figure 25 The original circular cast iron stair.

The interior of the lighthouse is substantially intact as originally constructed. The original circular cast iron stair provides access to the lantern house, and comprises open cast iron risers, solid iron treads, and cast iron rod balustrading (Fig 25). There are four semi-circular cast iron landings, supported centrally by stacked cast iron columns with ornate capitals and moulded bases at each level. The small windows have fixed metal framed glazing. The original cupboard and doorway to the auxiliary light survive at first floor level, located within an arched opening (Fig 26).

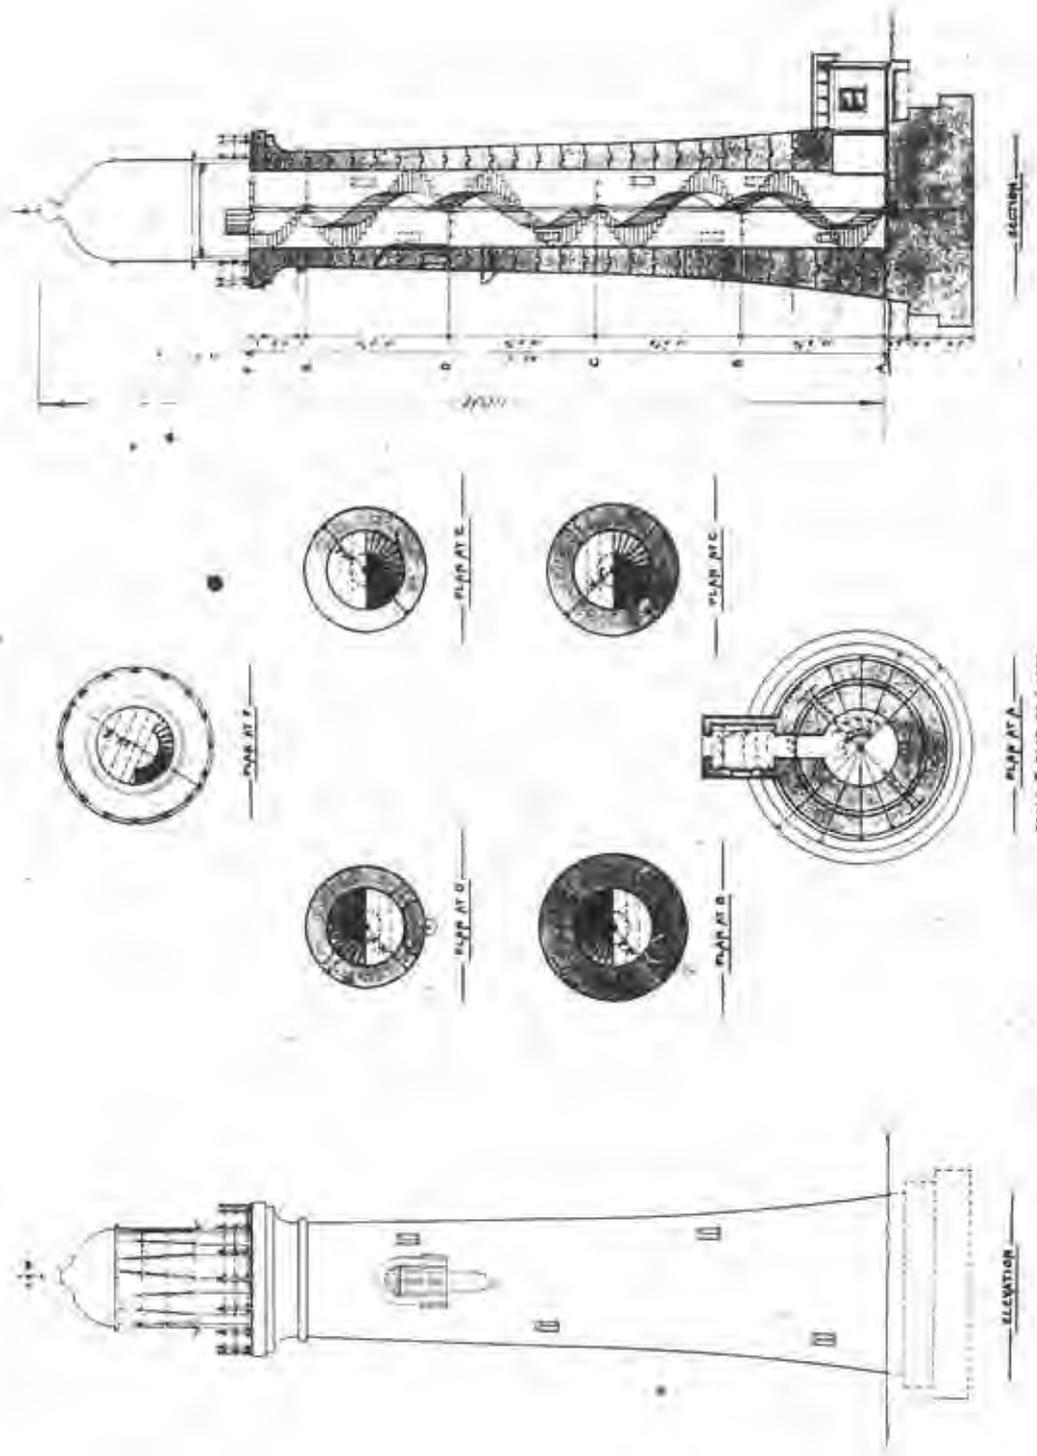
DRAWING N. 2.

SPLIT POINT LIGHTHOUSE
TOWER

Figure 24 Original construction drawings for the lighthouse, dated 1889.

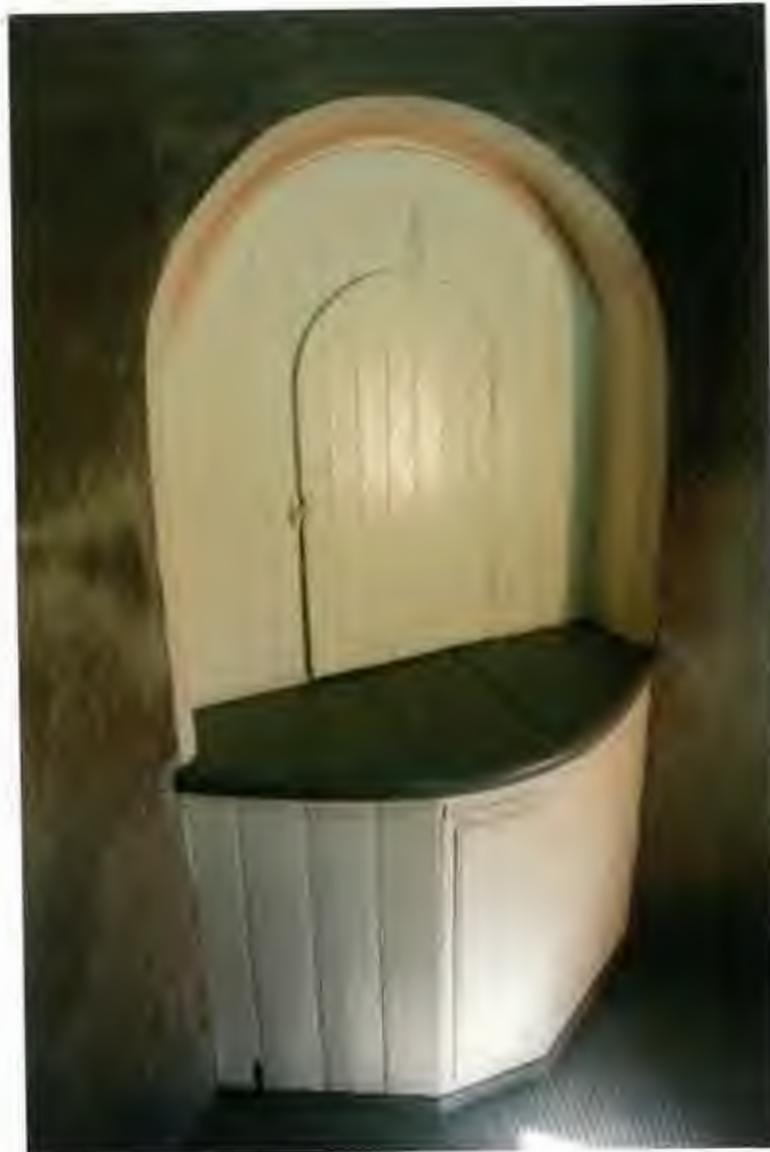
Figure 26 The door opening to the auxiliary light at first landing level. The auxiliary light was discontinued in 1919.

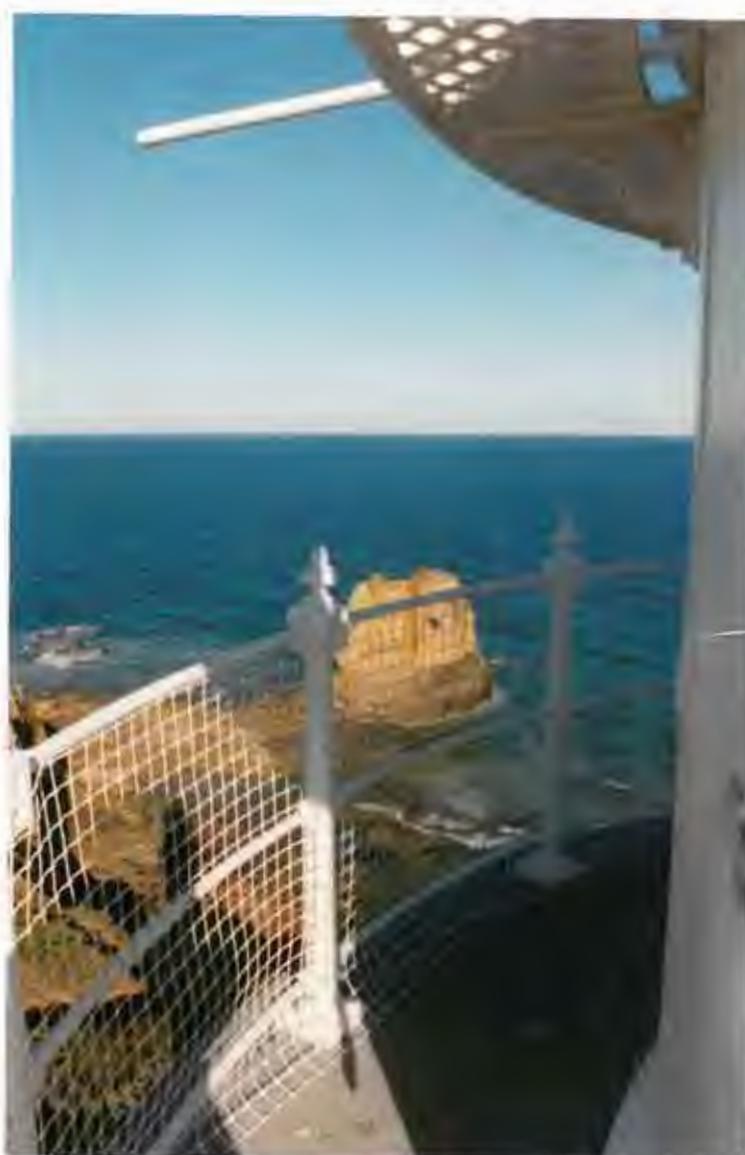
Figure 28 The exterior gallery, with original cast iron balustrading and recent mesh infill.

The lantern comprises two levels (Fig 27) The lower level is accessed via an original narrow varnished timber stair lined with V-jointed boards. A brass plaque with the name of the manufacturer's of the equipment, "Chance Bros." , is fixed to the original central cast iron pedestal supporting the light and lens structure. Walls at this level are lined with sheet metal. A heavy door opens out onto the exterior gallery, which retains the original simple cast iron balustrade (Fig 28). Mesh has been added recently to the balustrading.

Figure 38 Gallery level at the Cape Nelson Lighthouse (cf. Fig.28). Reproduced from Cape Nelson Lightstation.

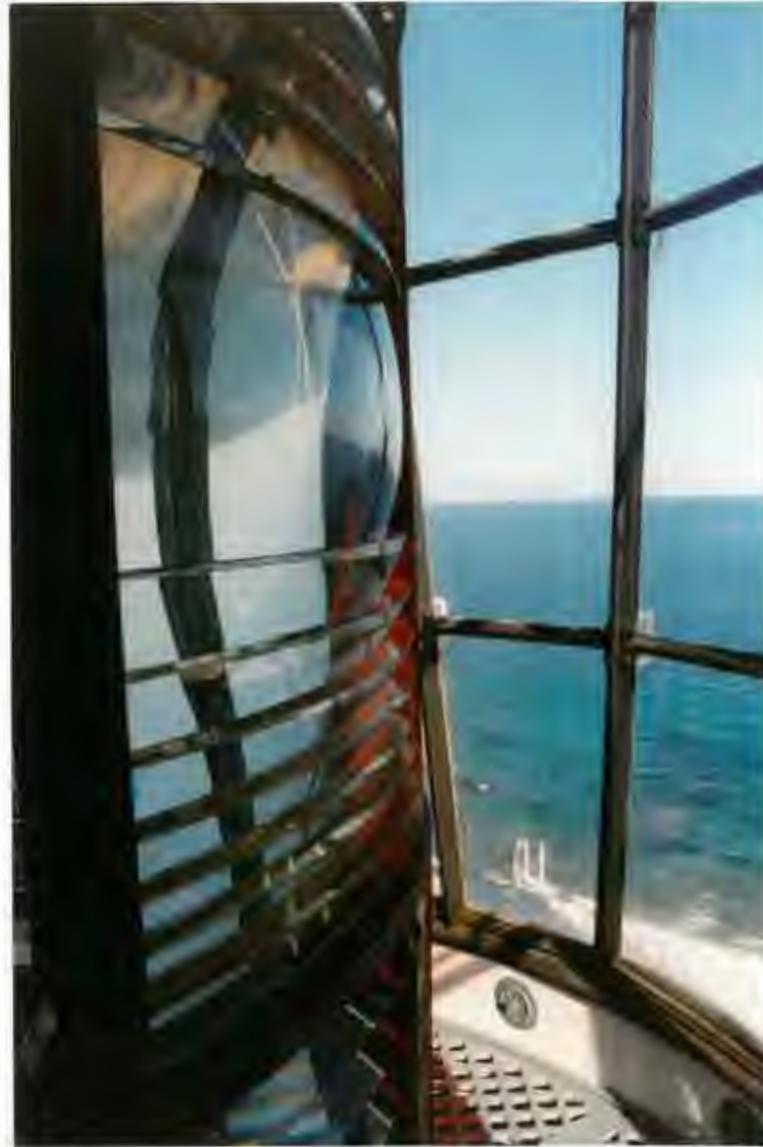
Figure 29 The optic lens at upper lantern level. Note the ventilation covers below the glazing.

The Split Point Lighthouse originally ran on the dioptric system. (Fig. 29)

The upper level of the lantern room is accessed via a narrow cast iron ladder and a recently added hatch in the floor. The lantern has a cast iron frame infilled with diagonal patterned glazing, except for the north face which is clad with sheet metal. Red perspex sheeting covers narrow sections of the glazing at each end. The original small, circular ventilation covers at skirting level have been painted shut. A narrow, open cast iron floor supported on cast iron brackets runs around the perimeter of the inside of the lantern, and has been extended relatively recently with metal decking. The optic lens and light source occupy most of this level (Fig 29).

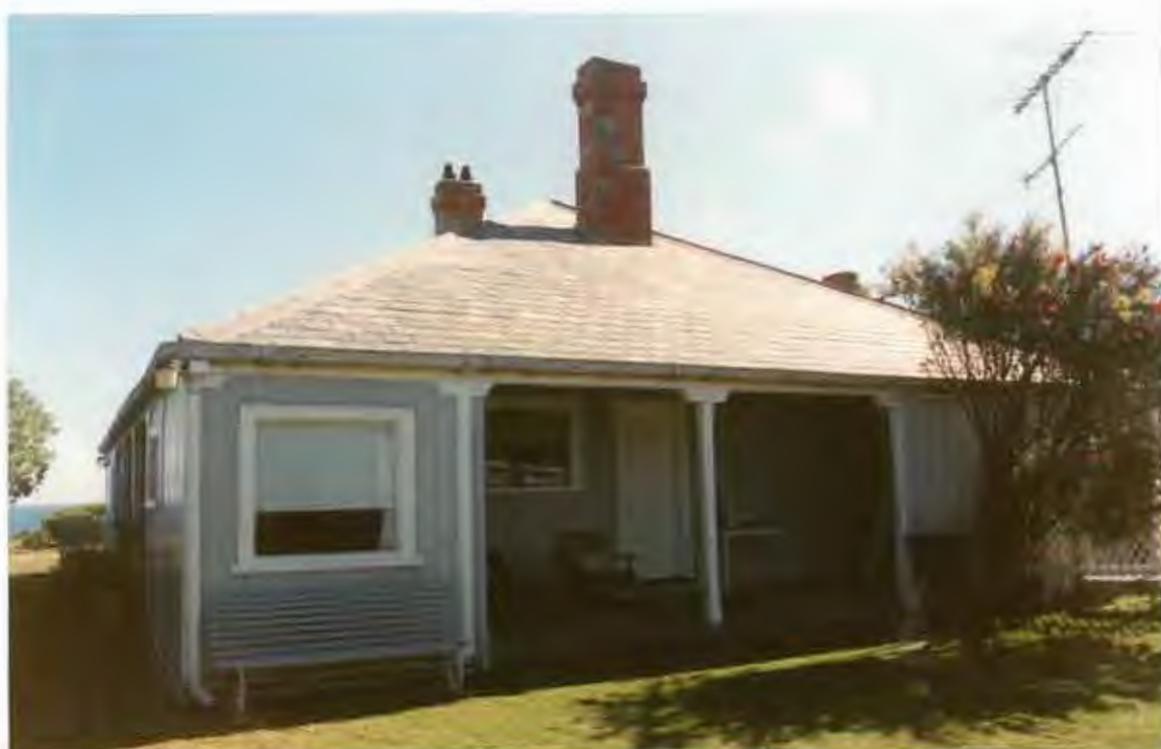
Figure 30 The east elevation of the former Head Lighthouse Keeper's cottage

The former Head Lighthouse Keeper's Cottage is located to the north-west of the tower, at the south end of Federal Street. The cottage is a single storey weatherboard building, L-shaped in plan, with a steeply pitched hipped slate roof encompassing a deep verandah encircling the building on three sides (Fig 30). The verandah is supported on chamfered timber posts and has carved timber brackets. The three chimneys are of red brick, only one of which has its original terracotta chimney pots. Doors are four panelled, and the original windows are timber-framed, double-hung sashes. A small brick paved courtyard with a concrete water tank and original, or early, water pump exists on the north side.

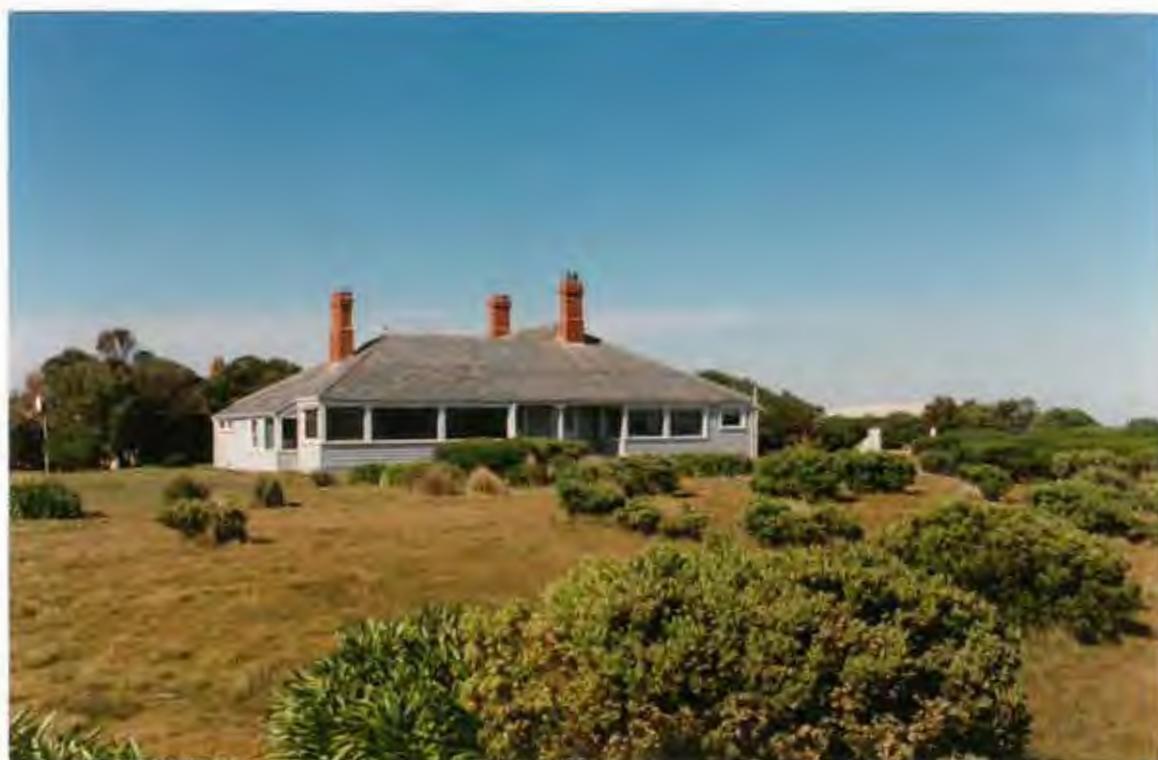
Figure 31 The south elevation of the former Head Lighthouse Keeper's cottage.

The former head lighthouse keeper's cottage is substantially intact externally. Alterations have been made to the verandah, which has been partially infilled variously with V-jointed boards, weatherboarding and large areas of glazing on the north and south sides, and has been paved with concrete.

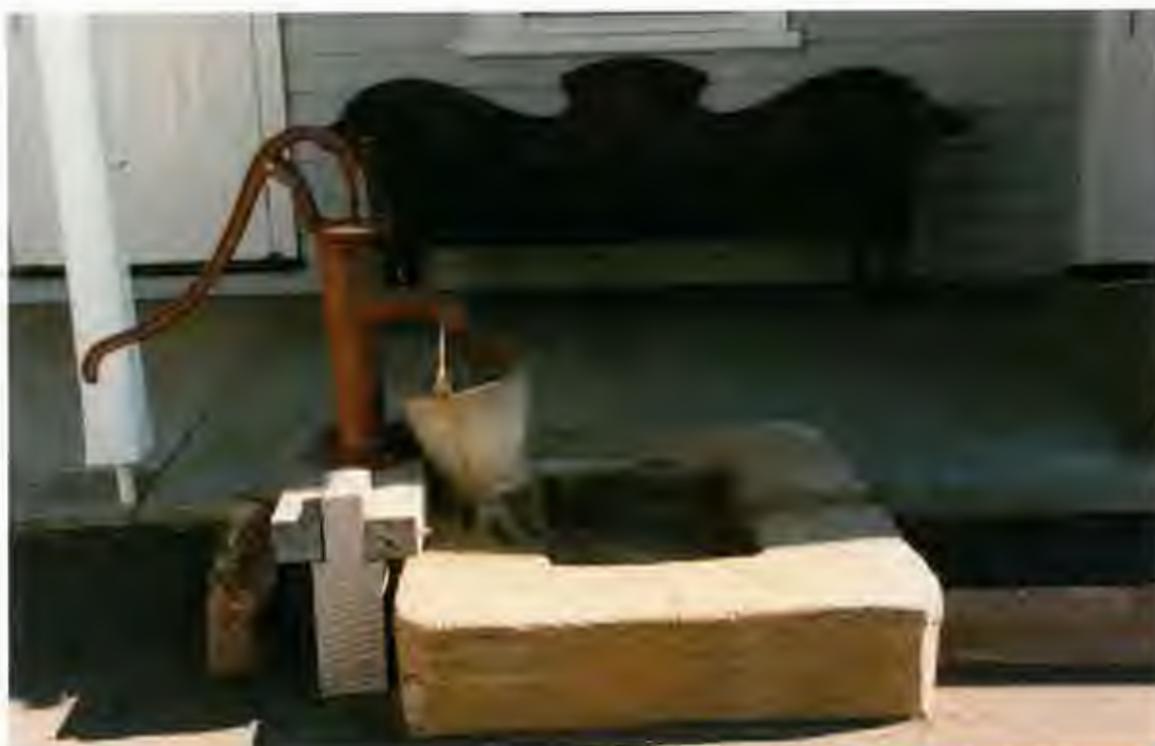
Figure 32 The pump at the rear of the former Head Lighthouse Keeper's cottage.

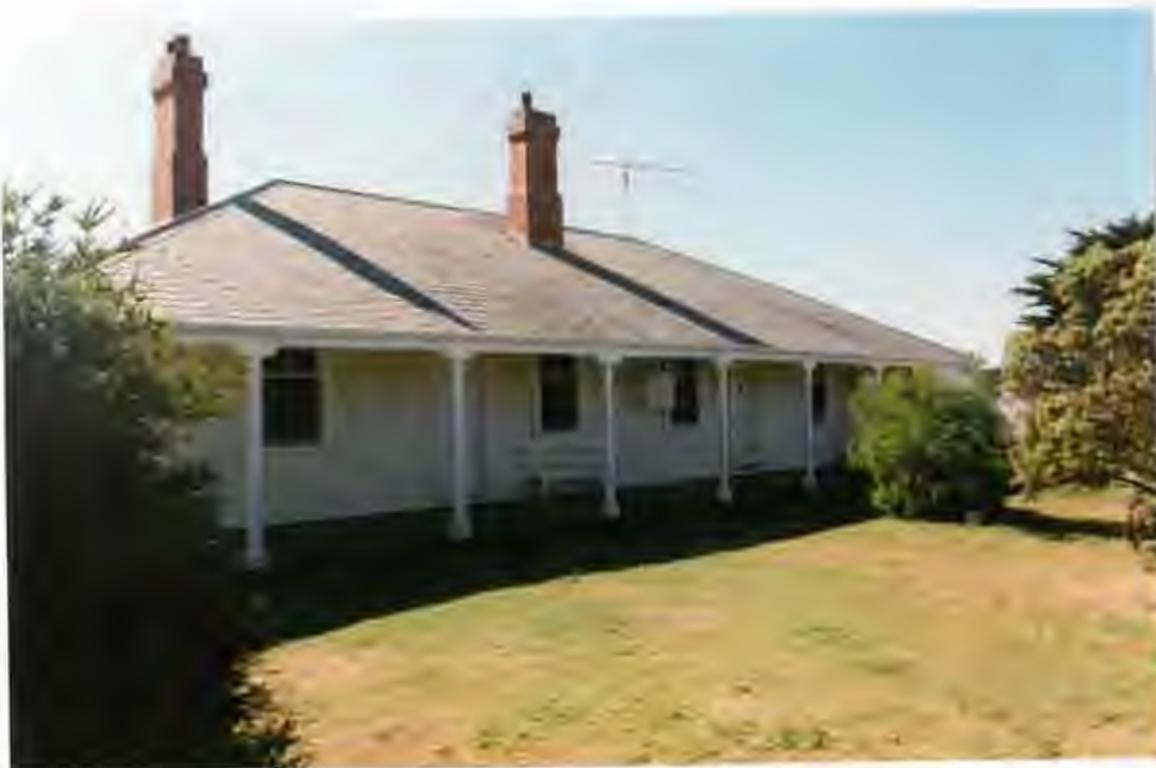
Figure 34 The east elevation of the former assistant lighthouse keepers' cottage

The building is substantially intact externally. As with the head keeper's cottage, alterations include the infilling of part of the verandah on the north and south sides with V-jointed vertical boarding. Recent additions have been constructed on the west side.

The building was not inspected internally. The original drawings show that the entrance doors opened directly into the living room, with a fireplace on the party wall. Two other principal rooms, possibly bedrooms, faced east and west, with a services accommodated in a rear wing.

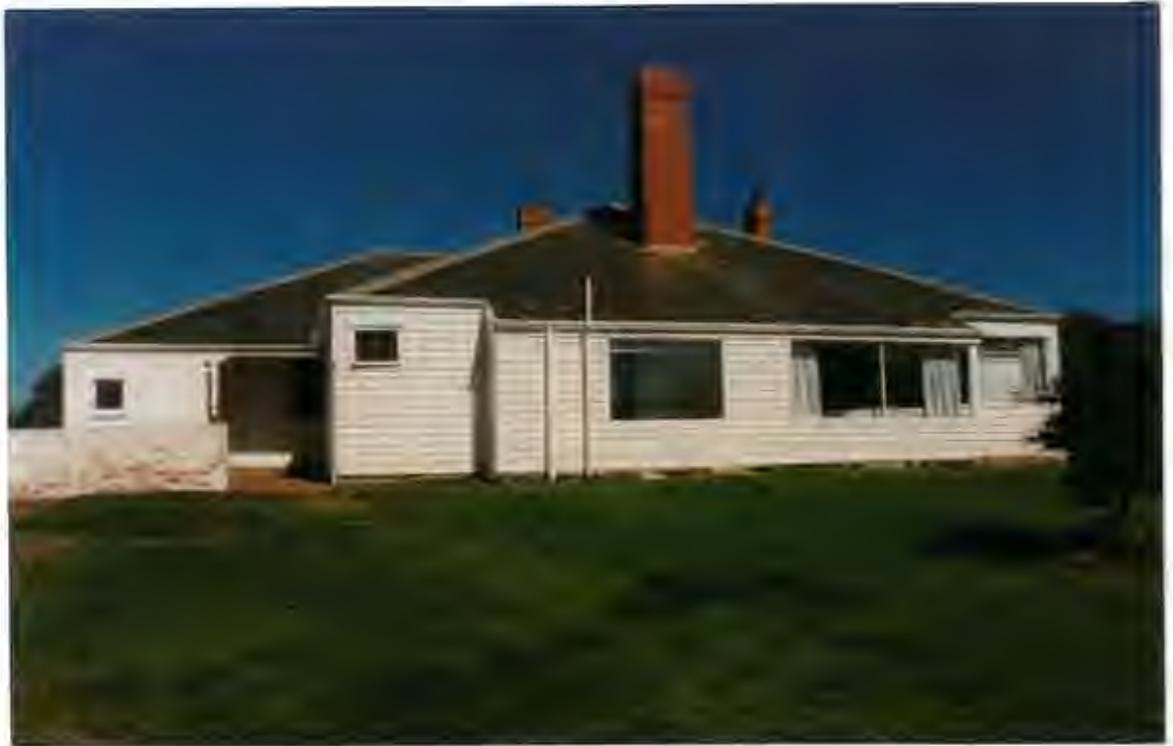
Figure 35 The west elevation of the former assistant lighthouse keepers' cottage

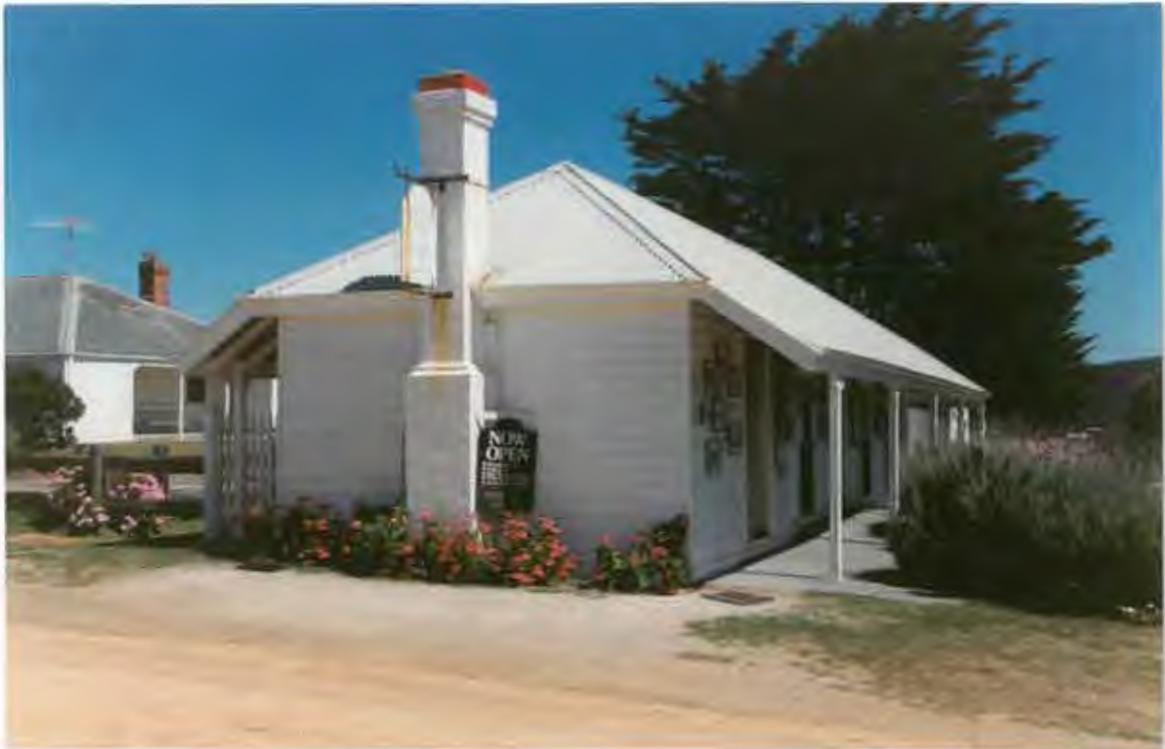
Figure 36 The former stables from the east.

The former stables is located to the north of the assistant lightkeepers' cottage. (Fig 36) It is a small, single storey weatherboard building, rectangular in plan, with a hipped roof recently reclad with corrugated galvanised steel roofing. Verandahs have been constructed relatively recently on the north and south elevations, and are supported by chamfered timber posts with carved timber brackets, the same as those on the two cottages. There are three vertical V-jointed board doors and three double-hung sash windows on the north elevation.

Internally the building has been considerably altered. The building is divided into two sections. The east portion, now a tea-room, has been completely refitted with pine V-jointed lining boards and timber floors. The west portion, now a shop, comprises three bays, separated by timber slab partitions, probably original. The upper walls are lined with recent pine boards. The original timber block floor exists beneath the rubber matting.

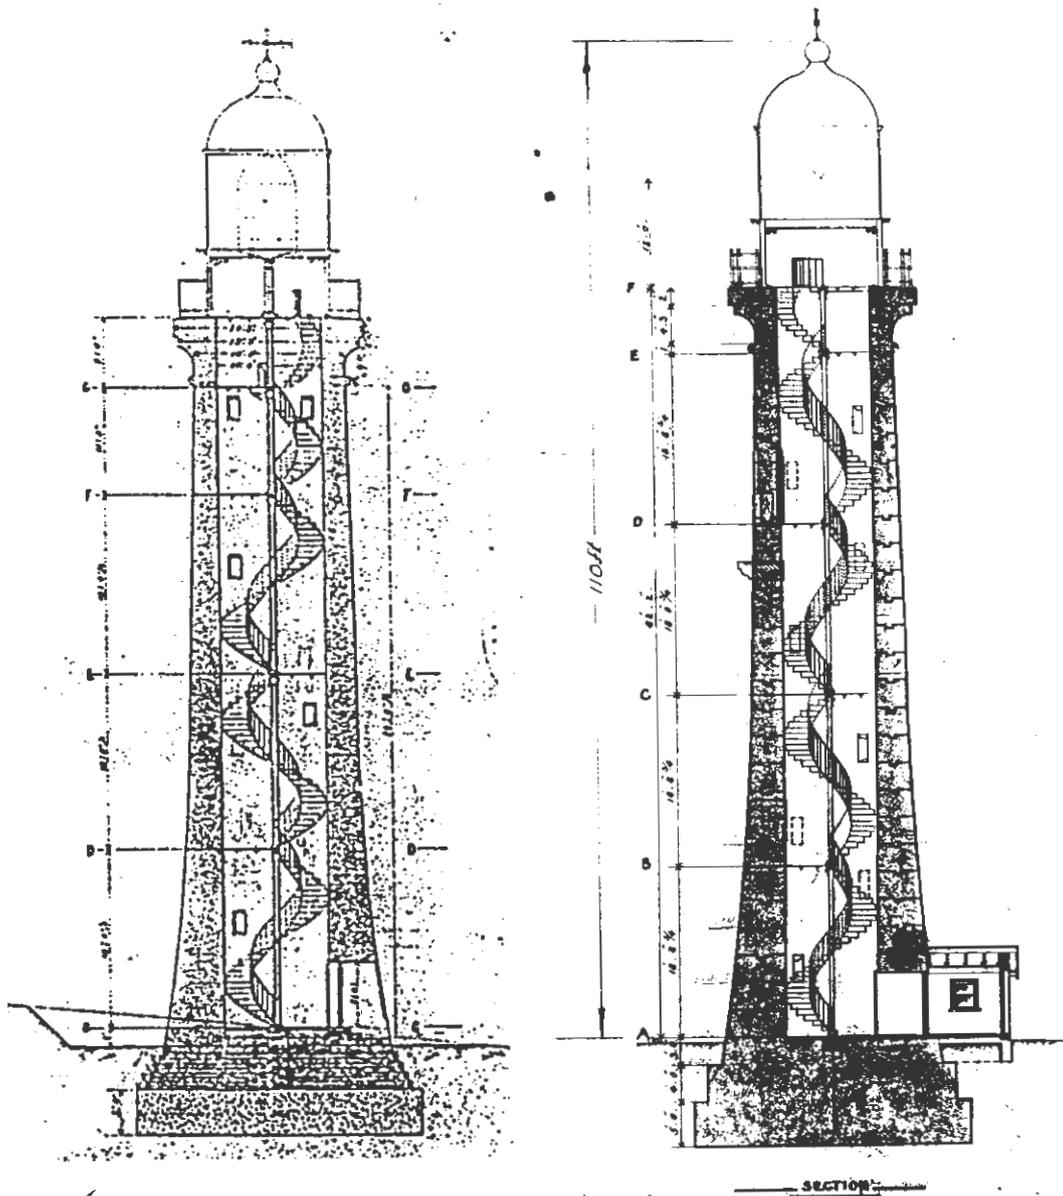
Figure 37 Comparative original drawings of the Cape Nelson and Split Point Lighthouses. The Split Point Lighthouse is on the right. Reproduced from Cape Nelson Lightstation.

The Cape Nelson Lighthouse is a 23.9 metre (73') high tower of basalt construction, painted white. In general form and scale the lighthouse is very similar to the Split Point lighthouse (Fig 37). The building is circular in plan, tapering as it rises, terminating in a coved cornice and surmounted by a glazed lantern house. The 3.6m (11' 10") diameter lantern was constructed in 1883, and, as at Split Point, has diagonal patterned glazing. It has a similar profile to that at Split Point, and is also capped by an orb and weathervane. The cast iron balustraded gallery is likewise similarly detailed (Fig 38). Internally, the tower also retains its original cast-iron staircase.
