SPLIT POINT LIGHTSTATION

CONSERVATION ANALYSIS
AND
MASTERPLAN

**Prepared for the
SURFCOAST SHIRE**

Allom Lovell & Associates Pty Ltd
Conservation Architects
35 Little Bourke Street
Melbourne 3000

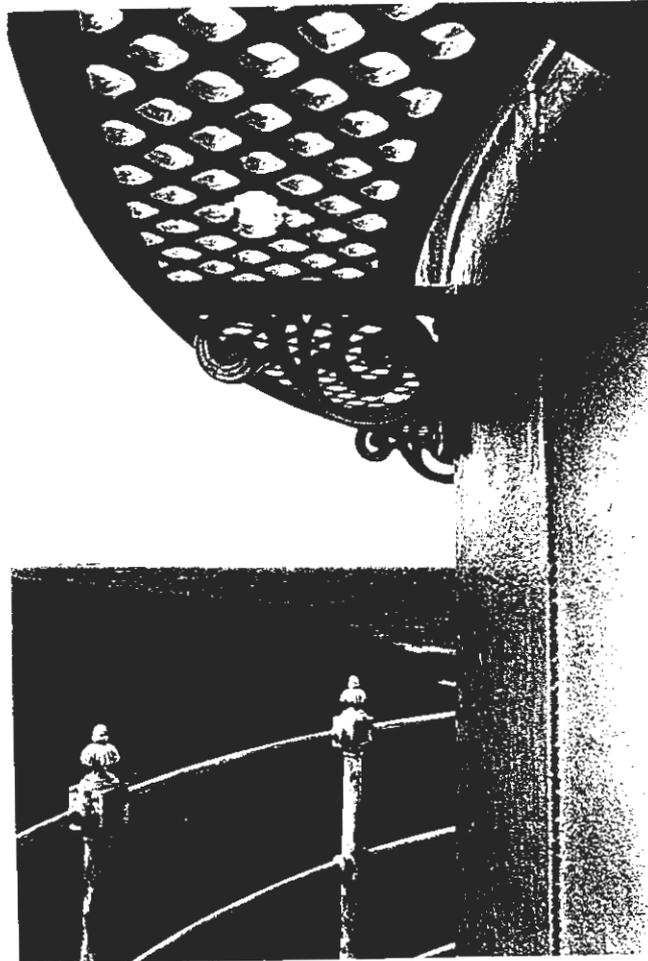
Figure 38 Gallery level at the Cape Nelson Lighthouse (cf. Fig.28). Reproduced from Cape Nelson Lightstation.

The Cape Nelson Lighthouse is a 23.9 metre (73') high tower of basalt construction, painted white. In general form and scale the lighthouse is very similar to the Split Point lighthouse (Fig 37). The building is circular in plan, tapering as it rises, terminating in a coved cornice and surmounted by a glazed lantern house. The 3.6m (11' 10") diameter lantern was constructed in 1883, and, as at Split Point, has diagonal patterned glazing. It has a similar profile to that at Split Point, and is also capped by an orb and weathervane. The cast iron balustraded gallery is likewise similarly detailed (Fig 38). Internally, the tower also retains its original cast-iron staircase.

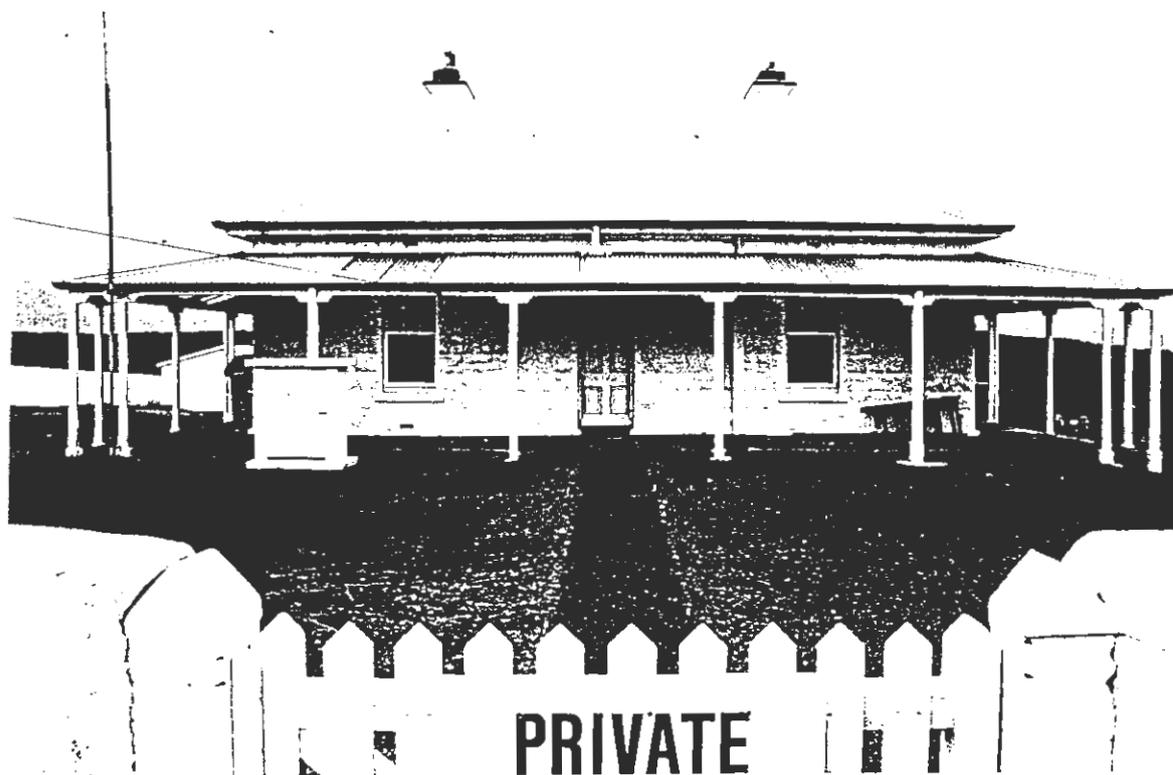
Figure 39 Cape Nelson Lighthouse Keepers' Cottage. Note the timber verandah posts and carved timber brackets. Reproduced from Cape Nelson Lightstation.

Surviving associated structures include the Head Keeper's cottage (c.1883), Assistant Keeper's cottage (c.1883), Assistant Keeper's former kitchens (c.1883), lookout (c.1890), powerhouse (c.1930) and office and workshops (c.1883).³ Later buildings include the fowl house (c.1940) and two garages (c.1990). The Keepers' cottages are of masonry construction, but nevertheless have in common with the Split Point cottages a number of several minor details. Verandahs are supported on chamfered timber posts, with similar carved brackets (Fig 39). Internally, fireplaces have similar carved timber mantelpieces.

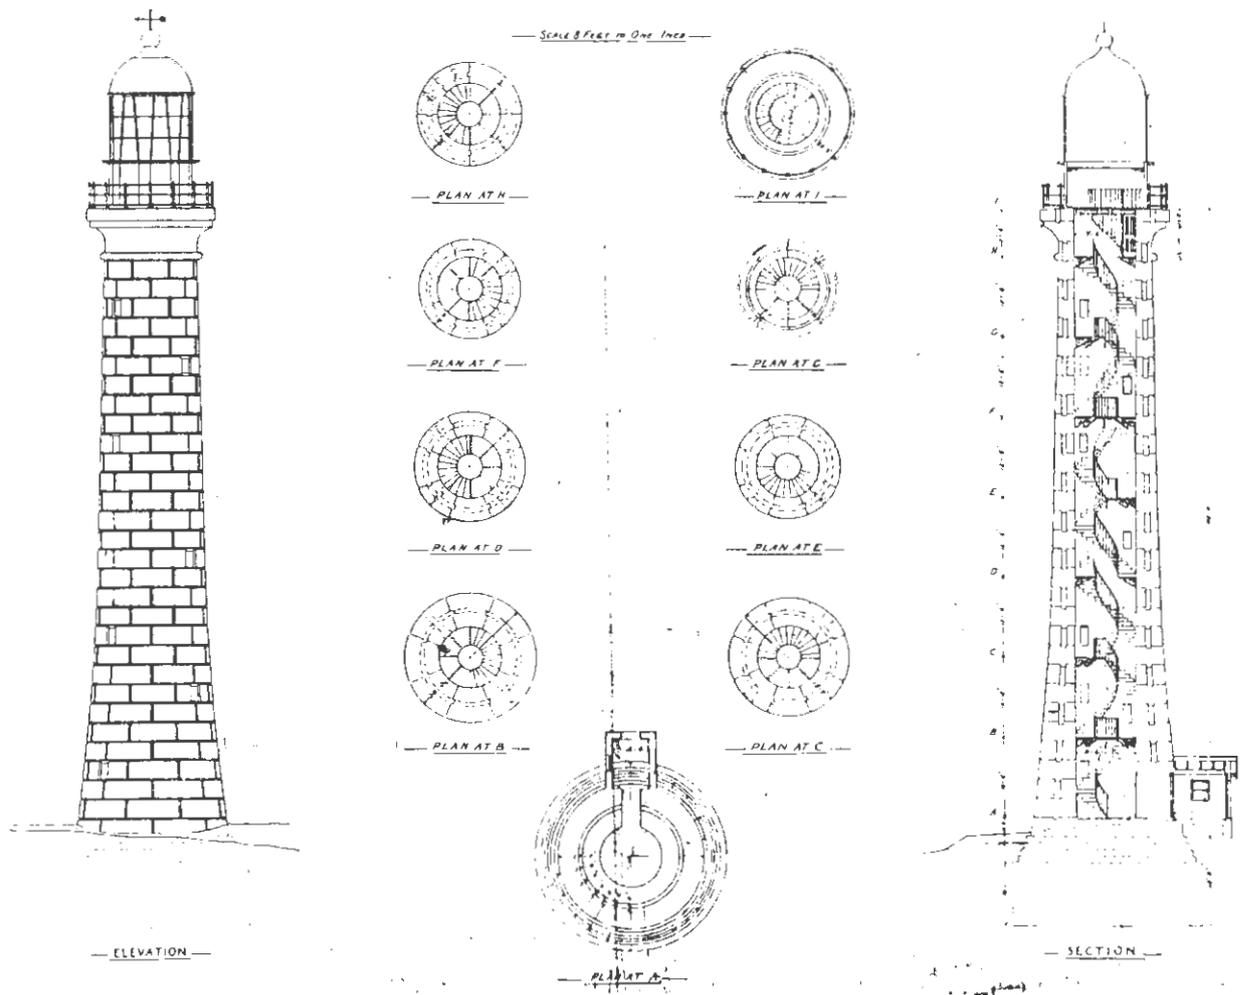
Figure 40 The original contract drawings for the Point Hicks Lighthouse, with similar lantern, gallery, coved cornice and gabled entrance porch to the Split Point Lighthouse. Reproduced from Point Hicks Lightstation.

The history of the construction of the lighthouse bears some similarities with that of Split Point. The tower was originally intended to have been constructed of stone, and contract drawings were prepared by the Public Works Department, signed by Frederick M. Hynes.⁵ (Fig 40). The tender prices of 1886, however, greatly exceeded the original government estimate. A decision was made to erect the tower in concrete, after an option to construct an iron tower had been rejected.⁶ Following difficulties in getting materials to the remote site, the lighthouse was eventually completed November 1889.

The design of the tower is very similar to that at Split Point. The white-painted tapered tower is circular in plan, punctuated by small openings and terminating in a coved cornice. The lighthouse also had an auxiliary light, situated within an arched opening at the upper level of the tower, as had originally been envisaged for the Split Point tower (Fig 41). The Chance Bros. lantern is near identical to the Split Point lantern, having a cast-iron frame with diagonal patterned glazing, and surmounted by a hemi-spherical dome with an orb. The tower originally had a similar gabled entrance porch, demolished in 1938.⁷

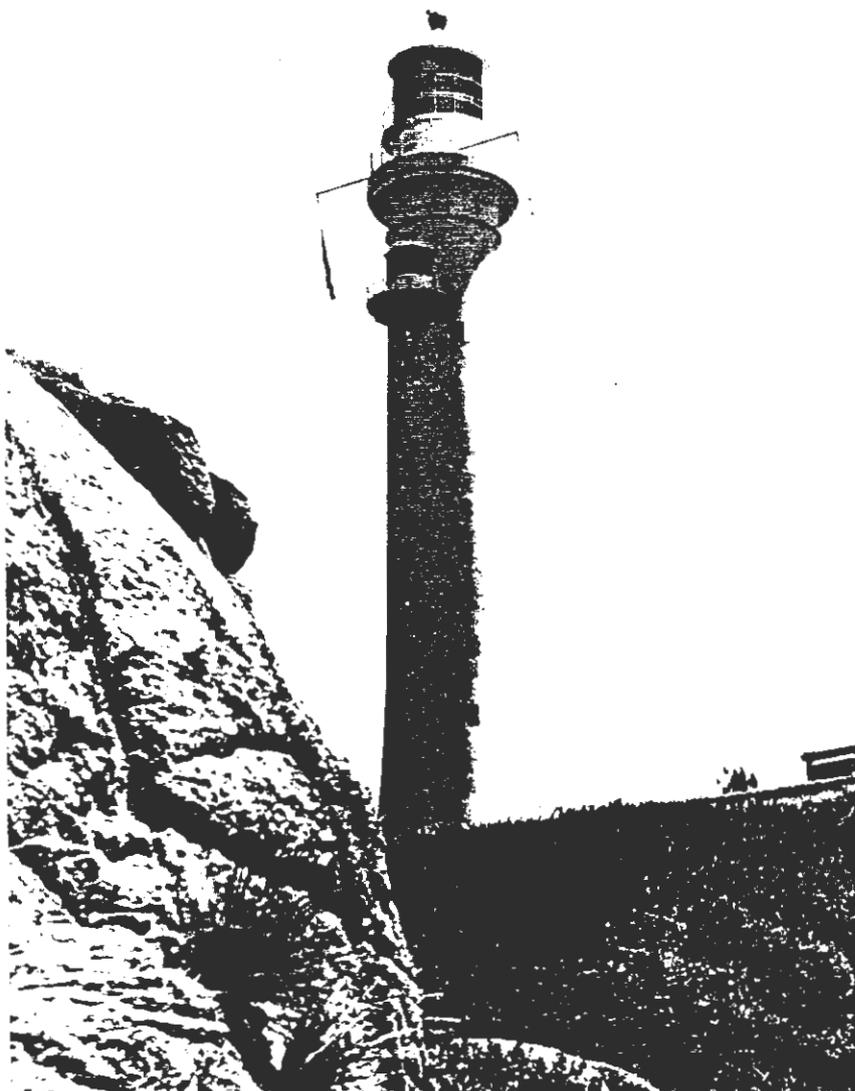
Figure 41 *The Point Hicks Lighthouse, photograph dated 1975. Note the original auxiliary light. The balcony has since been removed. Reproduced from Point Hicks Lightstation.*

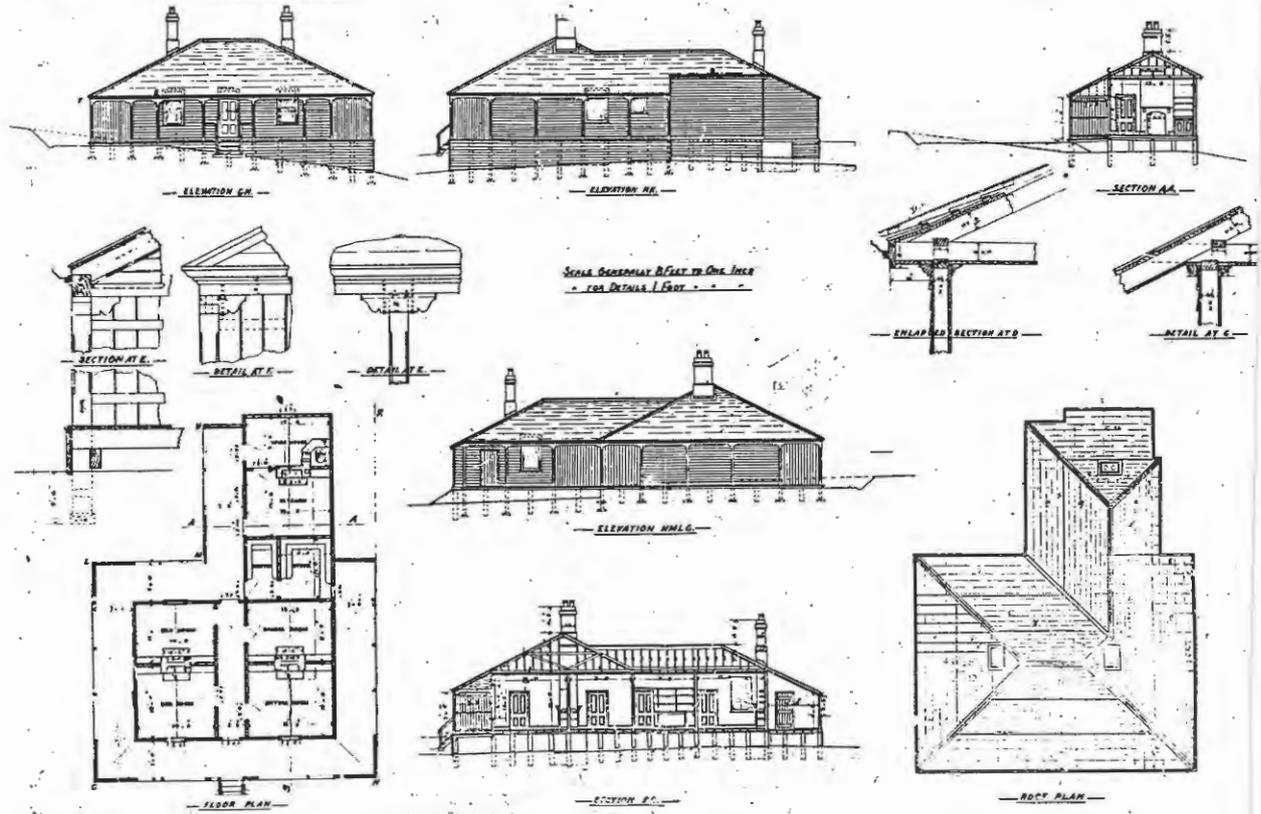
CAPE EVERARD LIGHTHOUSE
POINT HICKS PRINCIPAL'S Q'ARTERS

Figure 42 Original drawings of the weatherboard Head Lighthouse Keeper's Quarters. Reproduced from Point Hicks Lightstation.

Also surviving at Point Hicks are the original head lighthouse keepers' cottage, the assistant lighthouse keepers' cottage, two coal sheds, a workshop/office and two store buildings. The two keepers' cottages bear many similarities to those at Split Point and are probably of a standard design. The head keeper's cottage has a similar L-shaped plan form, except in mirror image, and has similarly detailed timber verandah posts and brackets (Fig 42). Likewise, the assistant keepers' cottage is T-shaped in plan, with similar timber verandah

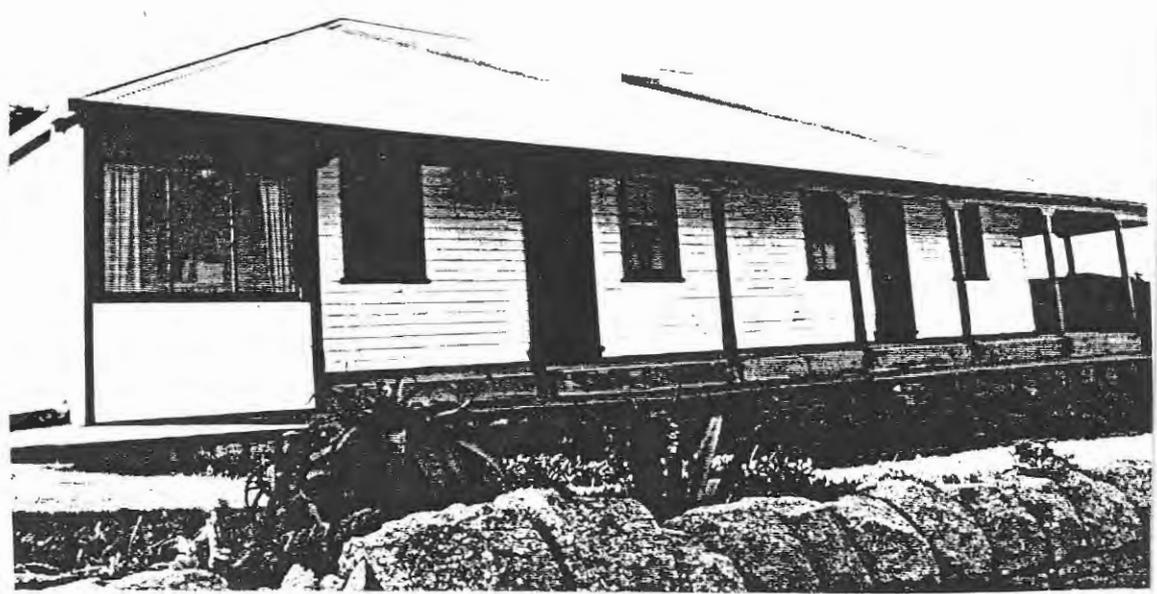
Figure 43 View of the assistant lighthouse keepers' quarters, of a similar design to the cottage at Split Point. Reproduced from Point Hicks Lightstation.

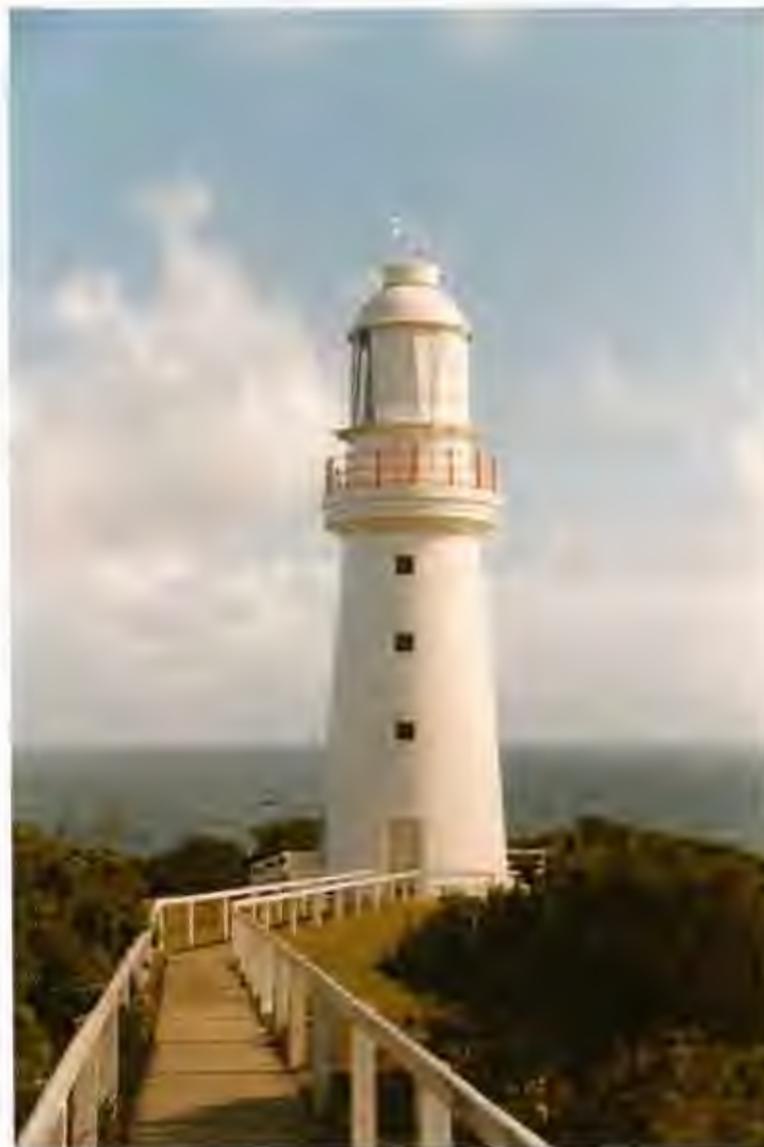
Figure 45 Cape Otway Lighthouse, constructed 1848, with 1891 Chance Bros. lantern.

The original lantern at Cape Otway was replaced in 1891 with a 3.7m (12'2") diameter cast iron Chance Bros. lantern.¹⁴ As at Split Point, it has diagonal patterned glazing, hemispherical copper clad dome and an external gallery with simple cast iron balustrading (Fig 45). The optic lens, also by Chance Bros., survives, and is of five groups, each with three panels¹⁵ (Fig 46).

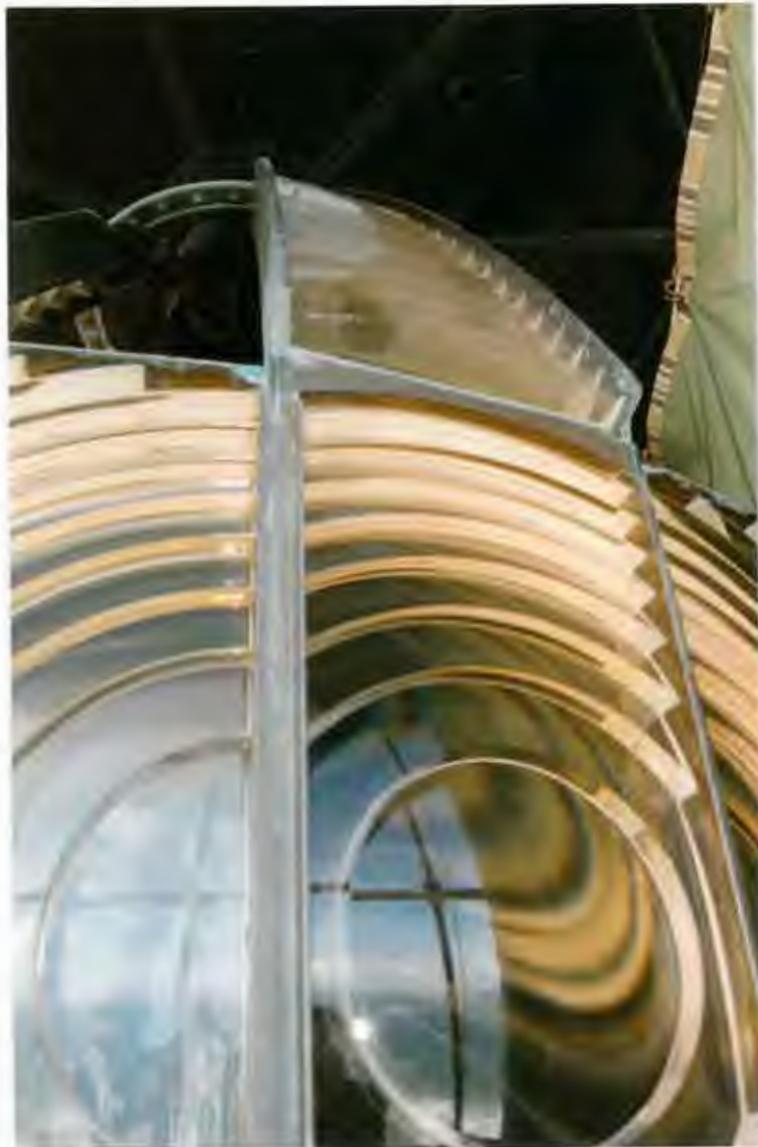
Figure 46 Cape Otway lantern interior, with original Chance Bros. optic lens.

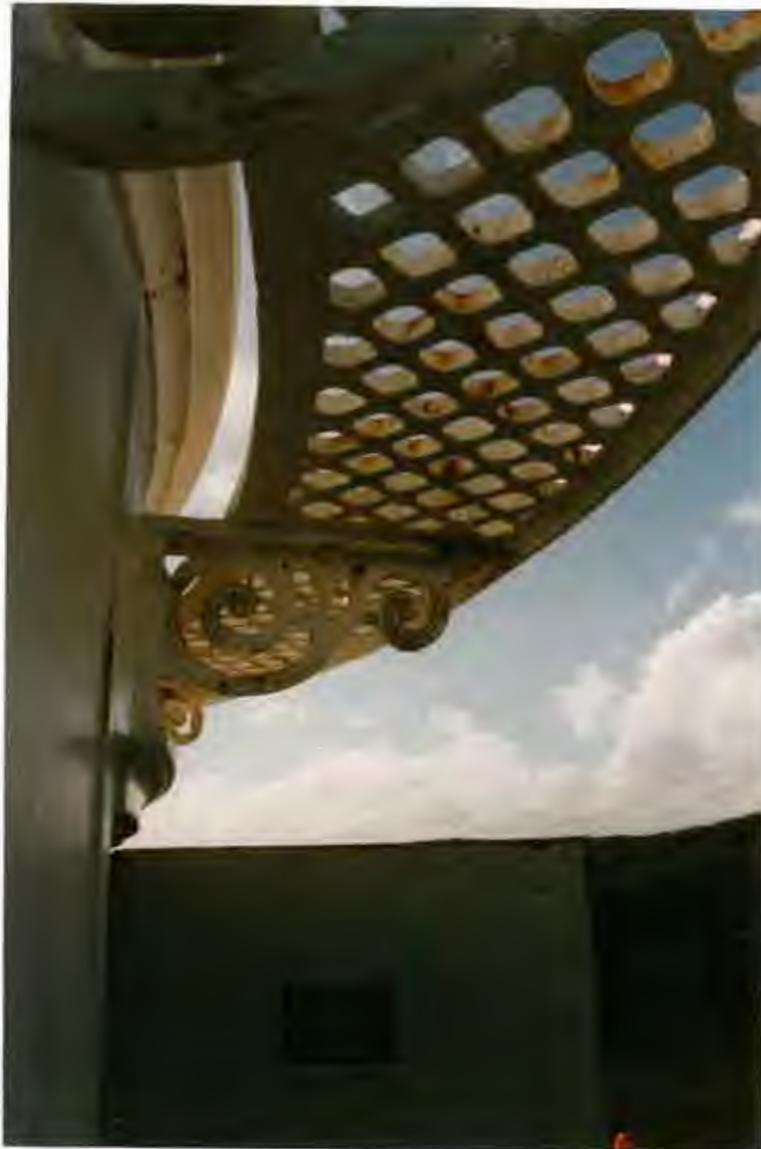
Figure 47 Cape Otway Lighthouse: cast iron gallery.

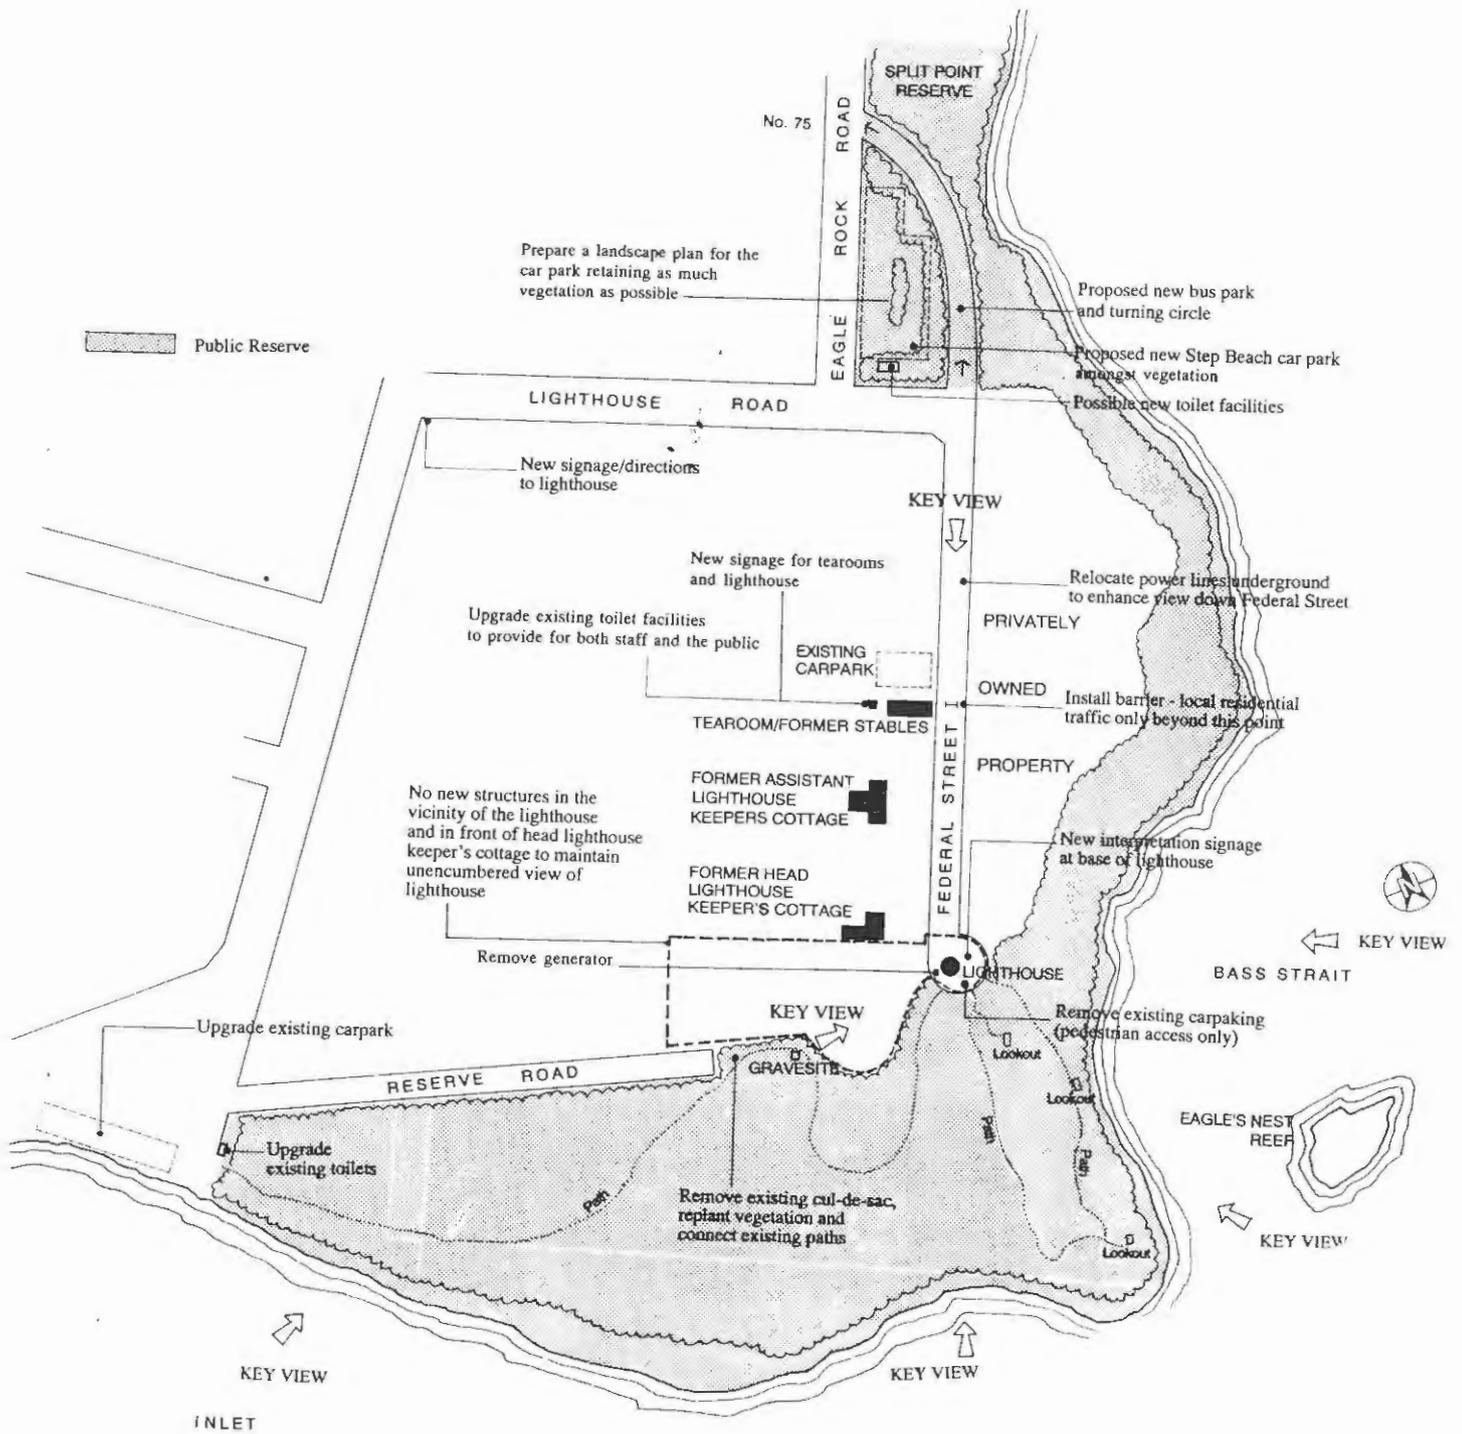
Figure 48 Proposed works to the lighthouse precinct
