Facility Development Plan Issues and Opportunities

Dean's Marsh Community Hub Surf Coast Shire June 2022 REV 1

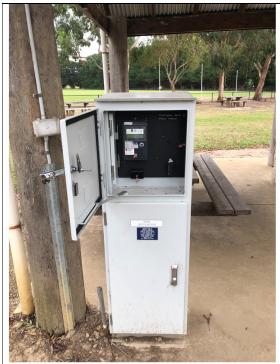
Figure 2- Authority meter panel installed in 2021 located in picnic shelter in Reserve

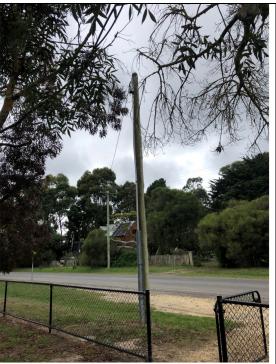
Figure 3- Existing overhead supply to the Reserve MSB/meter panel

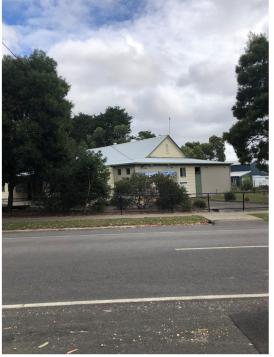
Figure 5- Existing overhead supply to the Hall from Pennyroyal Valley Road

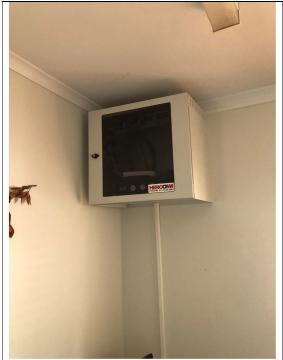
Figure 9- Comms rack located in MCH area of Community facility

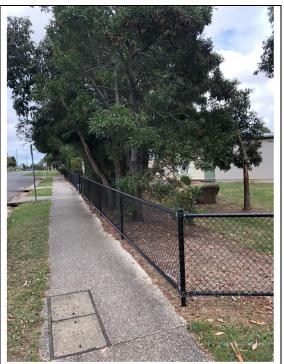
Figure 10- Existing Telstra/NBN pits located in the property boundary in NE corner of the site.

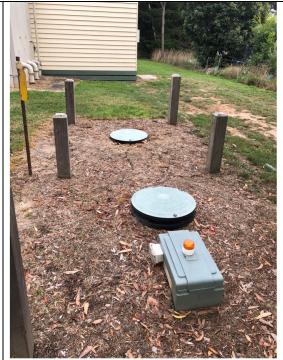
Figure 12- Wastewater treatment system with in ground storage/treatment tanks

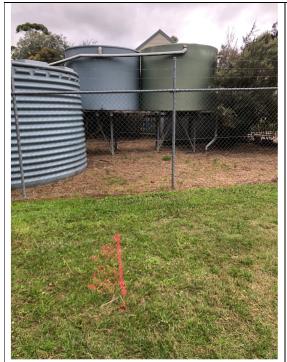
Figure 13- Onsite rainwater tank farm at rear of the site

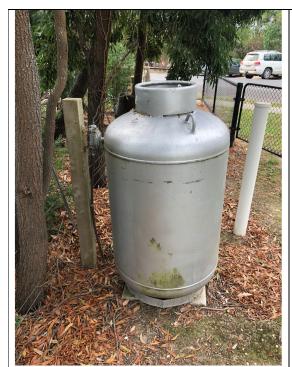
Figure 15- Onsite LP gas storage tank

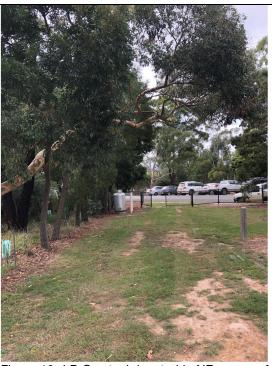
Figure 16- LP Gas tank located in NE corner of site

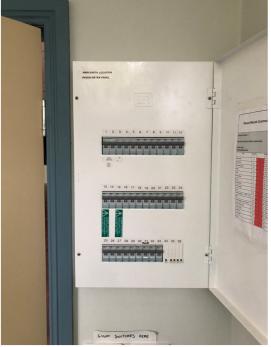
Figure 18- MSB located in Community Hall

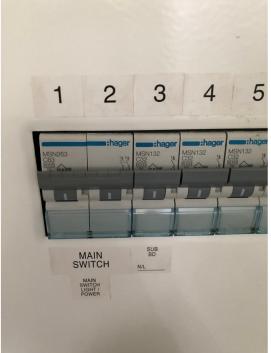
Figure 20- Two phase main switch & circuits not provided RCD protection

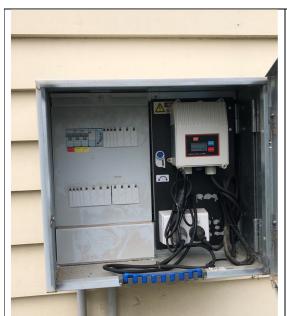
Figure 21- Wastewater Treatment system control panel

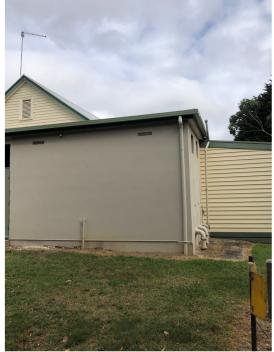
Figure 22- Sewer reticulation from local amenities adjacent the wastewater treatment system in NE corner of site

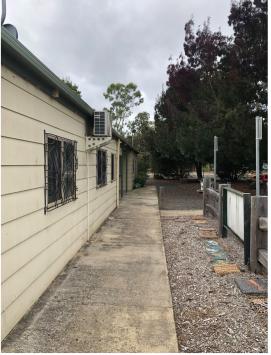
Figure 24- Condensing unit located on façade bracket at high level, installed in 2021

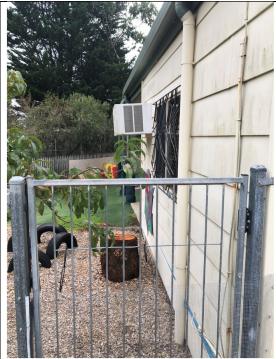
Figure 25- Room A/C unit located in childcare area at rear of the facility

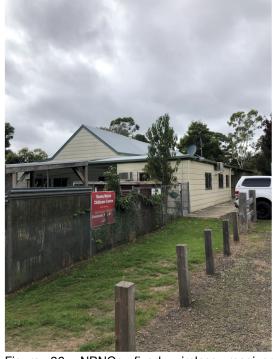
Figure 26- NBNCo fixed wireless receiver located at roof level

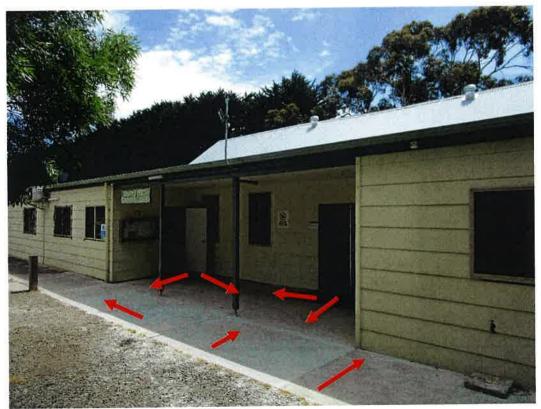
Photo 2; South of hall. Arrows show direction of paving fall.

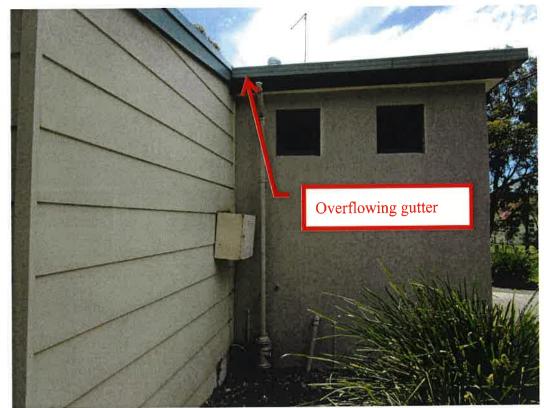
Photo 3; Building south east re-entrant corner.

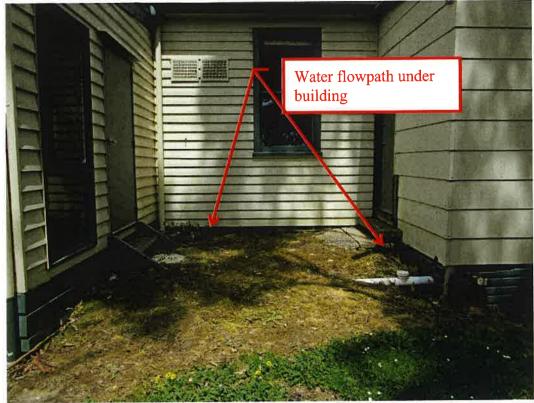
Photo 7; North courtyard; soil surface level higher than under building.

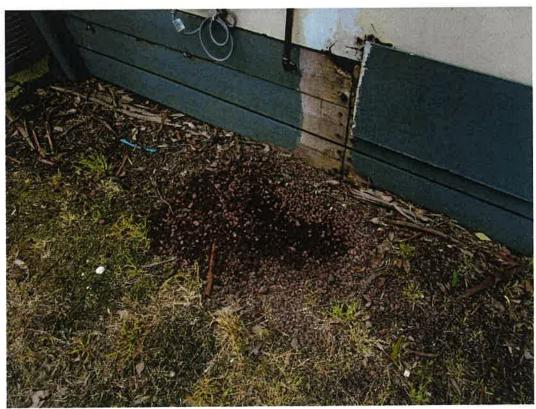
Photo 8; North side. Scoria filled hole. Purpose unknown.

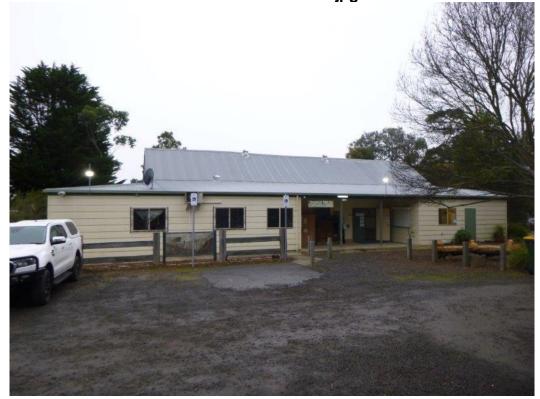
Photo 02 - External.jpg

The carparking area and uphill playground area and recreation reserve general falls towards the building with the relative low point being near the building's southern entry. There is little or no freeboard to the hall southern entry (Photo 02 & 03). Reportedly some concrete pavement works were carried out in this area to provide a localised spoon drain which it would appear directs small amounts of runoff away from the entry. However, there is no outlet or fall away from this low point. Refer to external levels in this area on Drawing 23688_F05 in Appendix B.

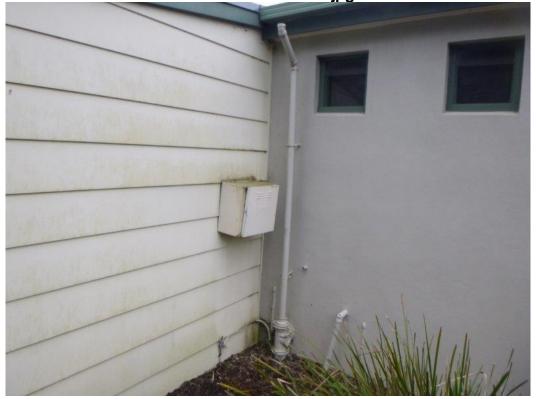
Photo 04 - External.jpg

There is generally a very slight fall away from the building on the east and southern side and better fall away on the west side. However, there are several areas around the building perimeter where water can pond (eg photo 04) and given the relative flat and marshy soils even with slight surface fall, drainage remains poor with water permeating the upper silty soils and being trapped on the underlying clay as noted in the footing exposures (Photo 10 & 12, Drawing 23688_F09 in Appendix B). There is also likely to be subsurface flow towards the building, following the natural ground slope.

Roof seals, screw rubber seals and flashing were in fair to poor condition with many poorly constructed. Roof sheeting was corroded in places (Photo 04, 22, 25-27). Signs of water ingress were noted internally in several locations (Photo 54, 56, 59-61, 66).

It appears the gutter system to the south east corner regularly overflows, with a build up of algae and staining visible (Photo 04).

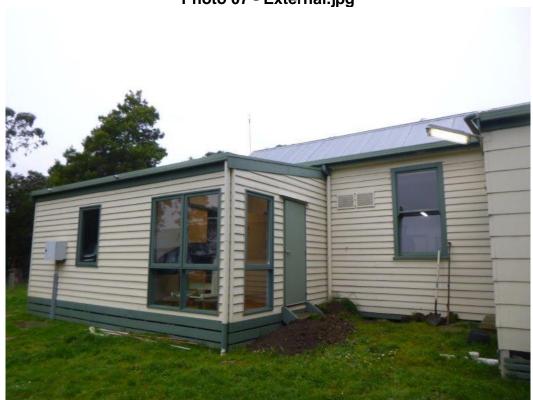
Photo 08 - External.jpg

Gutters on the northern side were falling away from the downpipe outlet, with water ponding in the gutter. Several overflow pops had been retrofitted further reducing the capacity of the gutters, with uncontrolled overflow contributing to the site drainage issues around the building perimeter (Photo 08, 23, 24, 26).

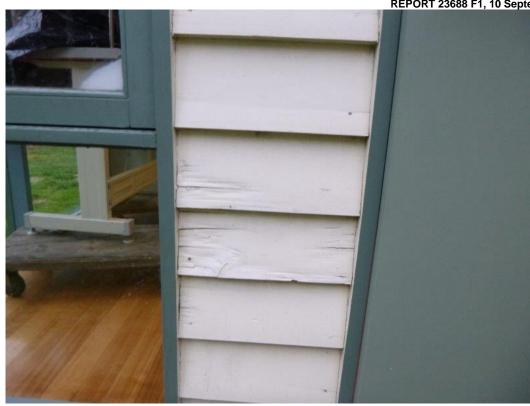
Photo 09 - External.jpg

Wall cladding varied in material, style and age around the building. The external cladding was mostly fibre cement weatherboard with some traditional timber weatherboard to the southern side. Refer to external photos in Appendix C for further details and extents. Some localised damage and rot were evident in some locations (Photo 09, 15, 19).

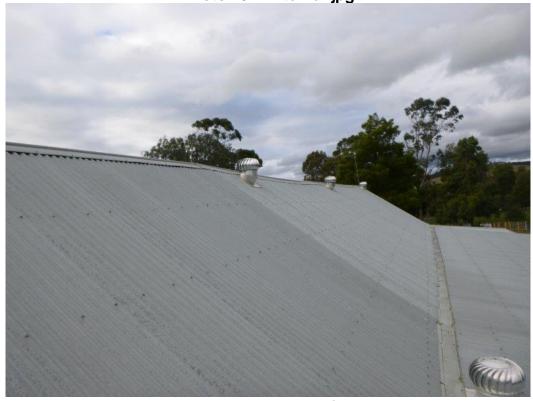
Photo 20 - External.jpg

A significant dip in the ridge vertical alignment in the area over the stage can be seen externally (Photo 20). The roof framing is this area (original hall) is framed without struts/web members to create a truss, unlike the remainder of the original pitched roof section. It was reported previously by another consultant that the struts visible elsewhere have been removed. On close inspection there were no signs of nail holes or different rafter colouration in the corresponding strut locations, commonly seen when original framing members are removed. The rafters appear to have rotated away from the ridge board. Timber cleats and packers fixed to the rafters appear to have been retrofitted to prop up roof battens and maintain pitch to roof sheeting, which presumably had deflected excessively (Photo 44, 45). The ceiling joists in this area were deflected excessively when partially loaded by a person (approximately 40-80kg).

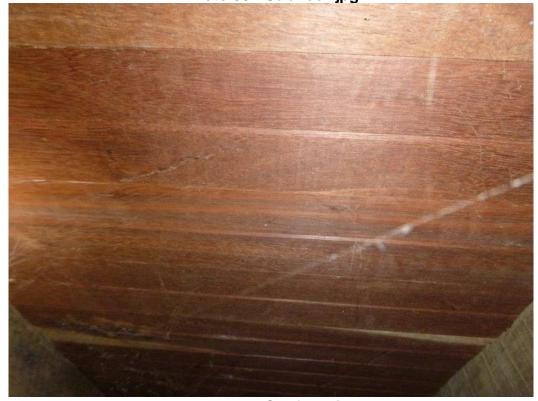
Photo 34 - Subfloor.jpg

The floor boards to the original hall do not appear to be original. The technology to achieve the machined edges visible from the underside would not have existed at the time the hall was originally constructed (over 130 years ago). It appears the floor boards may be tongue and grooved (Photo 34). The southern wing of the hall has different lighter coloured floor boards to the rest of the hall (Photo 50). The northern kitchen has chipboard flooring underlay with a vinyl finish.

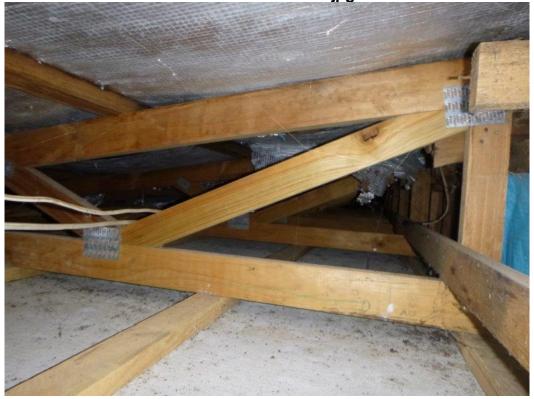
Photo 40 - Roof Space.jpg

- The southern kitchen roof consists of prefabricated trusses (Photo 40);
- The junction between the higher pitched roof and the "lean to" roof of the main hall is supported by a steel truss (TR1). There was rust present on much of the truss (Photo 42). Access to accurately measure the truss was limited however approximate dimensions are provided on the attached drawings. This truss spans approximately 10.5m. Columns, likely timber, are visible internally at the ends of the truss with two exposed bolt heads to the underside of the truss bulkhead. The timber panelling to the truss bulkhead appeared to be pine when viewed from the roof space;

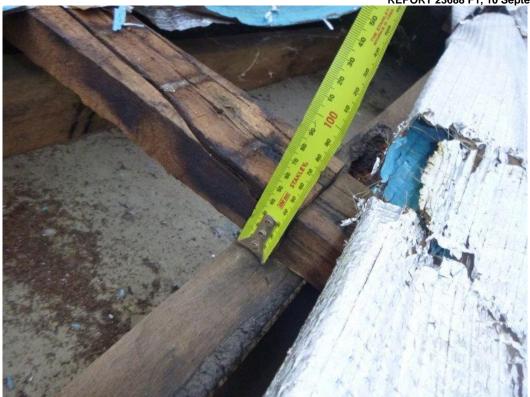
Photo 41 - Roof Space.jpg

- An excessive dip in the roof sheeting is visible externally (Photo 21). The
 reason for this was not explicitly clear on removal of the roof sheet, however
 some of the battens had signs of damage and/or defects (Photo 41). The
 battens were measured as approximately 70x35 on flat at approximately 9001200 CTS;

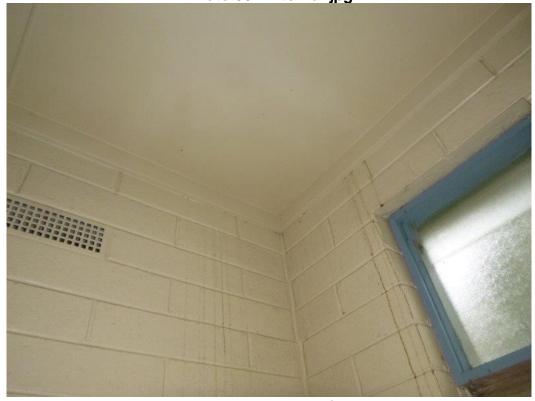
Photo 54 - Internal.jpg

Internal wall lining to the main hall area was a mixture of timber panelling (some possibly original) and plasterboard (unlikely original). Elsewhere the internal lining was typically plasterboard with exposed brickwork to the toilet area. Some minor cracking to brickwork and plaster was noted in some locations (Photo 55, 57, 58, 60, 62- 64). There were no other obvious signs of any major structural issues other than some localised signs of moisture ingress (Photo 54, 56, 59-61, 66).

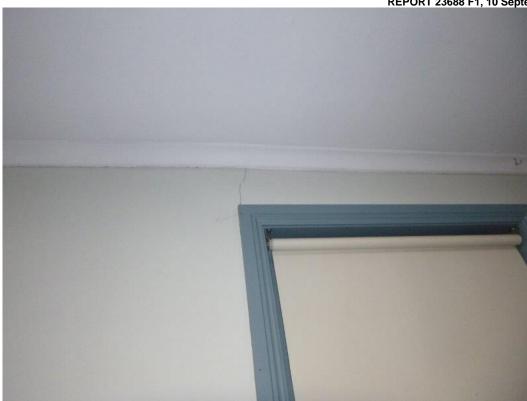
Photo 57 - Internal.jpg

Up to 70mm of relative level difference was measured across the central hall area with the southern side being higher relative to the northern areas. Some relatively minor cracking was noted on the southern wall (Photo 57, 58, 60). A localised level anomaly was observed in the north west corner of child care nursery with up to 60mm level difference between this room and the adjacent hall. Due to limited access at the time

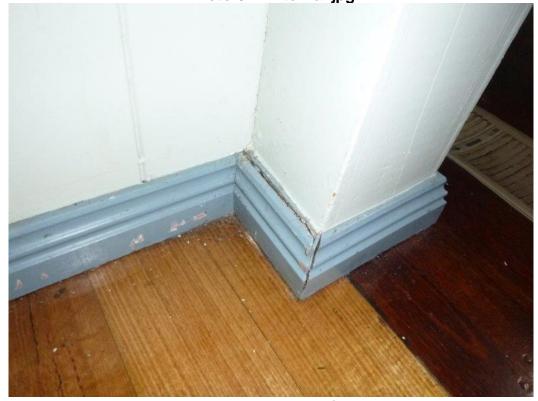
Photo 62 - Internal.jpg

of inspection it is not clear if floor level was set down lower that the adjacent hall. Some localised damage to the skirting was noted in this location (Photo 62).
